File Note: 006

Subject: Regent Road Wall - The Switchback

Document Ref: BMD01-HPM-XX-XX-FN-Z-100006 Revision: P02

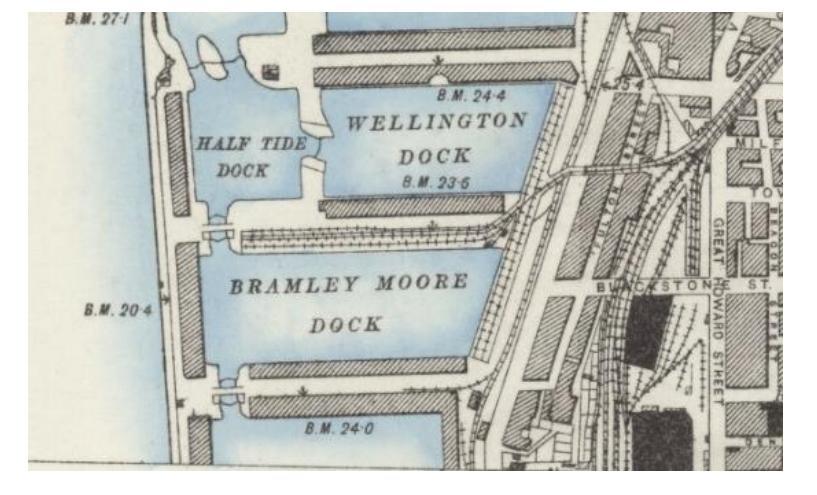
Northern Dock complex showing rail connections. OS surveyed 1890, published: 1894

Plan view of Lancashire and Yorkshire railway lines running into Bramley Moore Dock and Overhead Railway line following the line of Regent Road.

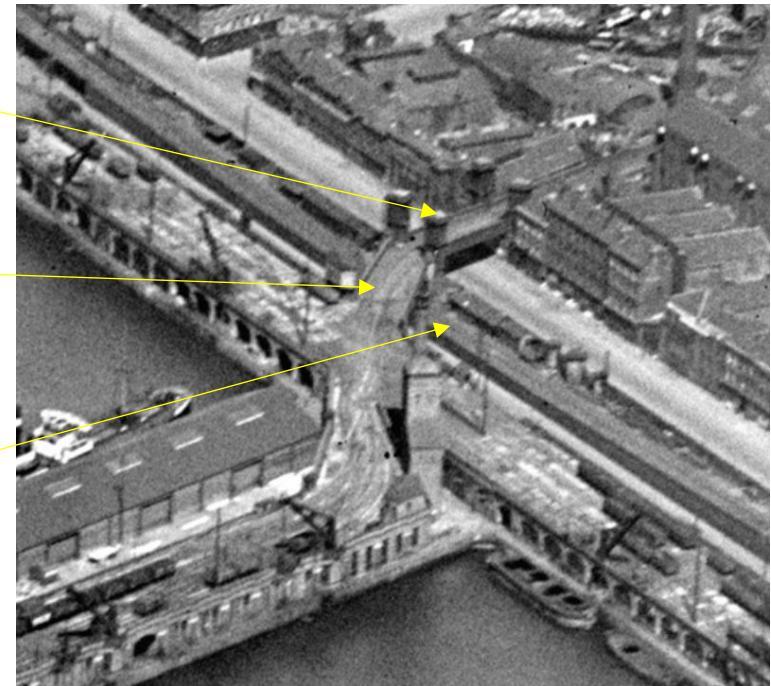
Aerial Photo - Bramley-Moore Dock, 1927

Hydraulically operated bridge over Regent Road (4No raising towers).

High level coal railway crossing over Regent Road wall.

Overhead Railway to rear of the Regent Road wall – tapering under the Hydraulic bridge.

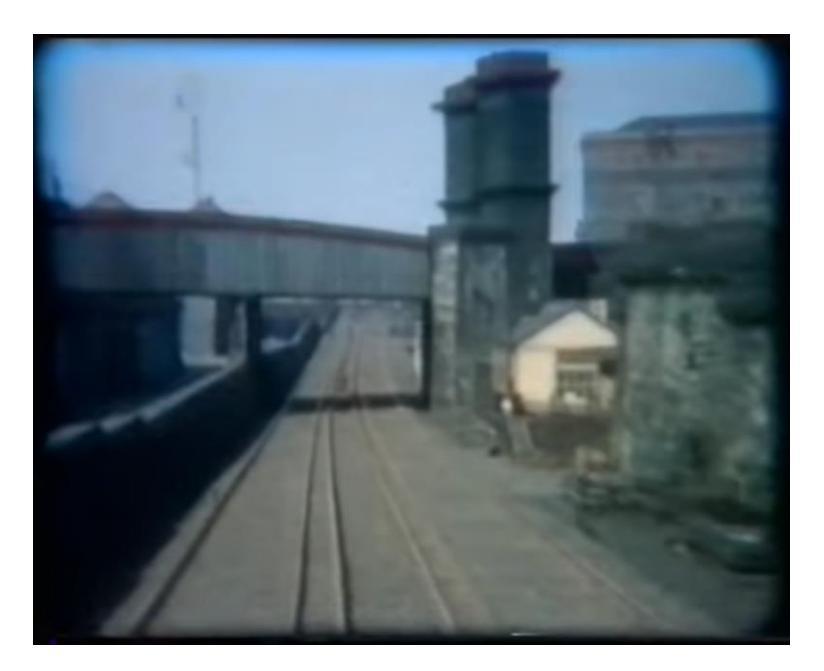
Image taken from the Overhead Railway travelling north approaching the Hydraulic bridge. (Internal elevation of the BMD entrance gate piers).

Photo taken from "Liverpool Overhead Railway" by Online Video (1990). Original footage dates unknown.

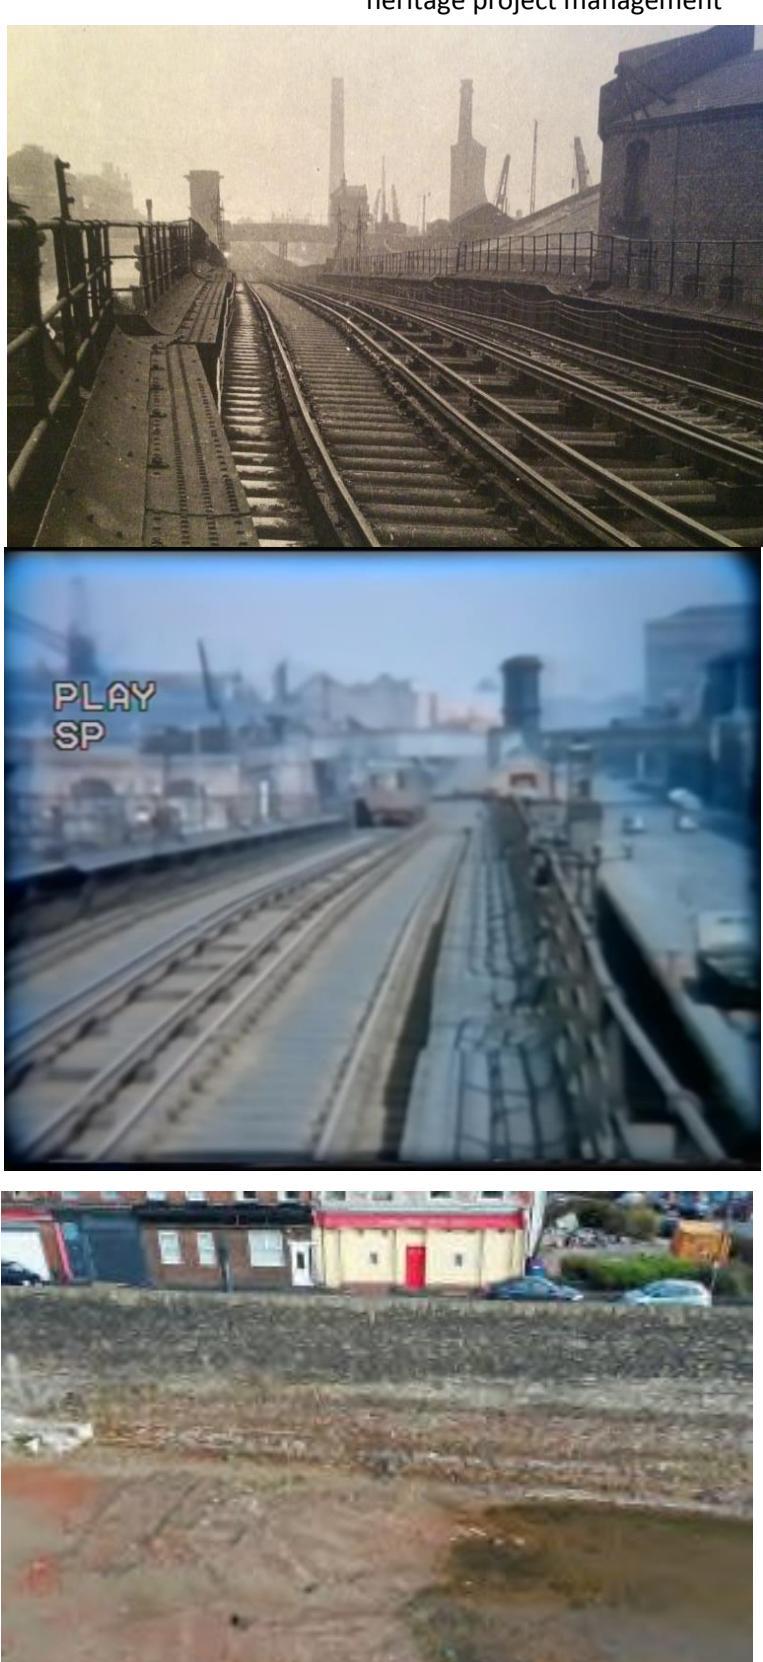
The brickwork to the rear of the wall aligns with the position of the "switchback" gradient and is one of the only remains of the Overhead Railway system.

Photo taken from Drone Footage (LoR 2020).
