# <u>Trees and Construction</u> BS5837 Tree Survey Assessment

- Site: Site off Great George Street
- **Ref:** 19025/A1
- **Client:** The Great George Street Project

**Tree Constraints Plan:**

As appended (19025/TCP/01)

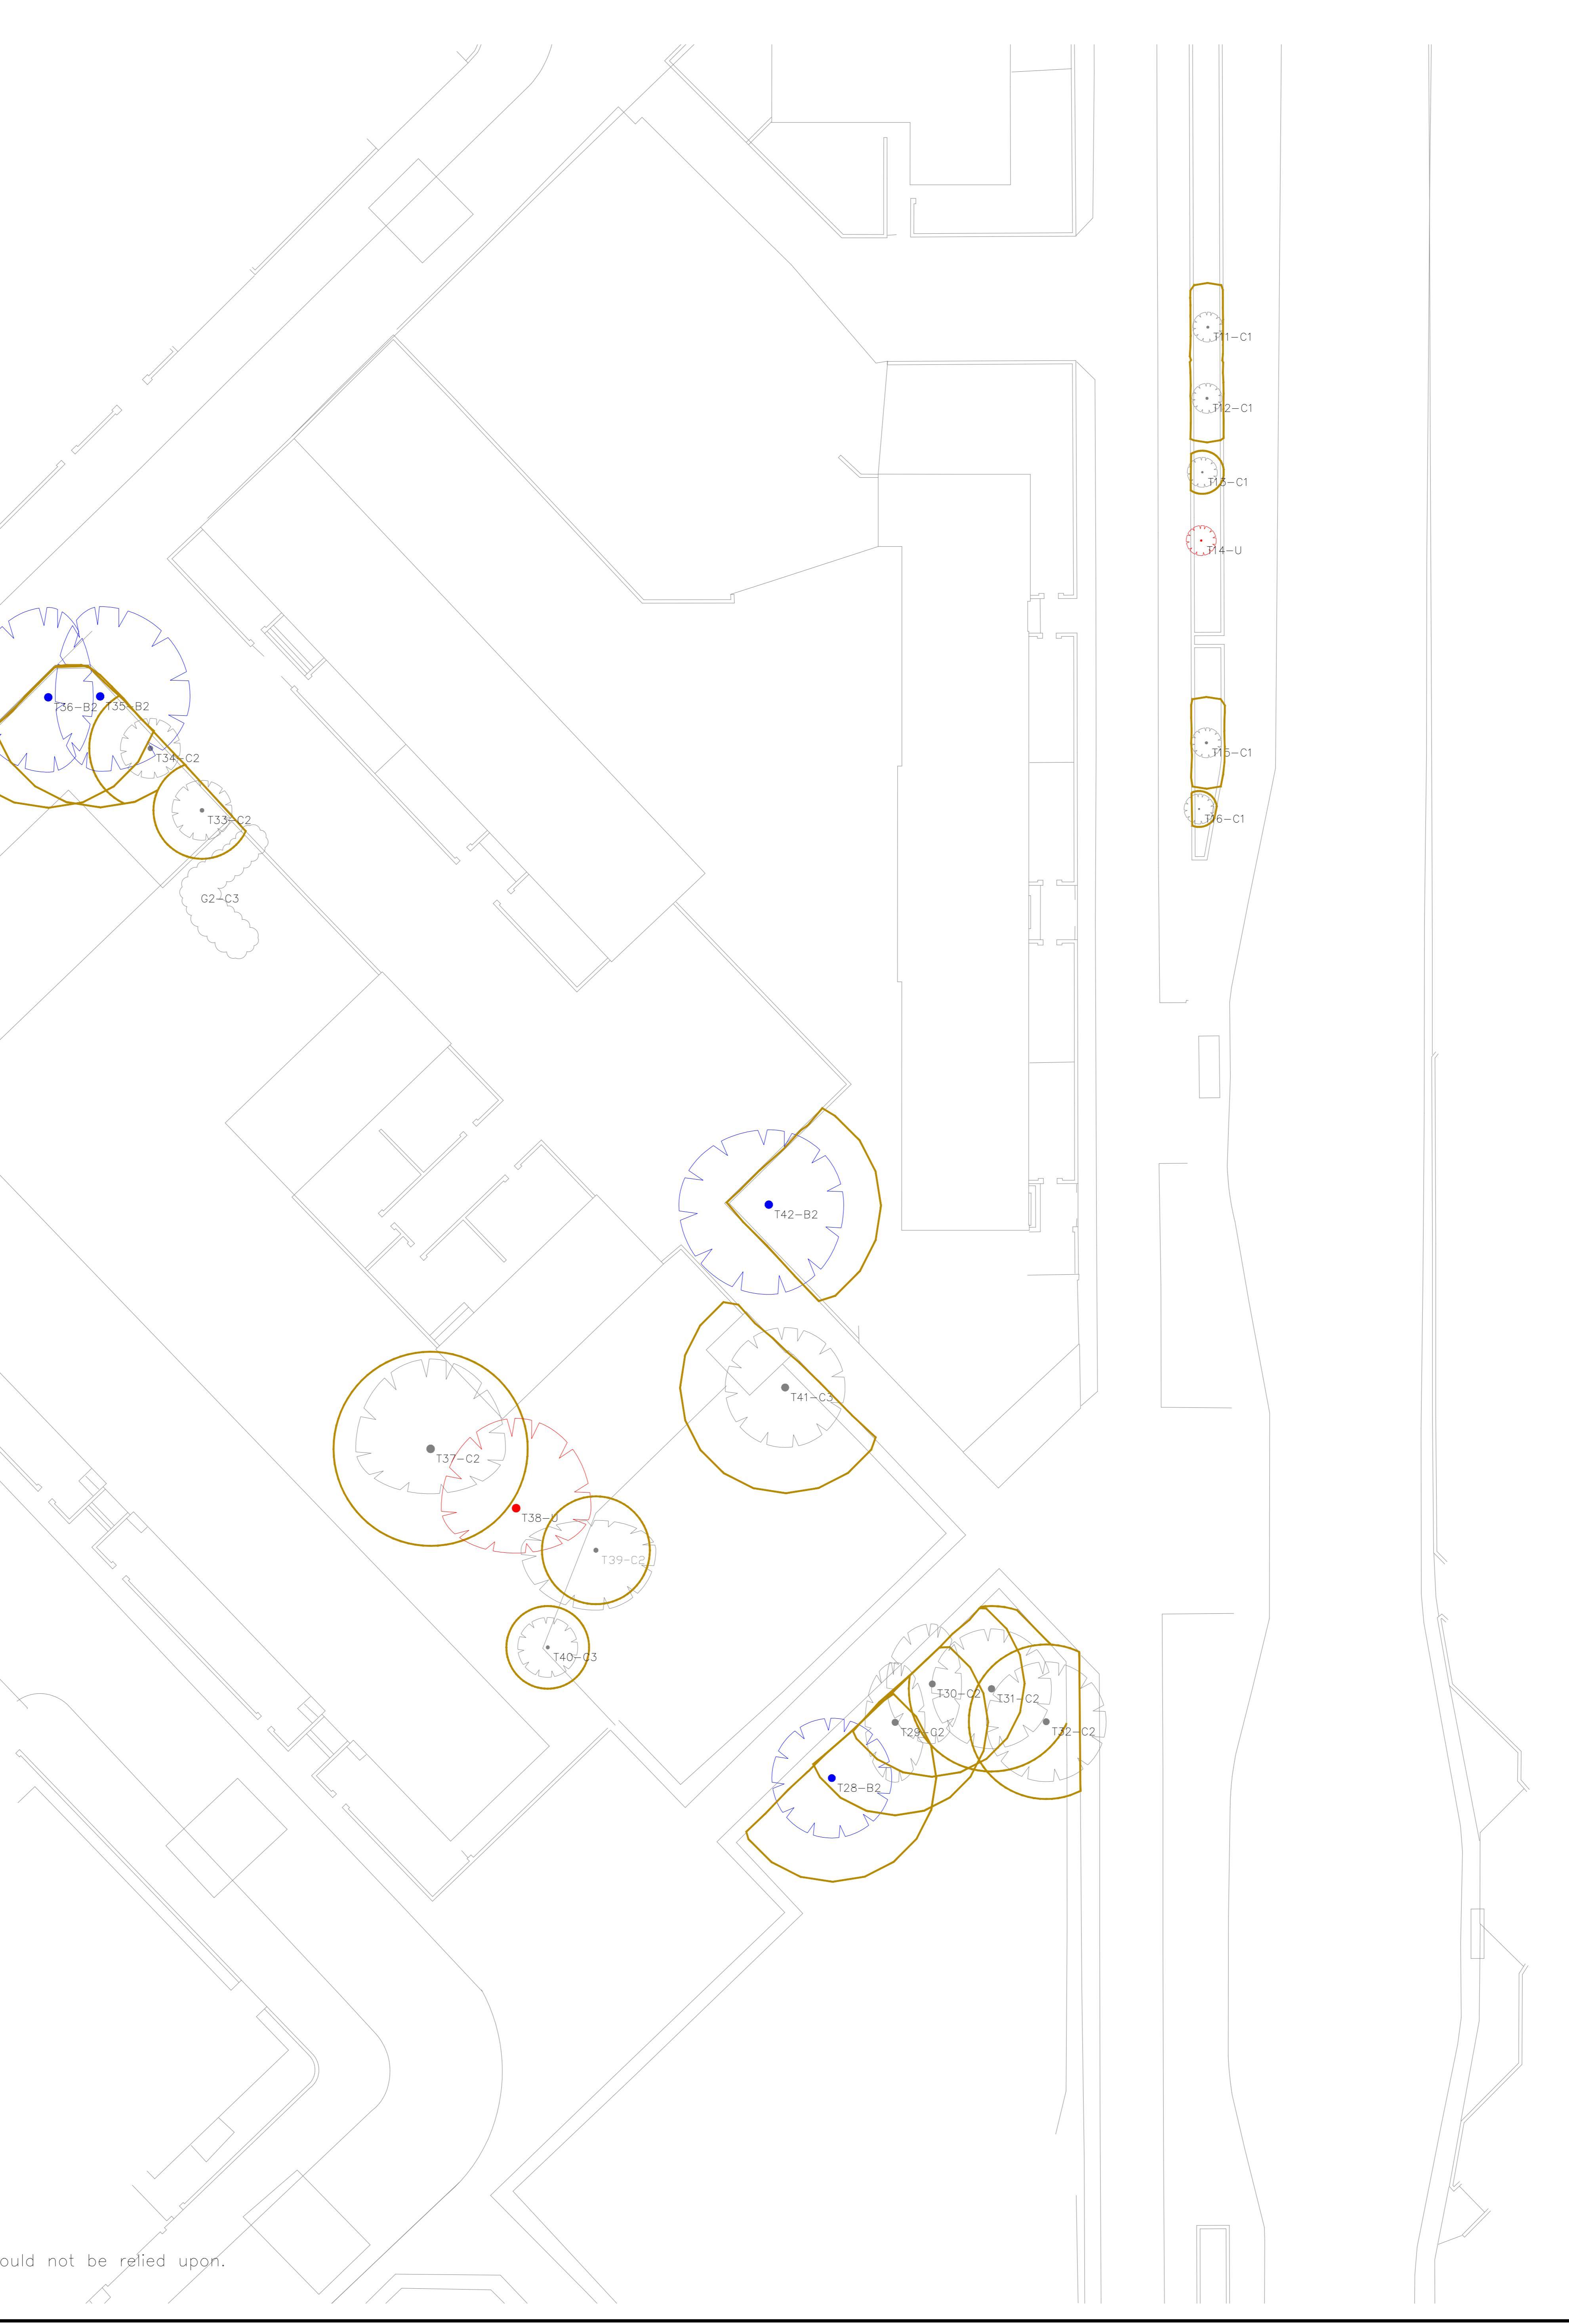
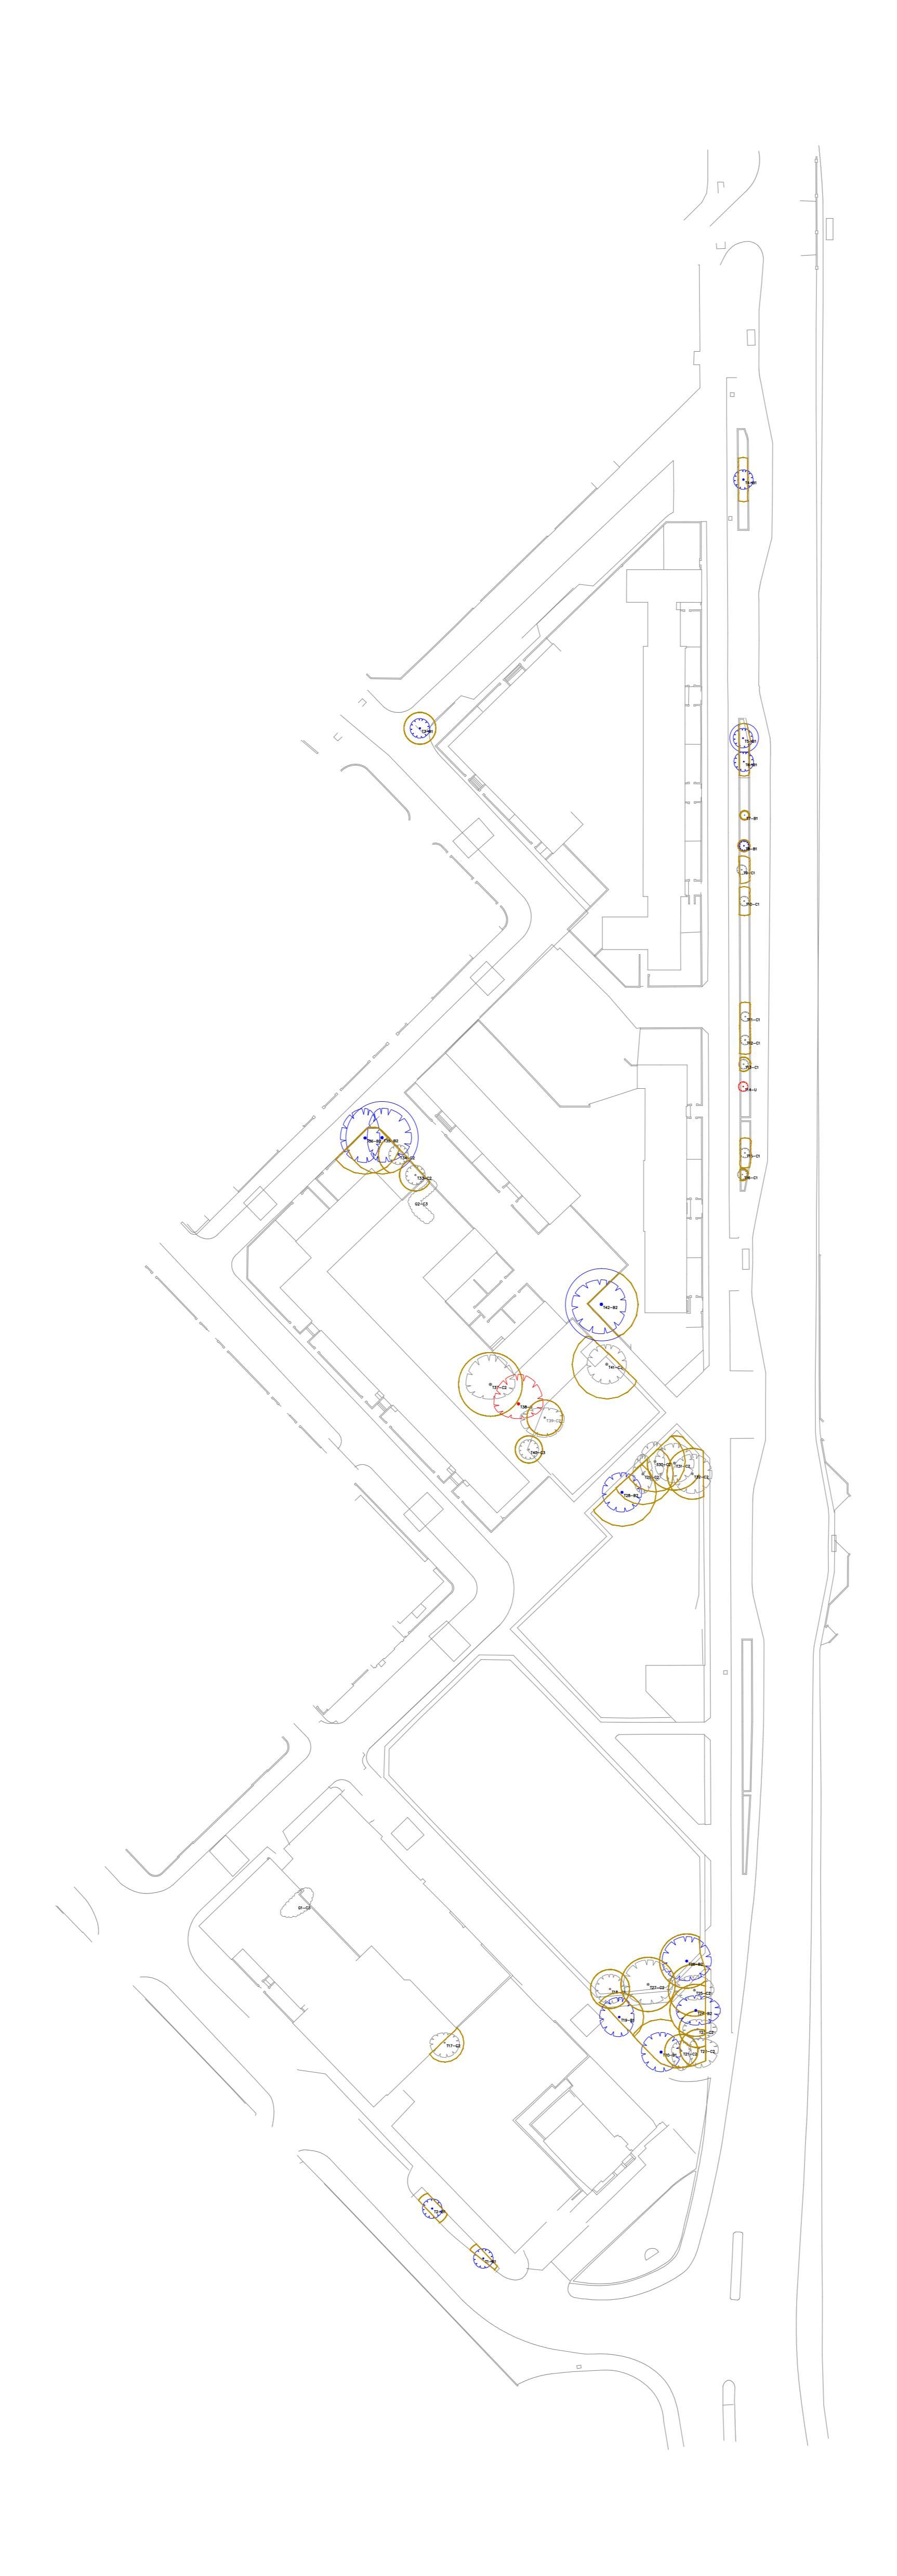
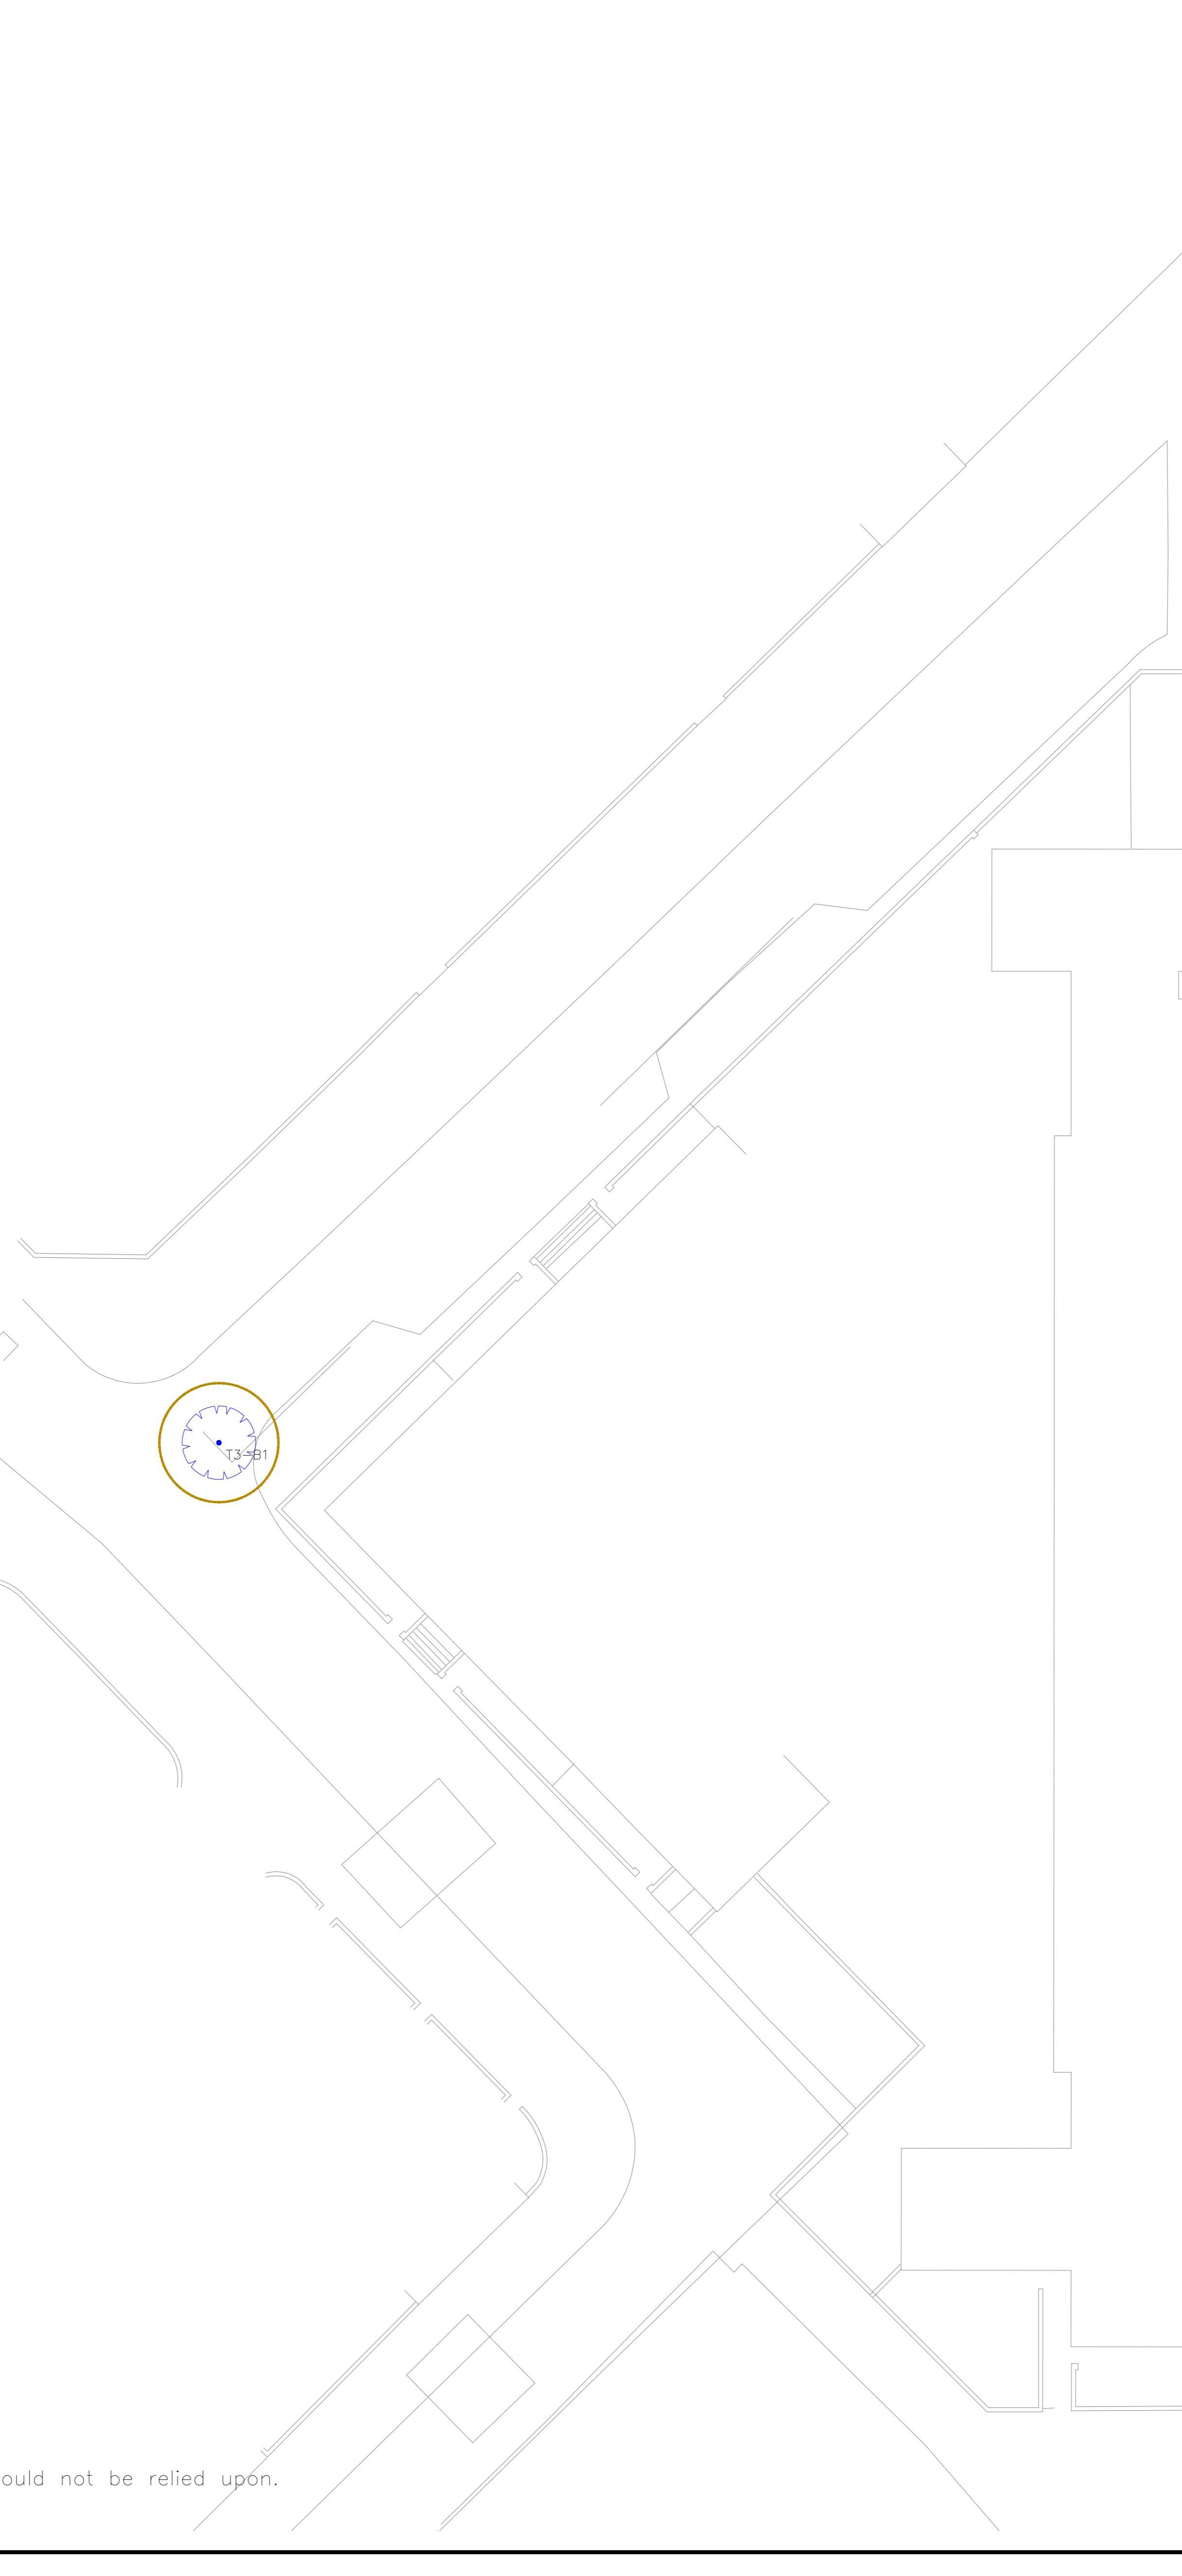
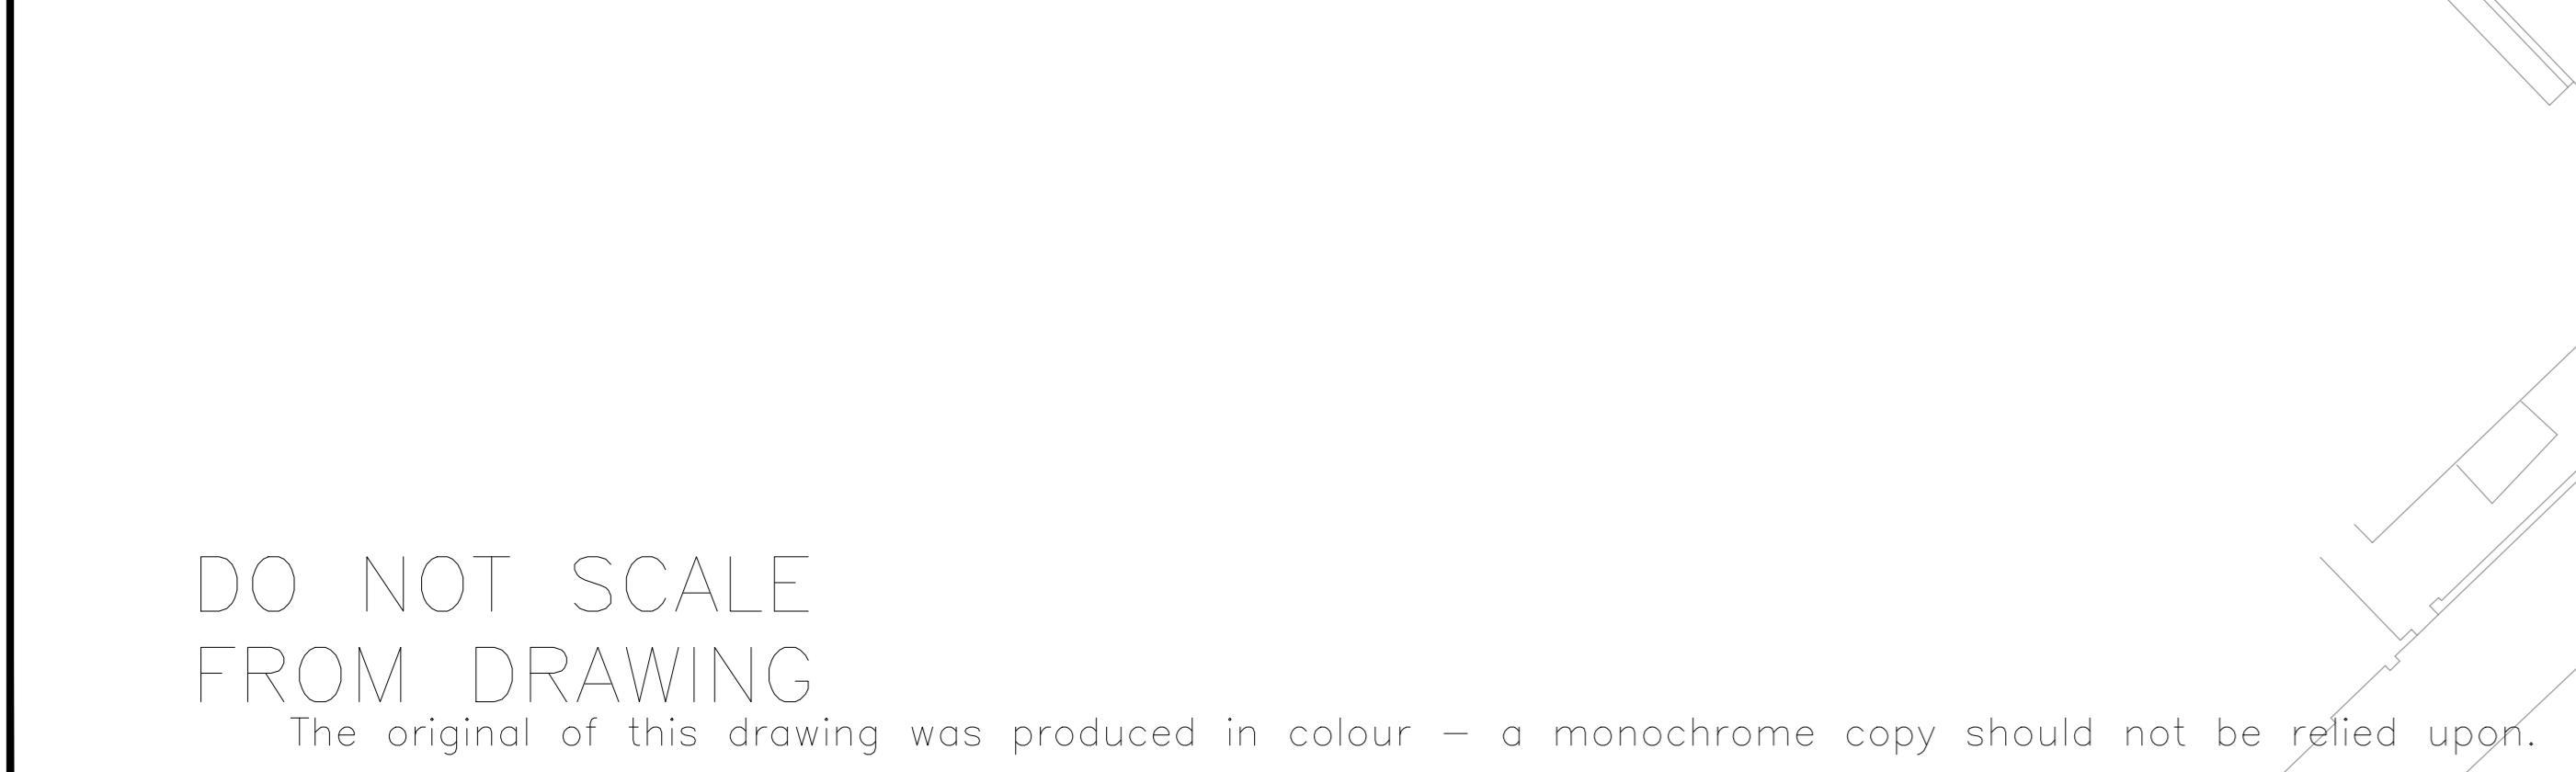
- 1.6 The survey data and site observations use the topographical survey to illustrate the surveyed trees in plan format as a 'Tree Constraints Plan' (hereafter; TCP); the TCP and the tree survey data table are at Appendix III.

- 3.1 The following information, as with the prior contents of this report, should be read with the appended tree data table and tree constraints plan (19025/TCP/01).
