Re: Section 211 Notification at 24 South Road, Grassendale Park, Liverpool L19 0LT

The Tree Description

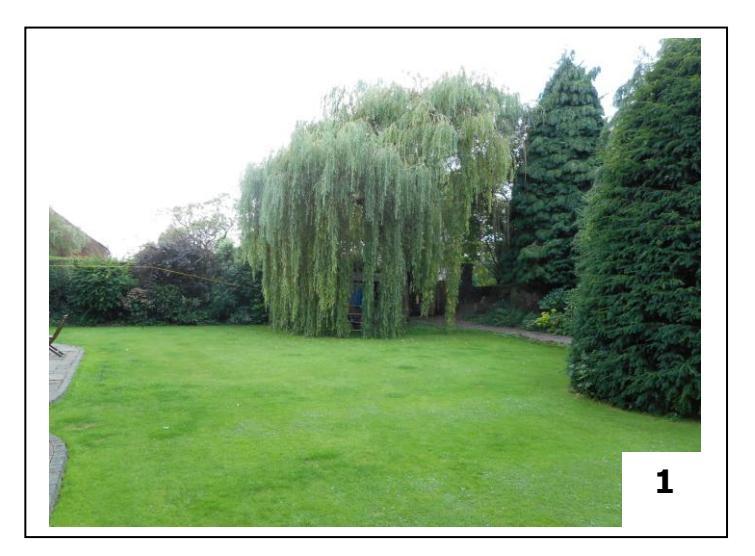
1. The tree is a mature specimen of weeping willow (*Salix alba Tristis* syn *S babylonica* and *S vitellina Pendula*) that is located in the north west corner of the rear garden of the property. It is approximately 12 to 15m in height with a measured DBH of 685mm and a radial crown spread of 12m, (Photograph 1).

Photo 1: The tree in the north west corner of the rear garden.

- 4. The tree is extensively decayed at the root collar and the lower portion of the trunk. The extensive crown (Photograph 1) makes the tree 'top heavy' and the white rot is undermining the strength of the wood at the base of the trunk. Therefore, there is a real risk of the tree failing in winds.
- 5. The targets in the event of failure are the garden, Mr and/or Mrs Newton and any visitors using the garden. The target rating is therefore 'medium' on the ISA TRAQ¹ scale but the likelihood of failure is 'probable'. The likelihood of failure and impact is 'likely' and the consequences of failure would be 'high'. On that basis the tree poses an unacceptable level of risk and should be removed.

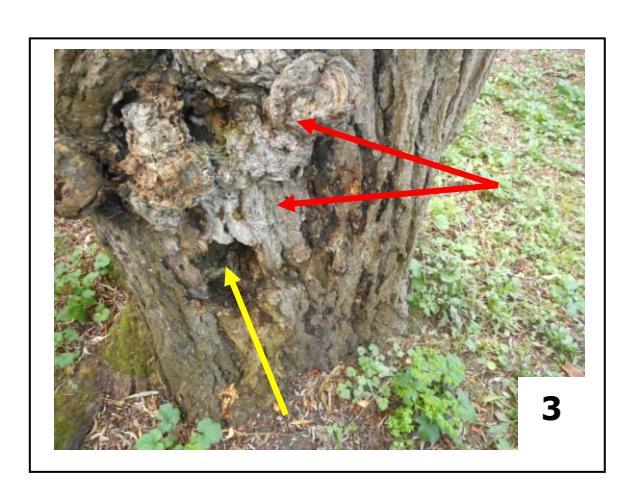
2. The base of the trunk has a major cavity that is extensively decayed, (Photograph 2). There is much reaction wood around this cavity but a sounding mallet suggests that the trunk behind the cavity is hollow and/or extensively decayed.

Photo 2: This picture shows the decay cavity (arrowed yellow) and the reaction wood (arrowed red).

6. There is no known cure for either *Armillaria* or *Ganoderma* and the infections will get worse progressively increasing the likelihood of failure. The only prudent intervention management is to fell the tree, poison the stump and plant a replacement tree.

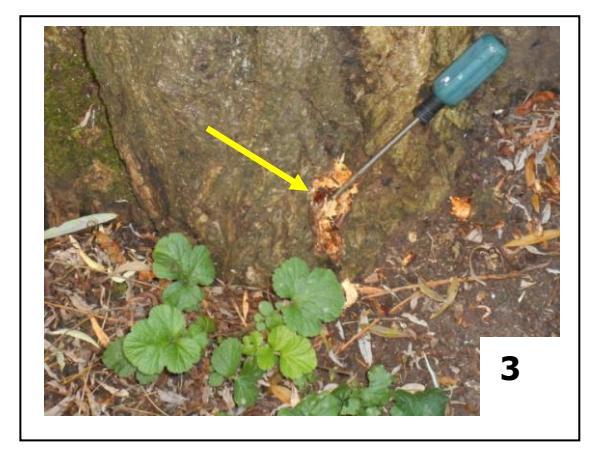
3. The root collar area is infected with honey fungus (*Armillaria* Spp) which is causing white rot at that location (Photograph 3). No samples were taken for identification but from the symptoms and the softness of the wood it is likely that the species of honey fungus is *Armillaria mellea*, which is one of the more aggressive species in this complex of species.

Photo 3: Exposed honey fungus infection on the root collar (arrowed)
