ARBORICULTURAL IMPACT ASSMENT For a proposed development

Upper Parliament Street Toxteth, Liverpool

Report Ref:

DTCL.119.AIA.2017

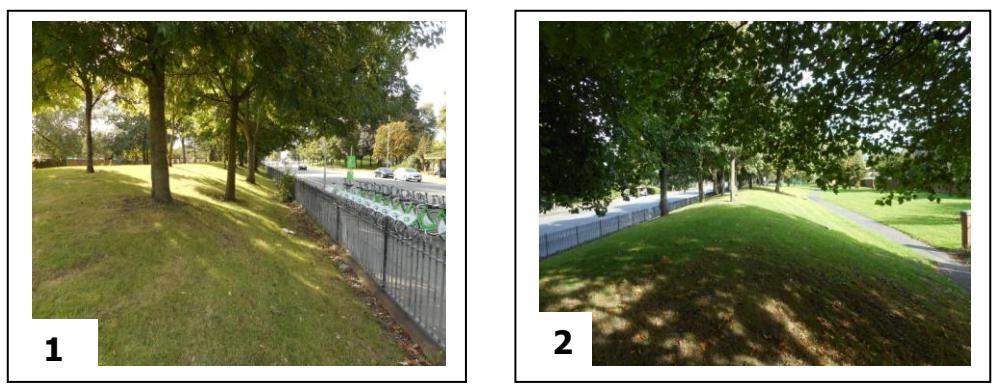
Photos 1 & **2**: Two views of the tree avenue frontage of the site to Upper Parliament Street: **1** looking to the west / southwest; and **2** looking to the east /northeast.

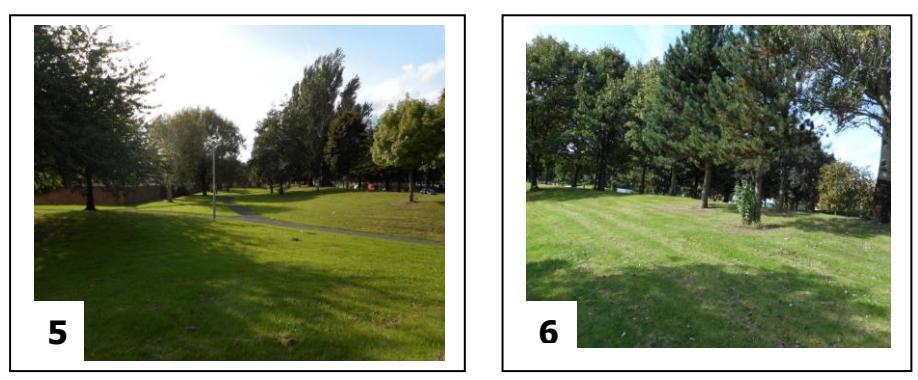
Photos 5 & **6**: Two representative views of the group and individual trees planted across the site; both views are of the eastern part of the site looking to the west / southwest.

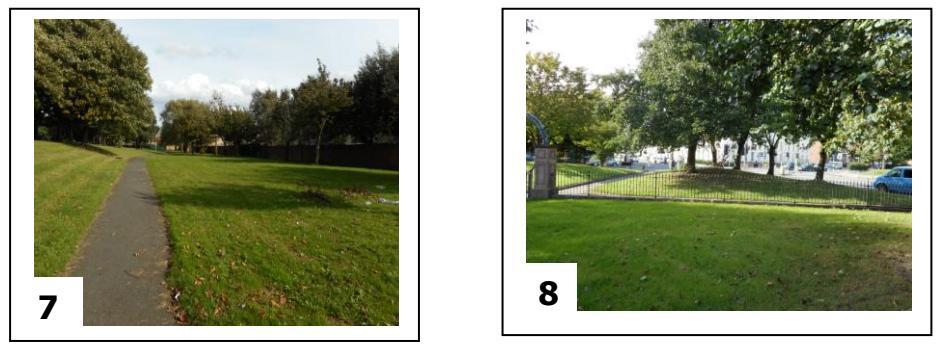
Photos 7 & **8**: Two further representative views of the trees at the western end of the site.

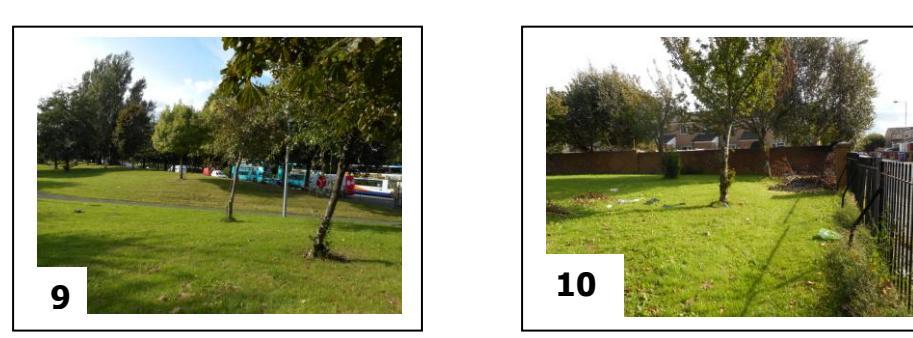
Photos 9 & 10: Examples of individual specimen trees that are in poor condition

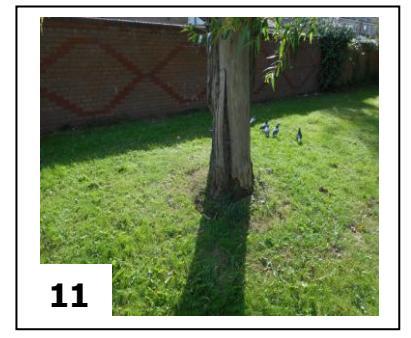
3.5 Fifty seven (**57**) trees would need to be removed to accommodate the development as set out in Table 2 below, and as shown in the schedule of trees attached to this report. Of these, thirteen (**13**) would need to be removed for sound arboricultural management reasons irrespective of the development. Some are in decline, while others have been damaged extensively (Photographs 11 & 12).

Photo 11: Damage to the lower trunk of a willow

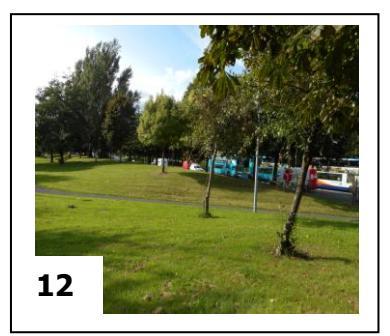
Photo 12: Poor specimens that are stressed and not developing well

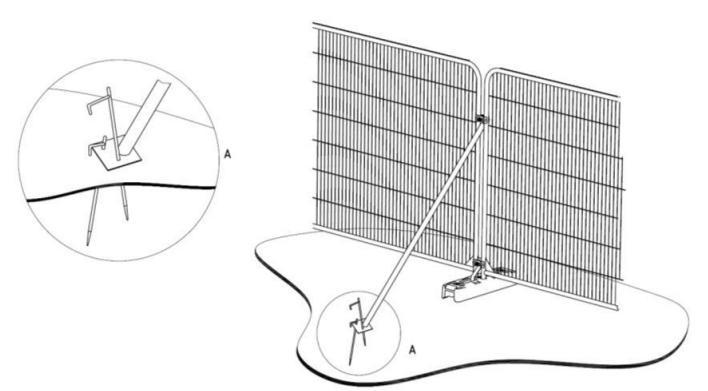
a) Stabilizer strut with base plate secured with ground pins

As Heras[®] type fencing can be easily moved; it must be mounted on rubber or concrete base plates and secured as shown in Figure 1 above. In order to provide semi-permanent protection using stabilizing struts and base plates and the Heras sections secured by 'U-Bolts' or Scaffold Clamps as shown in the photographs below.

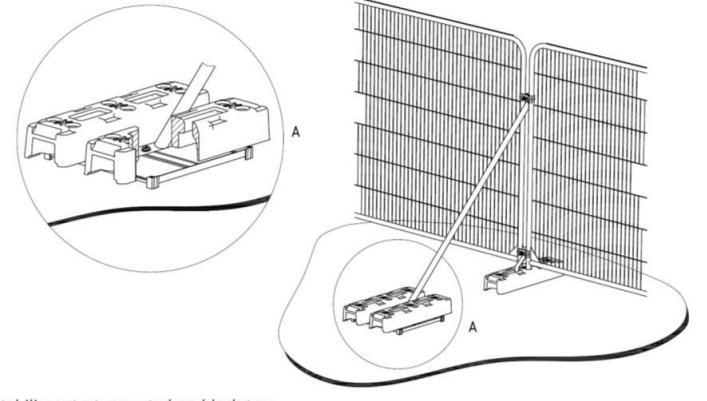
b) Stabilizer strut mounted on block tray

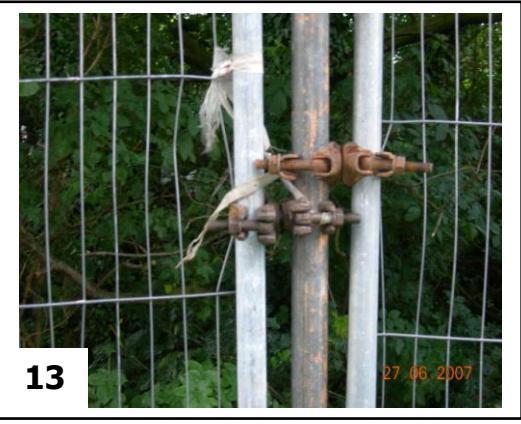
Photo 13: This shows close up of `U-Bolts' clamping the panels together

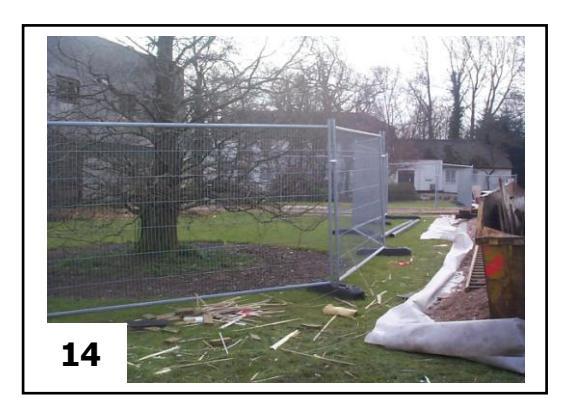
Photo 14: This shows the fencing in place around an individual tree.

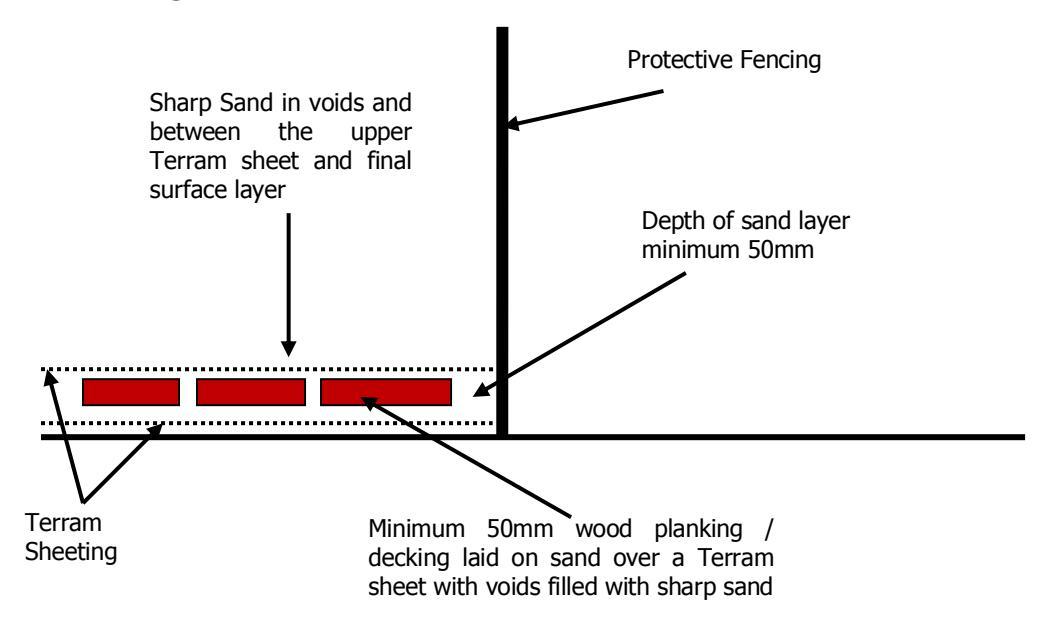
Figure 2 Ground Protection for Construction close to the RPA

3.8.2 Because the proposed construction would come close to the RPA of **T4** (*Robinia pseudoacacia*) and **T61** (*Platanus x hispanica (acerifolia)*) temporary ground protection to protect the RPA from construction activity would be installed as shown in Figure 2 below

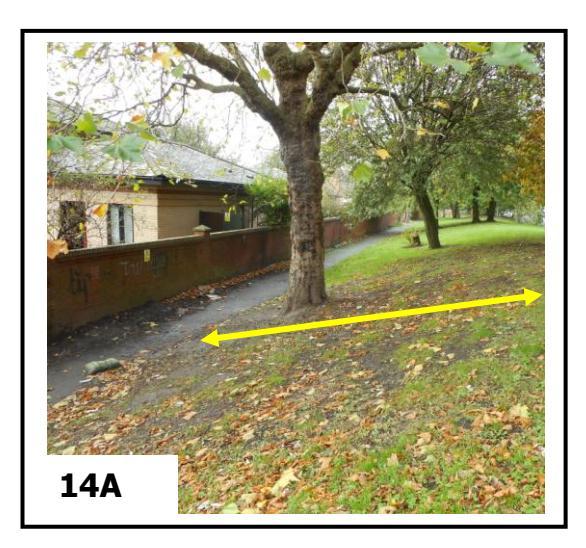
Photo 14A: This shows the location of **T61** at the base of the mound/bund with the location of the development arrowed.

- 3.9.3 Before excavation of the mound/bund using mechanical plant the area of the root zone to the east of the excavation line (yellow arrows in Photographs 14A & B) would be excavated using compressed air via an Air Spade to a depth of 1000mm to expose any roots, please refer to **Appendix 1** for details of the Air Spade methodology.
- 3.9.4 Once the roots are exposed and large woody roots would be cut cleanly using a purposed produced hand saw and secateurs for smaller diameter roots. The exposed face of the pruned roots would be covered with good quality topsoil and protected with a geotextile membrane as shown in **Figure 3**.

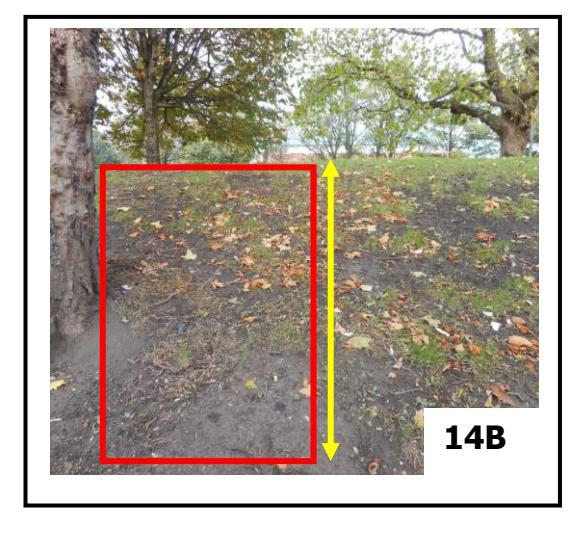
Photo 14B: This shows the juxtaposition of T61 and the excavation line (arrowed yellow) and the area on the east side the tree that will have ground protection installed, squared red.

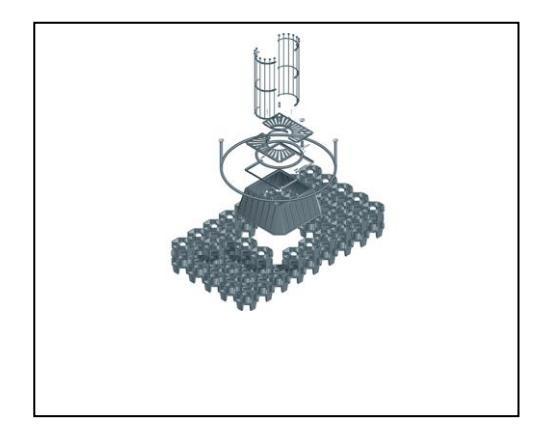
Figure 3 - Diagram of the Green Blue Urban Strata Cell Arborsystem®

- 3.10.3 The trees would be root balled or container grown specimens at 18/20cm girth at one metre above ground level. They would be pit planted using the Green Blue Urban Strata Cell Arborsystem[®] which is a soil cell planting system developed specifically for trees planted in urban locations, which is shown in **Figure 4**.

This system would be implemented across the frontage and the car parking area. This will facilitate lateral growth of the roots such that the area of soil available to each tree is maximised, and results in little if any compaction in the root zones, as shown in the photograph and diagram below.

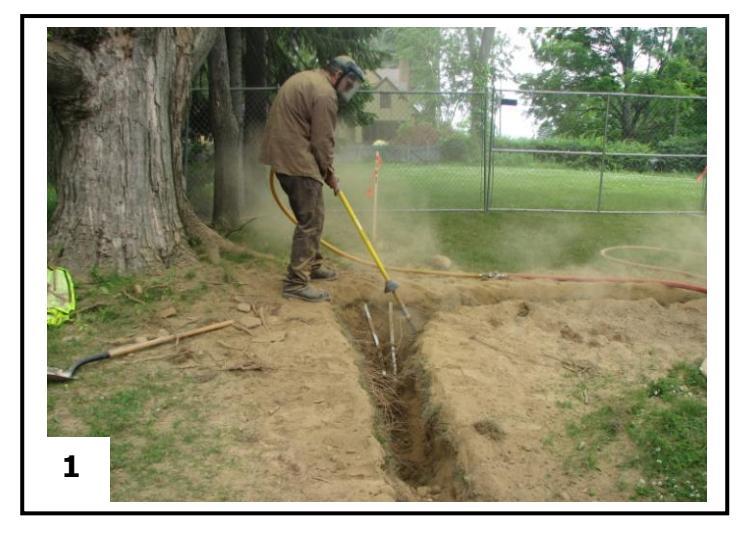
Picture 1: This shows the excavation process using an Air Spade

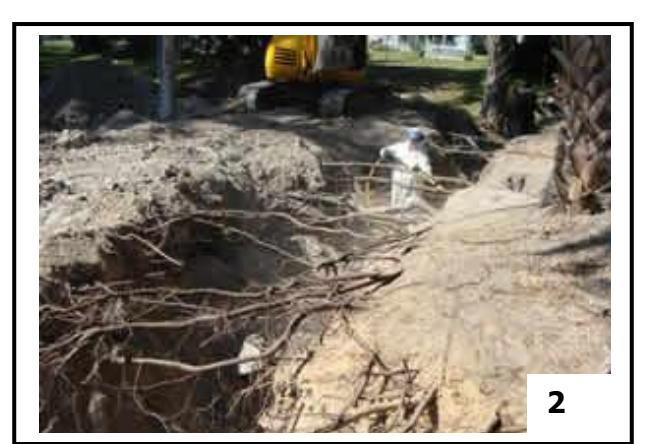
Picture 2: This shows the process of hand excavation below the root zone following the exposure of roots using an Air Spade

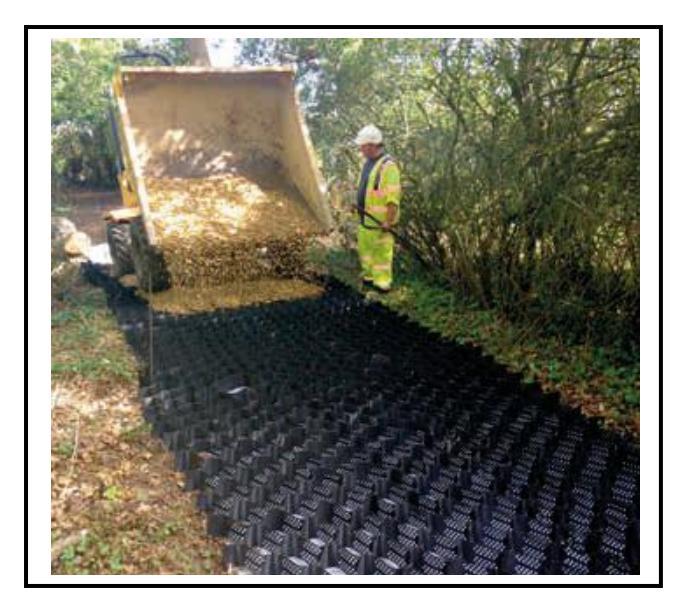
Installation of ProtectaWeb™ on site

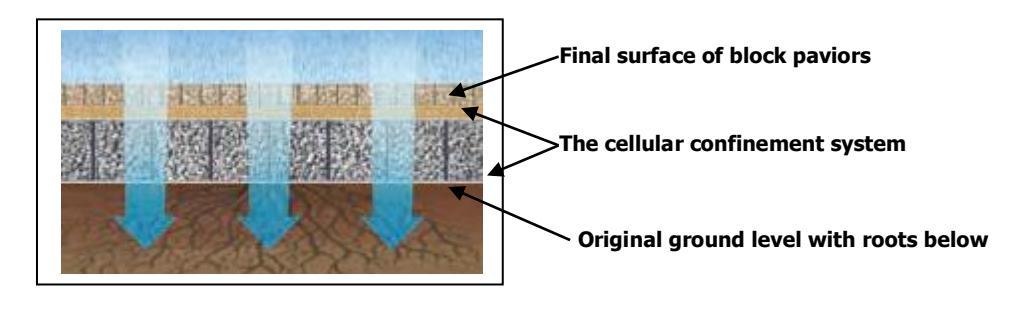
A schematic diagram showing how a cellular confinement system allows the percolation of air & water to the roots below.
