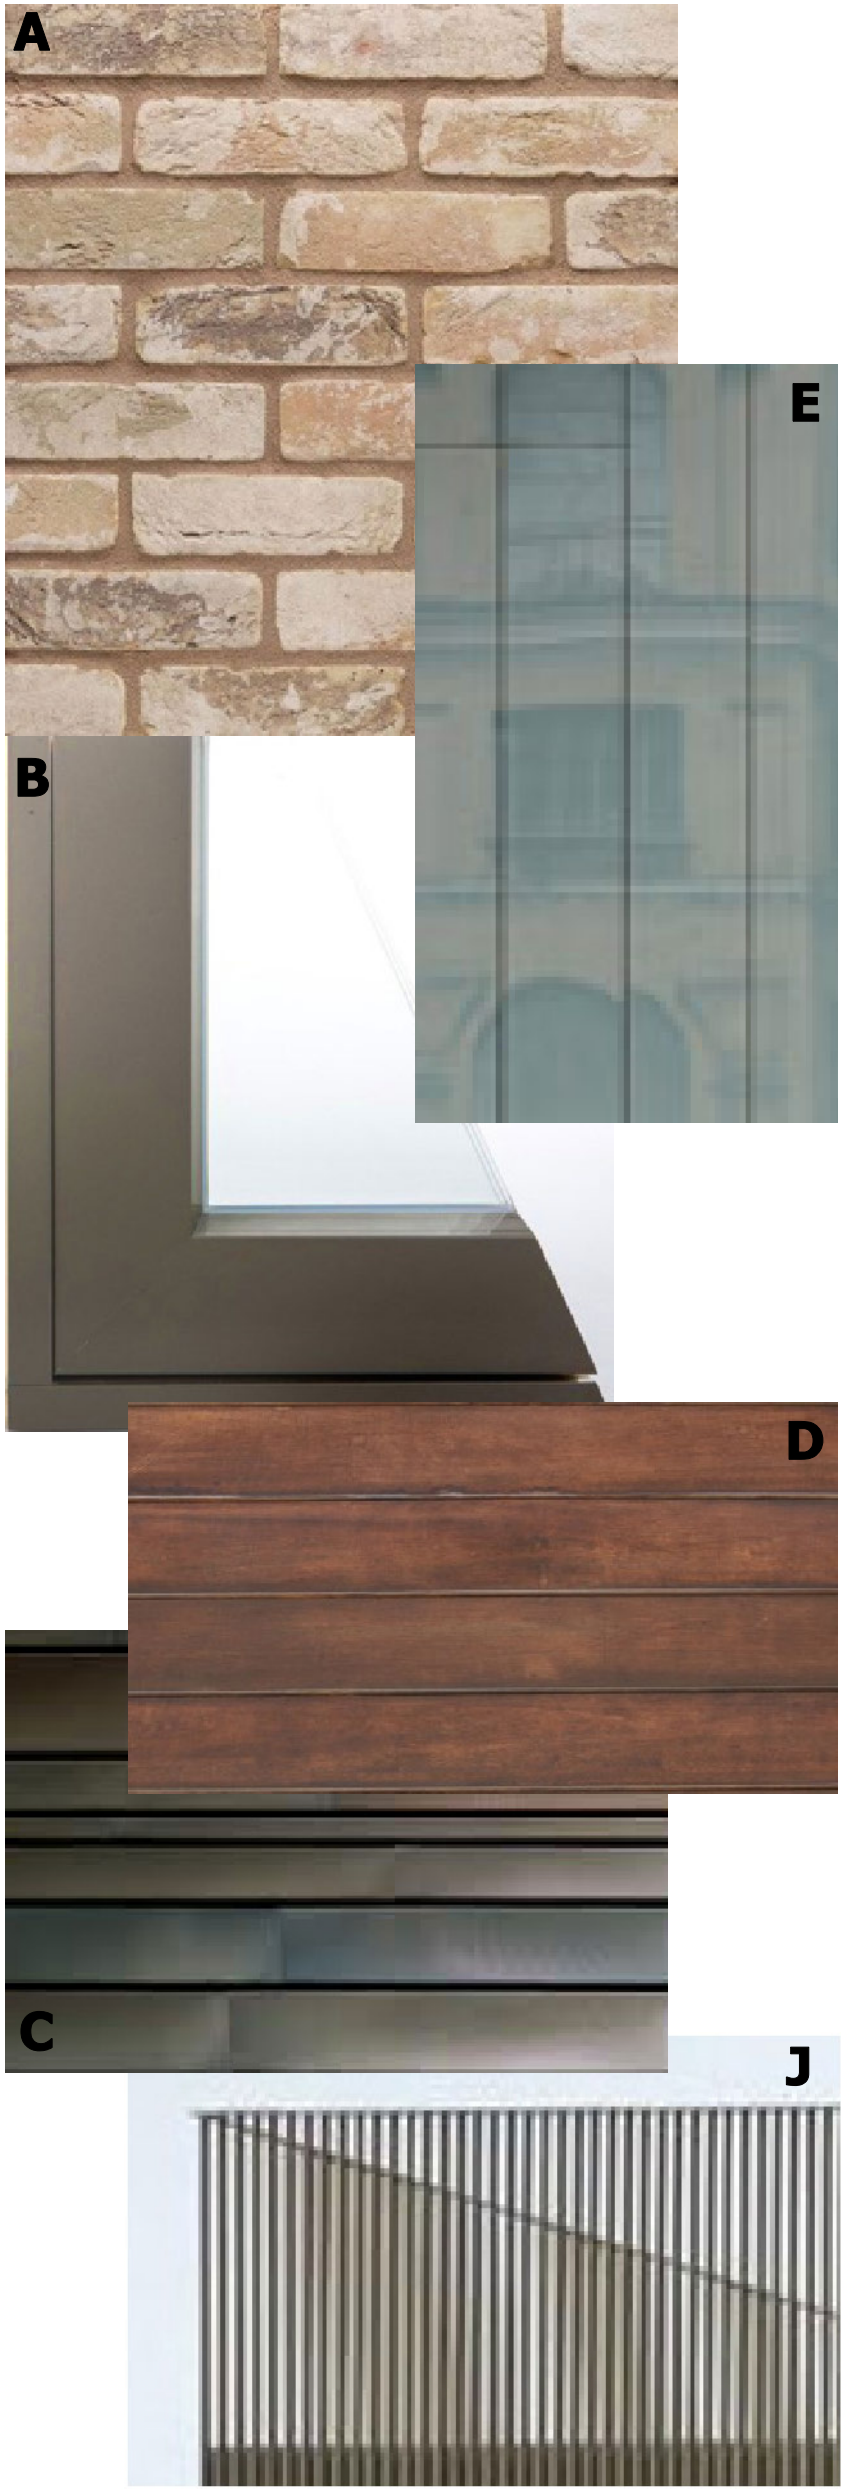
A. new apartment block

- A buff multi brickwork
- B bronze colour aluminium window frames
- C bronze colour standing seam cladding
- D stained timber (balcony linings)
- E glazed spandrel panel (ceramagite)
- J bronze colour metal balustrade

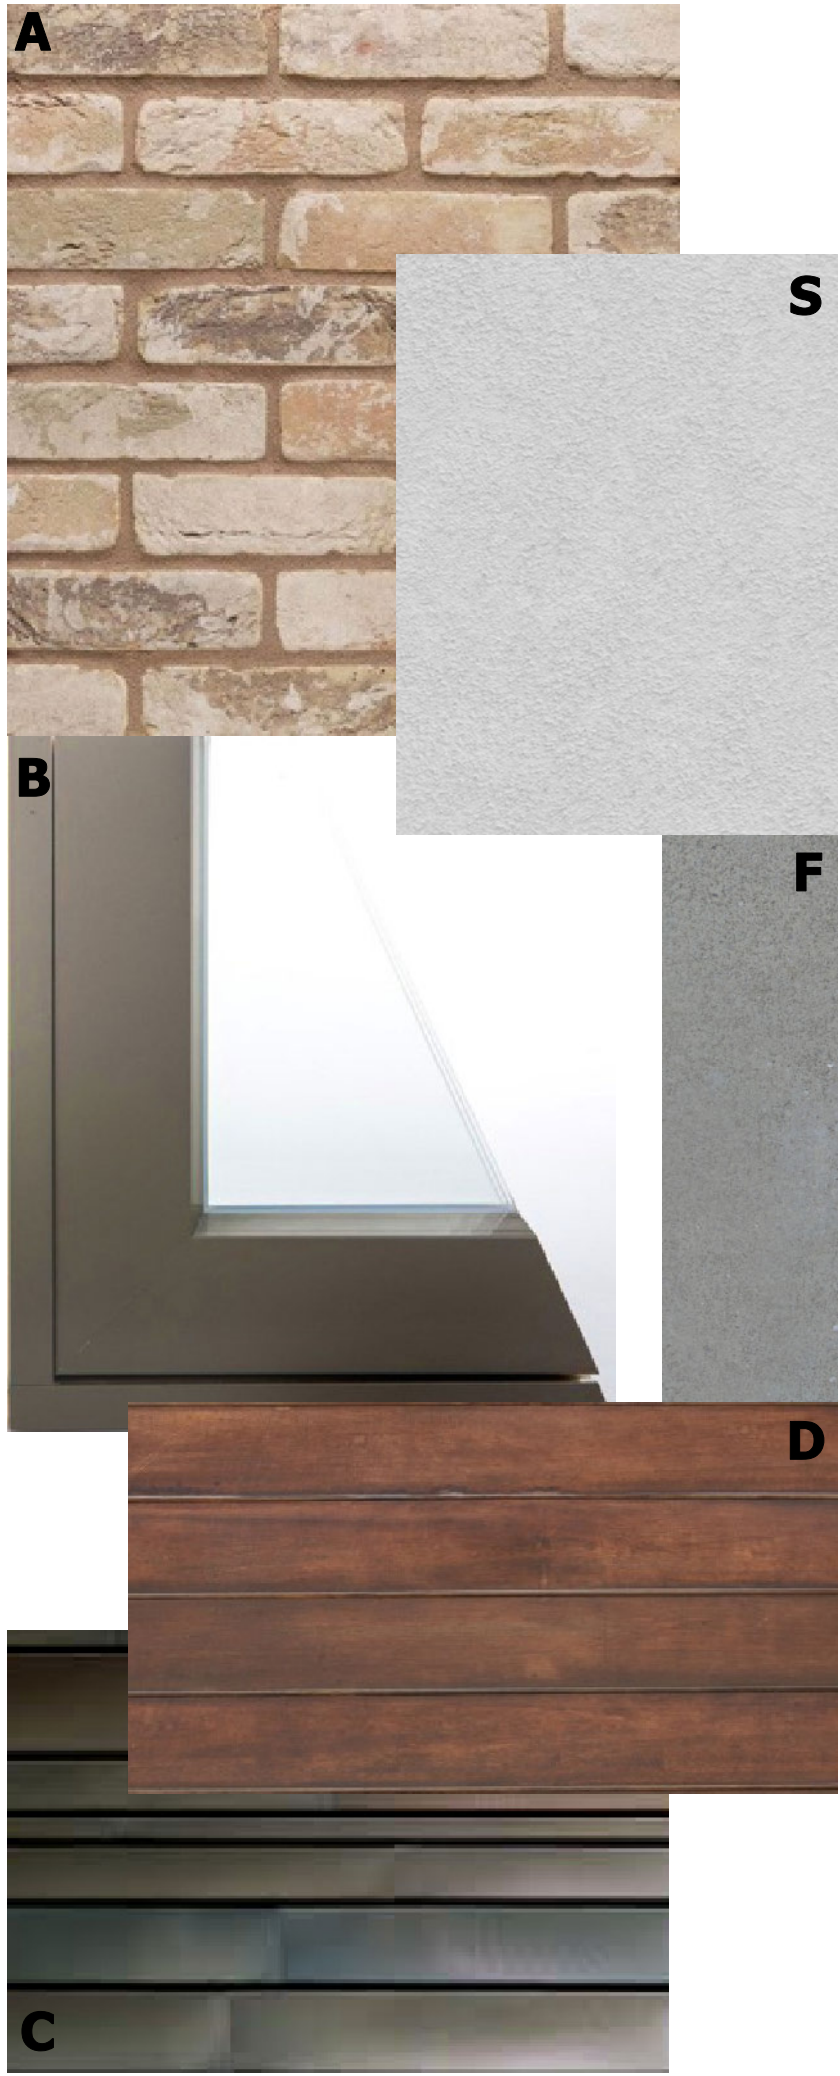
B. attached villas

- A buff multi brickwork
- B bronze colour aluminium window frames
- C bronze colour standing seam cladding
- D stained timber
- F pre-cast light grey concrete panel
- S through coloured render (off white)

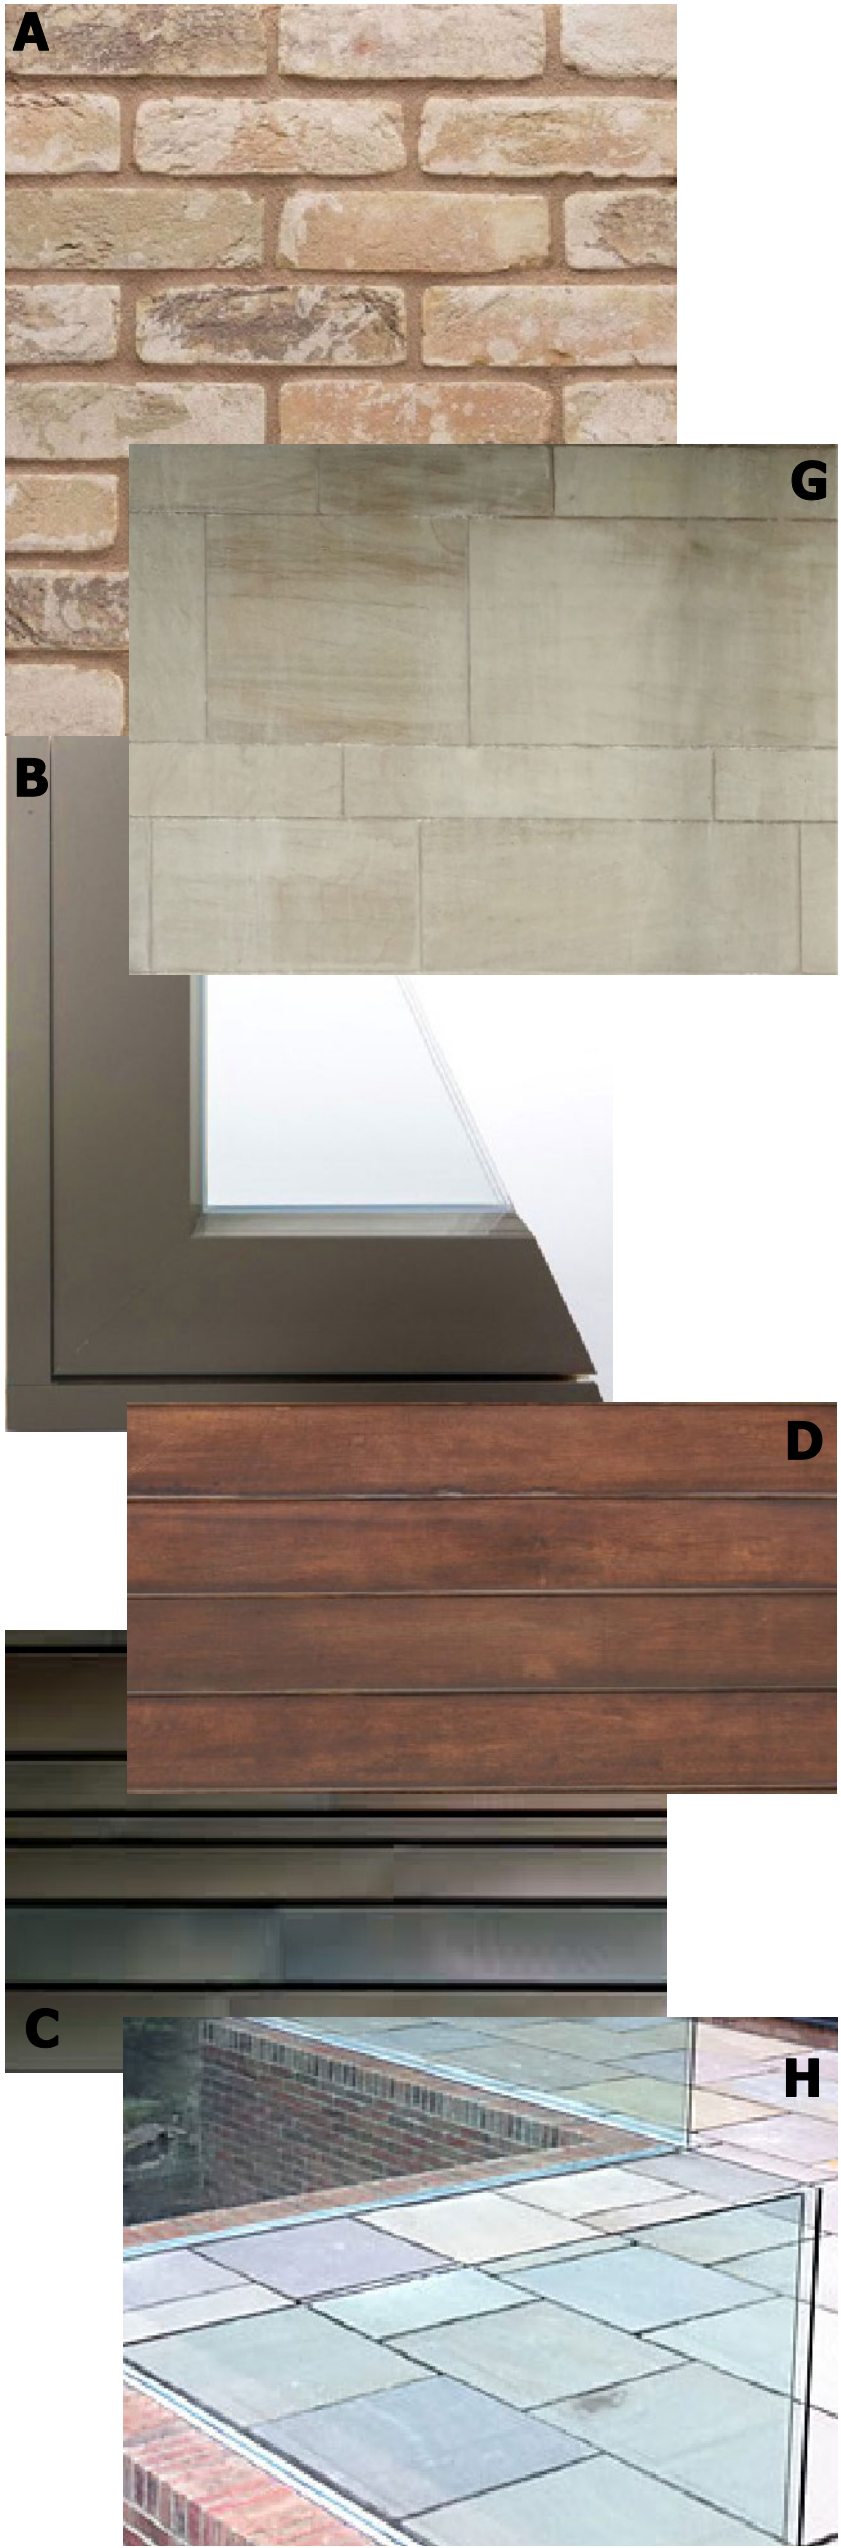
C. detached villas

- A buff multi brickwork
- B bronze colour aluminium window frames
- C bronze colour standing seam cladding
- D stained timber
- G buff ashlar stone walling
- H glass balustrade

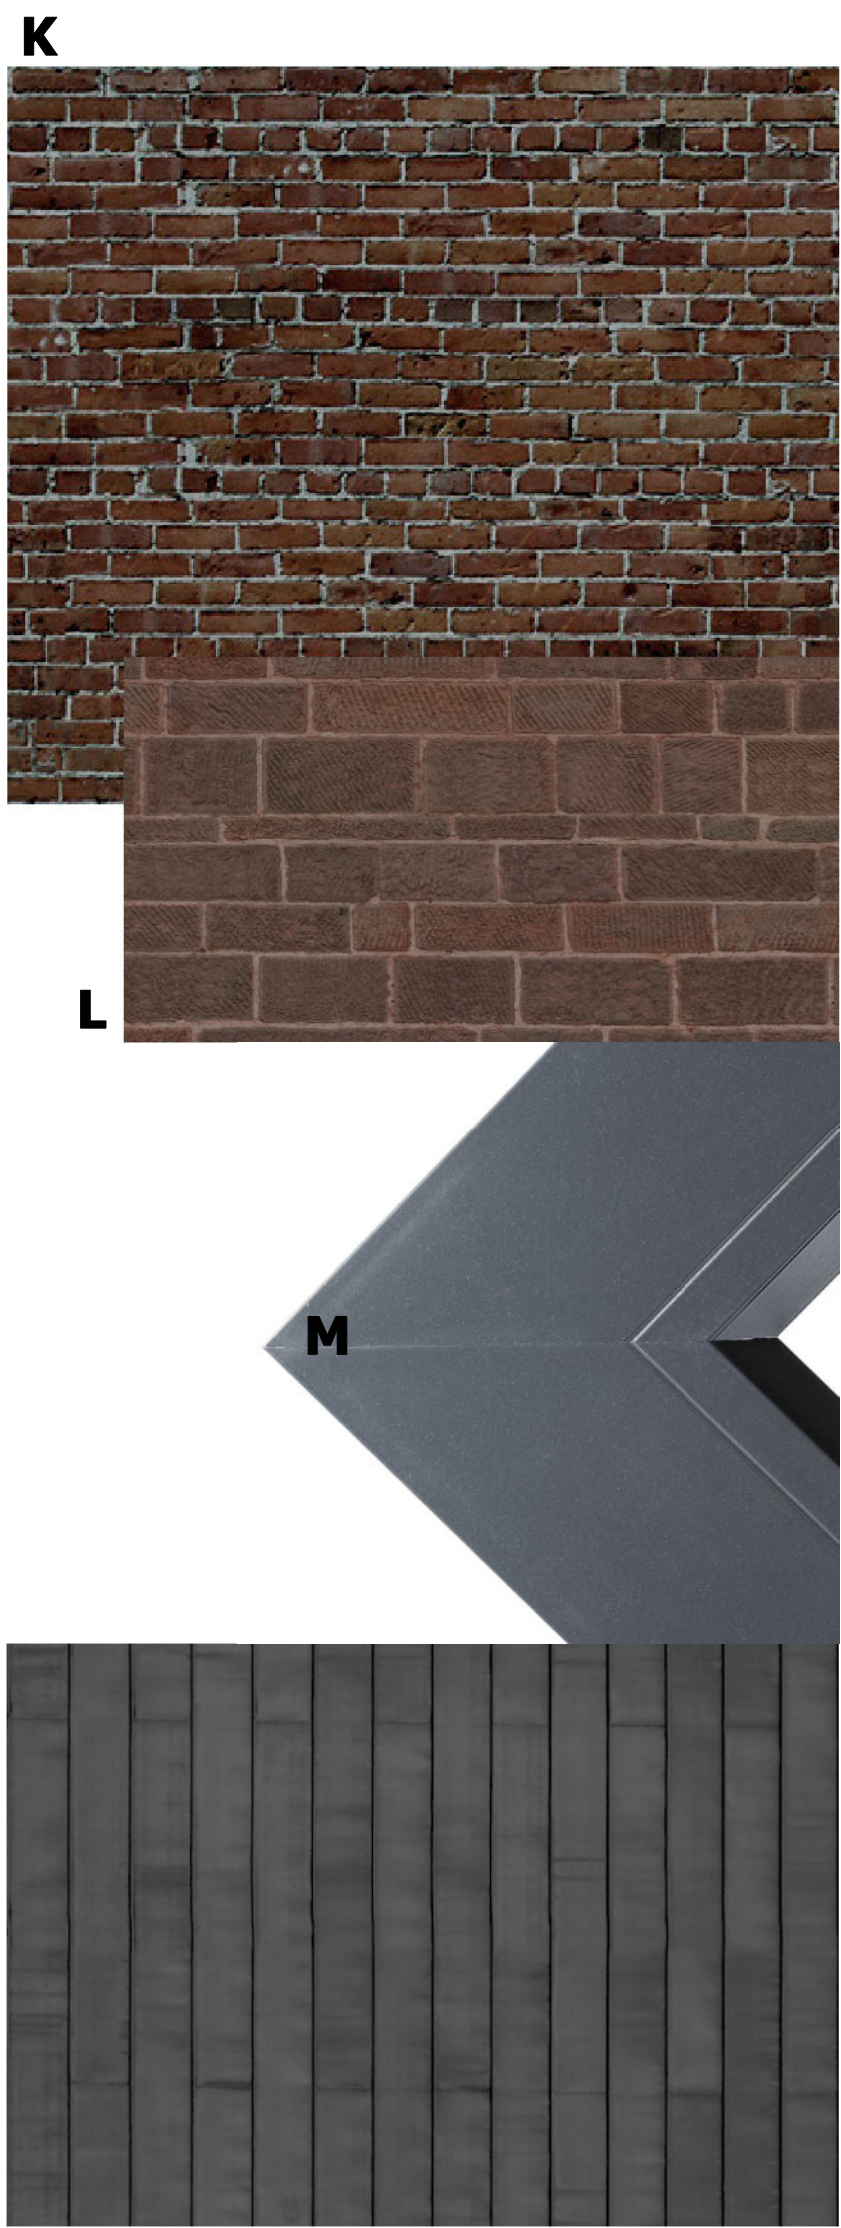
D. orangery house

- K re-furbished existing brick wall
- L red sandstone walling
- M dark grey aluminium window frames
- N grey zinc standing seam roof

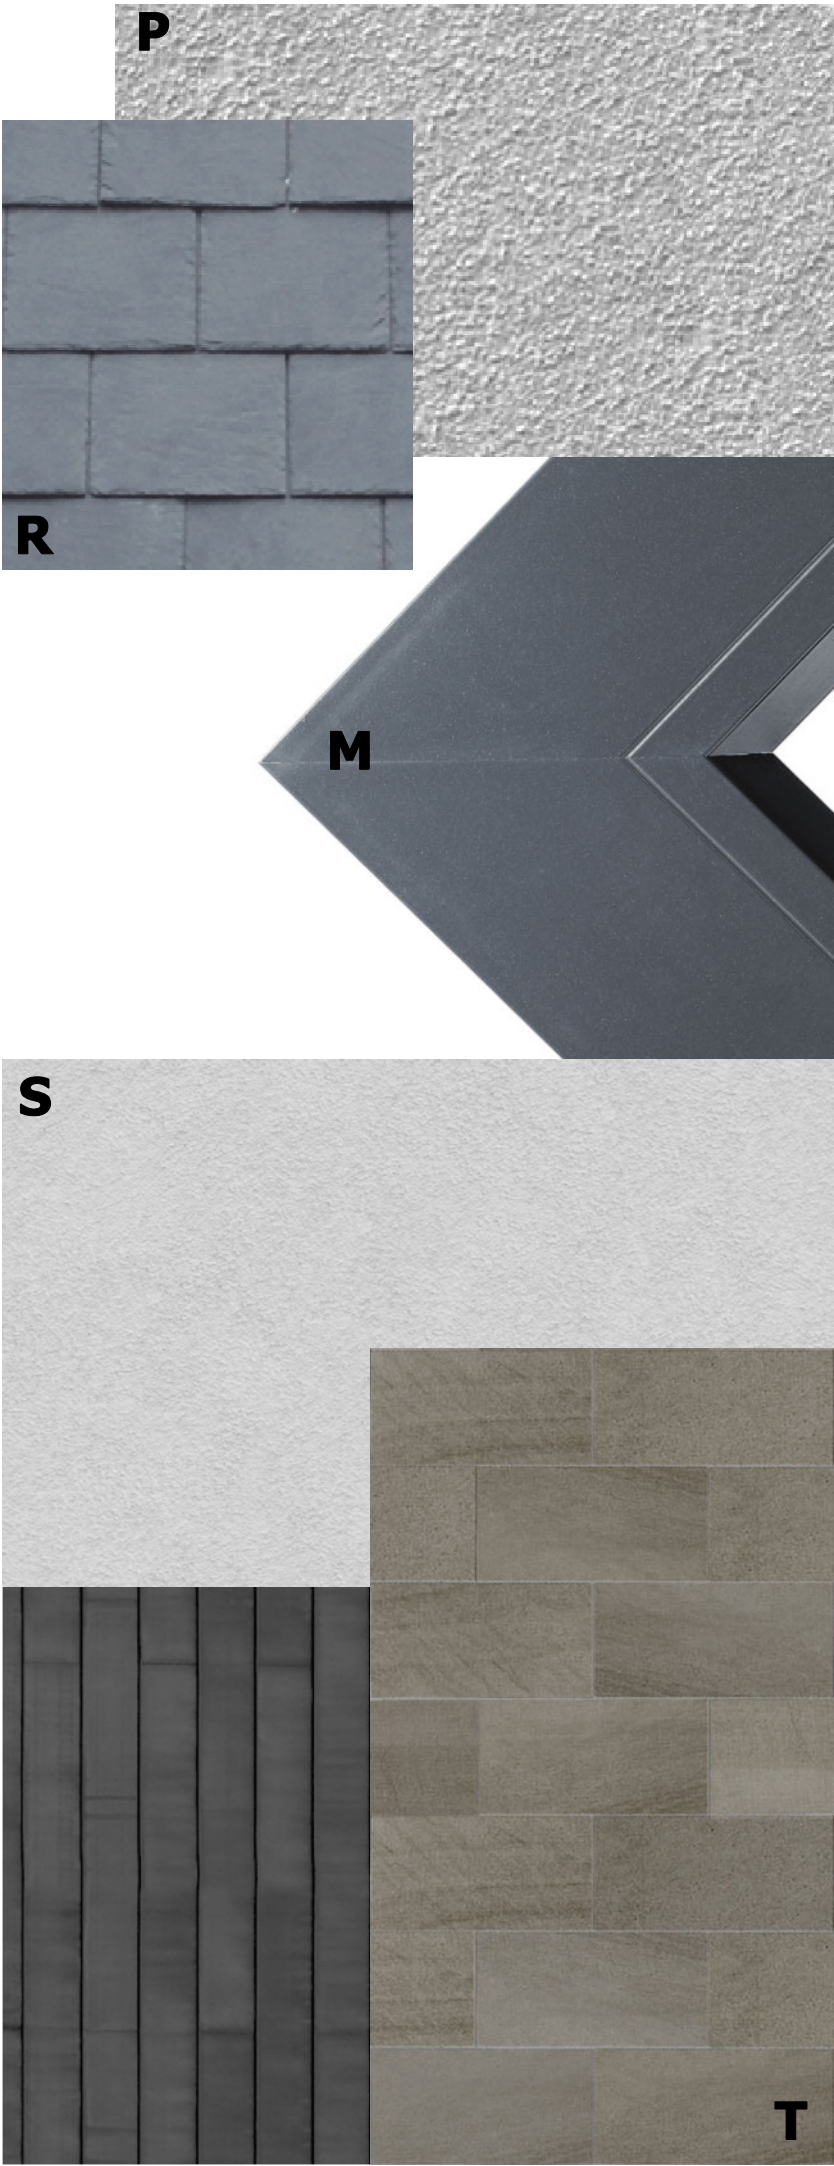
E. Greek lodge

- M dark grey aluminium window frames
- P refurbished stucco render
- R slate roof
- S through coloured render (off white)
- T light grey natural stone wall panels

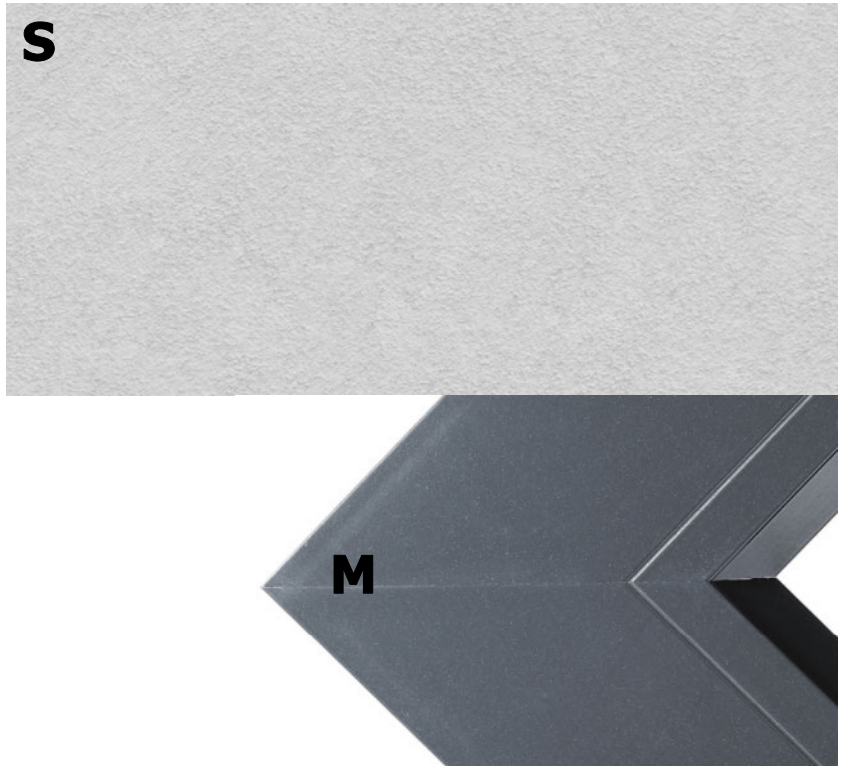
A. apartment link building

- M dark grey aluminium window frames
- S through coloured render (off white)
