Corten - Design Considerations

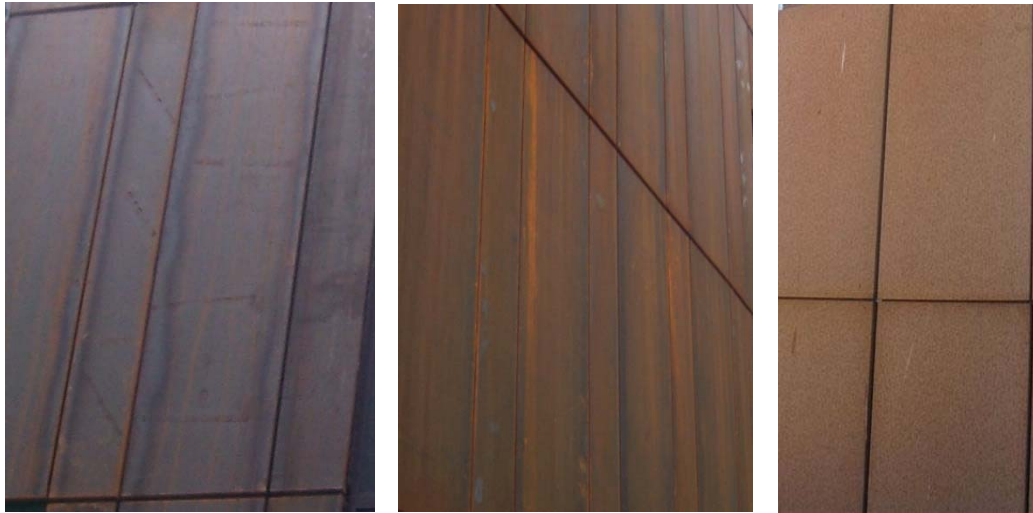
Examples of Corten 'patina' formation.
