DOCUMENT REFERENCE – ADS/65/HD/05DISCHARGE OF CONDITIONS RELATING TO APPLICATION No. 14NM/1510 DATED 07/08/20141. SUPPLY A SAMPLE OF THE BLACK GLAZED DOOR FRAME FOR APPROVAL

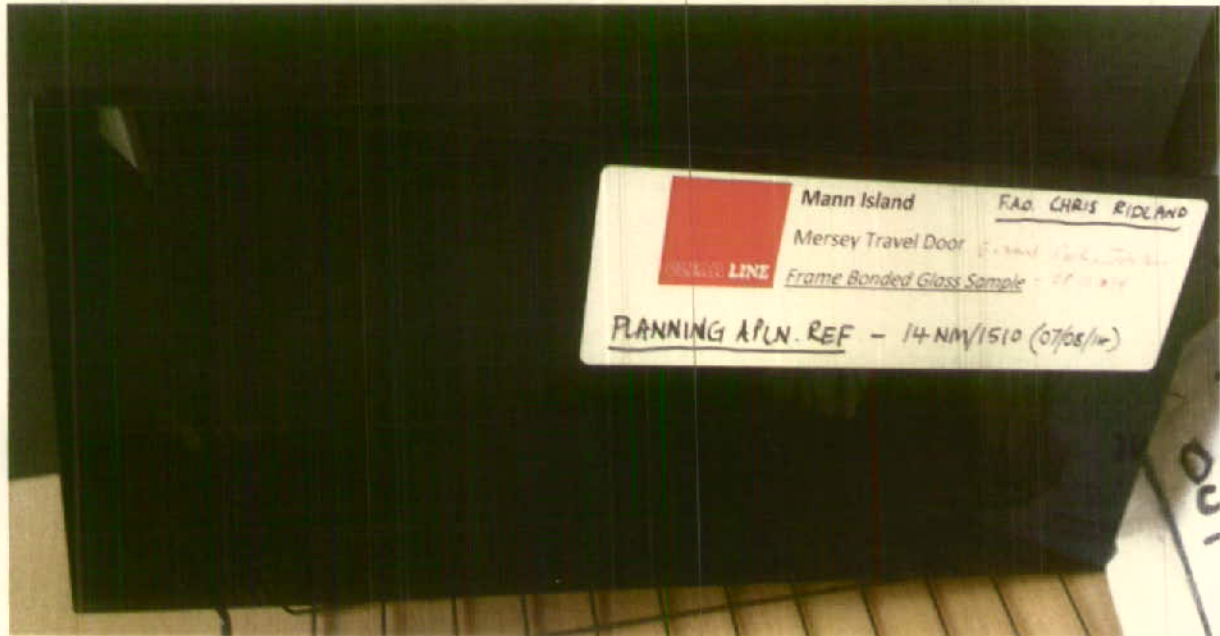
Frame bonded glass sample from contractor supplied (as shown below) to Chris Ridland on the 15th May 2015, email approval received from Chris on 15th June 2015.

The frame screening panels are back painted glass panels and these will be structurally bonded to the structural aluminium frame.
