BS5837 Tree Survey Assessment

Site: 1712 Tetlow Street, Walton, Liverpool

Ref: 14565 / A1

TITLE	Tree Constraints Plan
-------	-----------------------

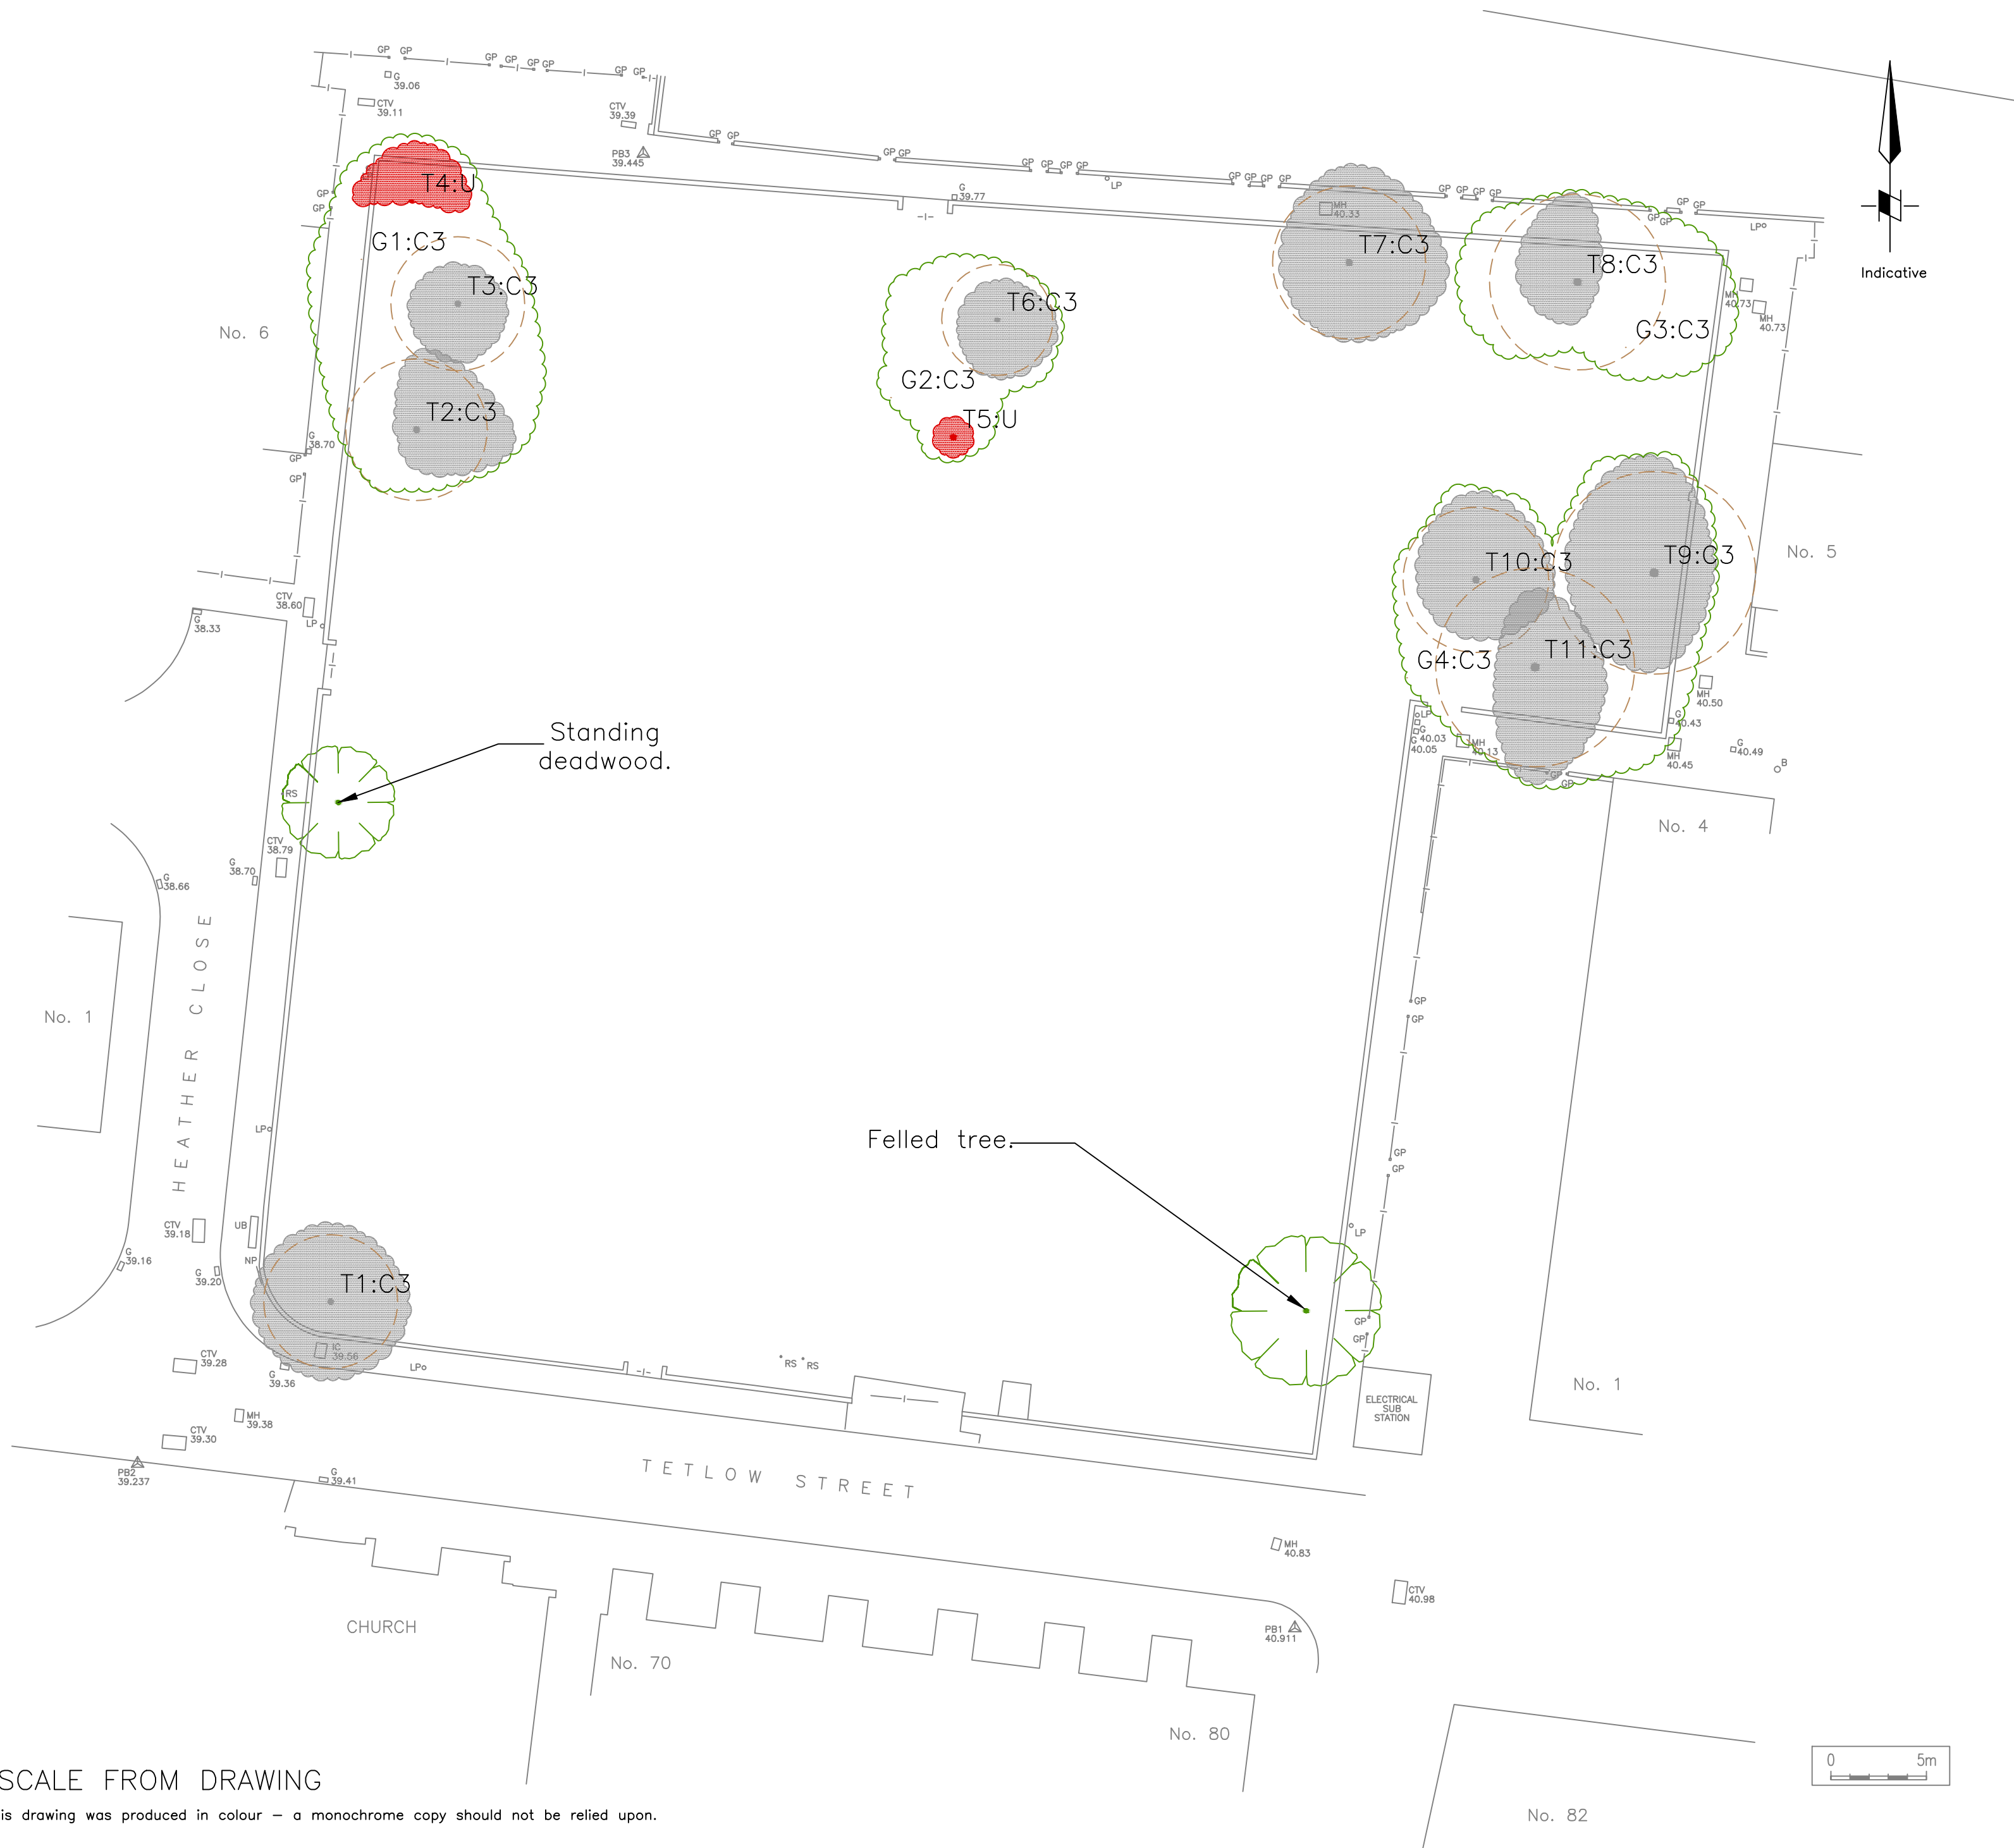
Drawing Number	A2
14565/TCP/01	REV.

- 1.6 The survey data and site observations use the supplied topographical survey to illustrate the surveyed trees in plan format as a 'Tree Constraints Plan' (hereafter; TCP); the TCP and the tree survey data table are at Appendix III.

- 2.4.2 For the most part, the trees at site are situated towards the north boundary. All growth is of limited value and contribution to the amenity of site. The majority are suffering due to vandalised stems and identified defects, this has resulted in the recommendation for tree removals, i.e. the category 'U' trees and standing deadwood.

The surveyed trees are illustrated on this Constraints Plan which is prepared in accordance with British Standard BS5837: 2012 'Trees in Relation to Design, Demolition and Construction - Recommendations'

- 3.2.1 Due to the poor condition and defects noted to the trees categorised as 'U' and in the context of a residential development with regular future site use it is recommended that T4 and T5 be removed. Also, the standing deadwood in the west and the felled tree in the east of site should be removed.

NOTE: The proposal shows all 'C' category trees as being removed. As above, said trees should not significantly guide nor constrain the scheme. Hence, the removals are considered acceptable as the proposal shows a considered approach to new tree planting. Further, replacement planting would mitigate said tree loss, and, in conjunction with the proposal, would represent an improvement to the amenity.
