Bramley Moore Dock - Regent Road Wall

Wall Condition Survey

June 2020

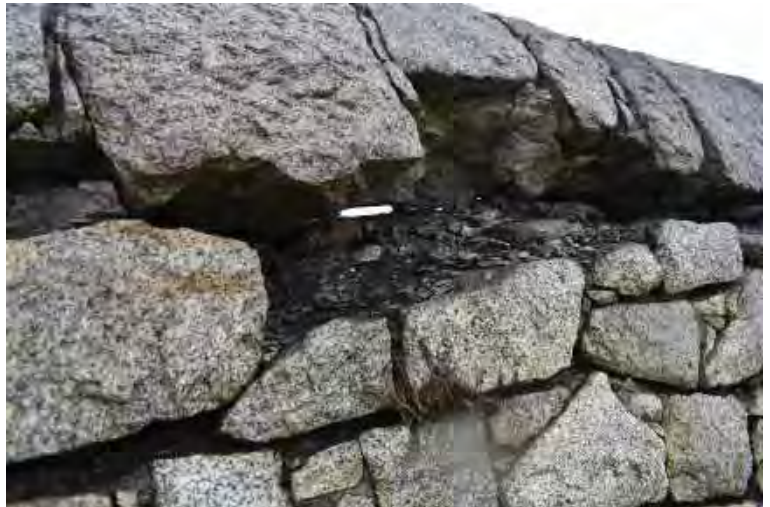
The dockside elevation of Regent Road wall in particular has areas of very loose stonework where the integrity of the mortar has been compromised and the stones are easily separated from the surrounding construction. Photo shows the worst area that was found (Section 29) where the stonework has separated from its mortar beds.

Where cracking is evident some of the smaller stones on the face are loose and pose a potential H&S issue especially in high wind conditions.

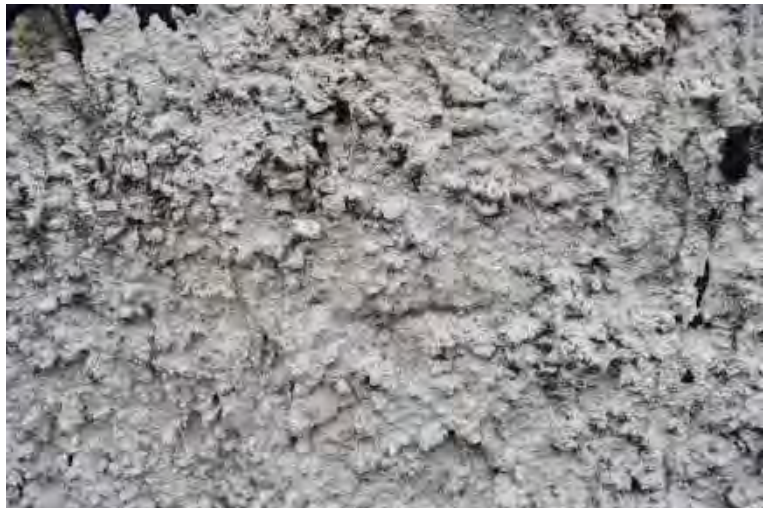
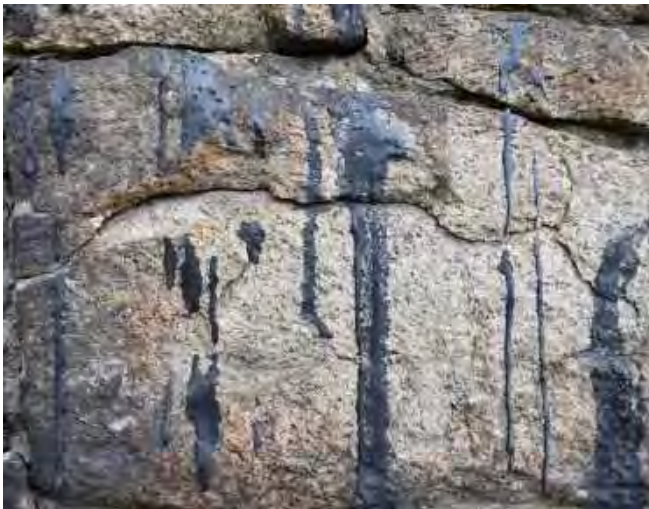
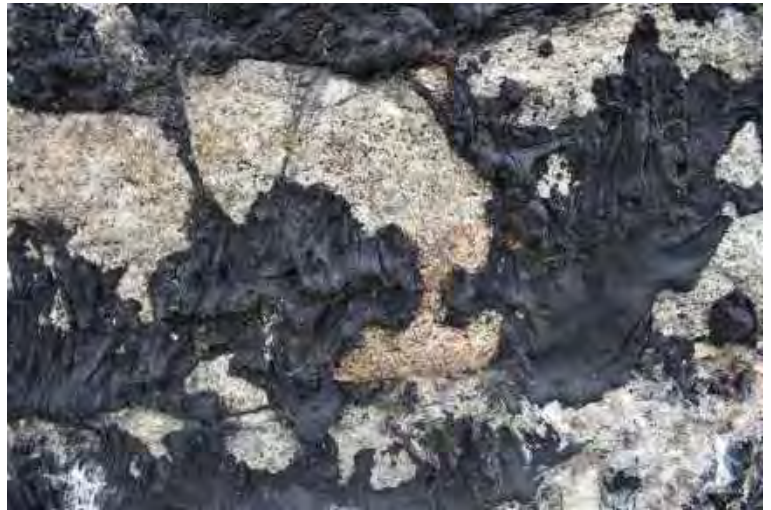
Areas of the wall have been subject to damage from concrete and other surface materials that have been applied either directly to or to adjacent structures.

These include:

- concrete from adjacent base construction.
- Paintwork
- Tar from adjacent roofing / waterproofing

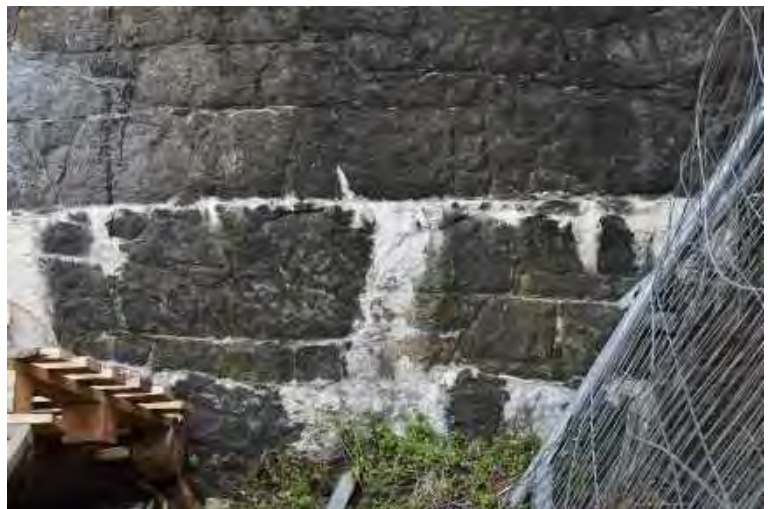
At low level there are a number of areas where calcium deposits have formed on the face of the wall indicating where water movement is present from the internal of the wall.

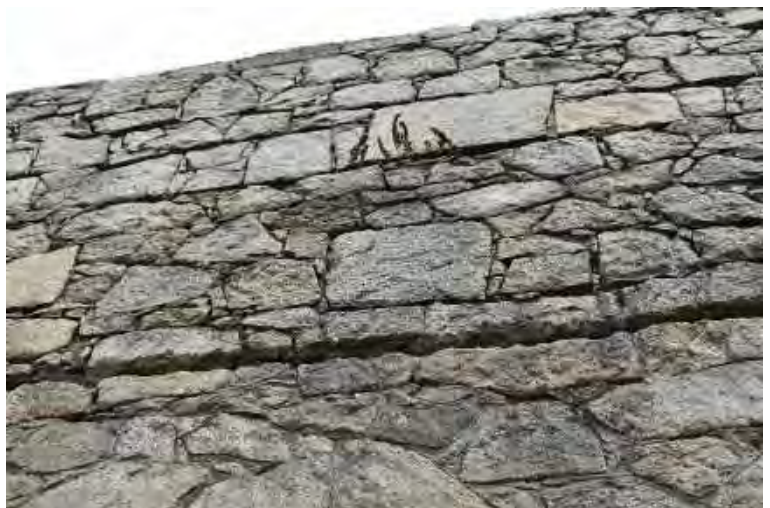
Additionally where previous roof constructions have abutted the wall chase lines have been formed for flashings. These rebates are approx. 50mm deep into the stonework.

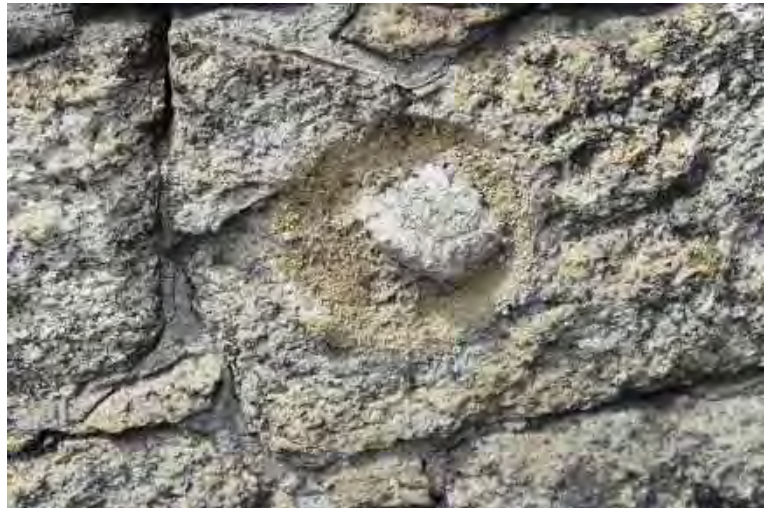
The location of previous wall investigations / coring is visible on the face of the wall.

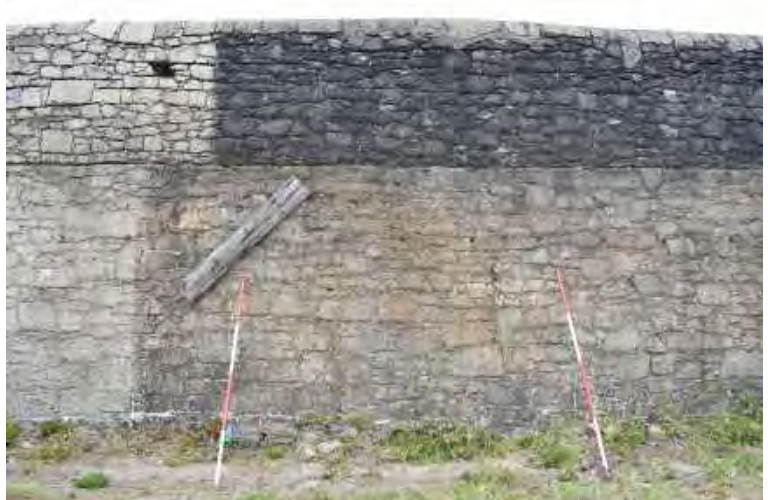
Areas of the wall have been cleaned at different times leaving some areas of the wall partly obscured by dirt and pollution. This is particularly apparent on the Bramley Moore dock side of the wall where different structures have previously abutted the wall.

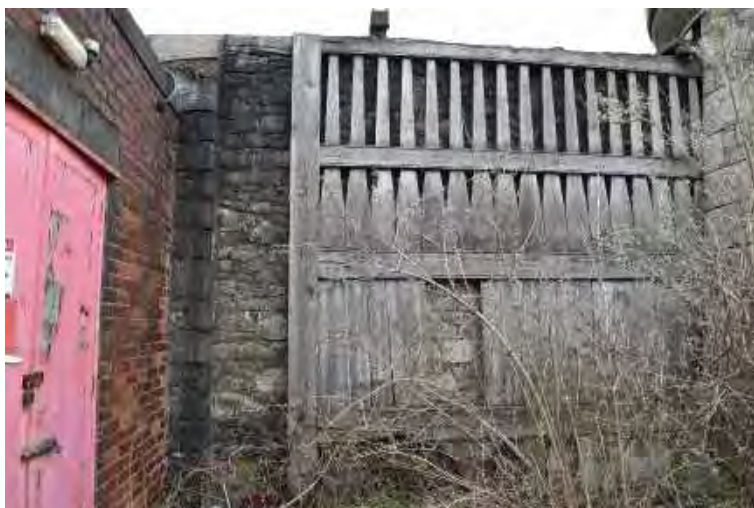
Southern gates are in a degraded condition although substantially intact.

Northern gates have been replaced with replica gates that are not operable.

Options for the conservation repair of the gates should be reviewed to enable these heritage elements to be retained.

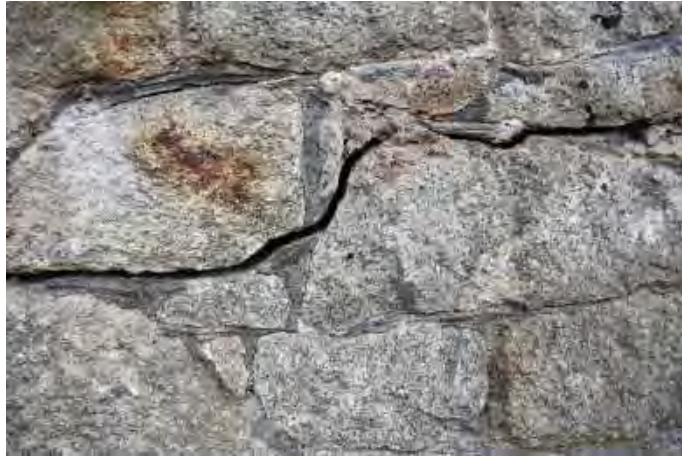
Diagonal cracking –
repoint (possibly
inject) to reinstate
wall integrity.

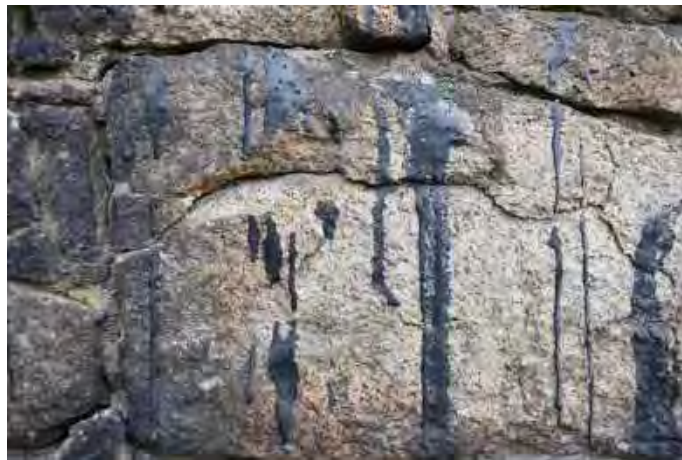
Paint on stonework.

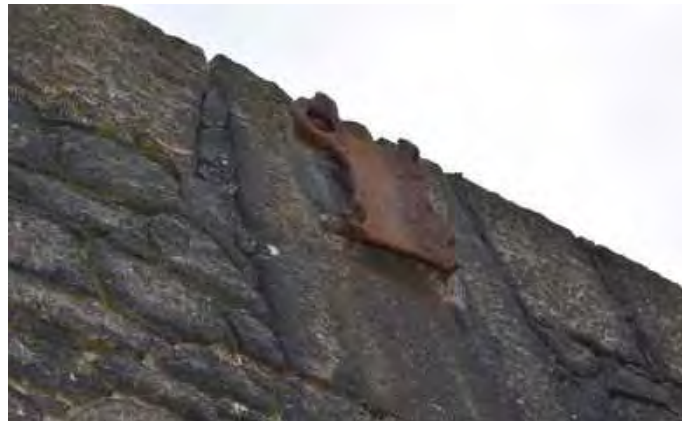
Broken guide bracket
fixed to wall.

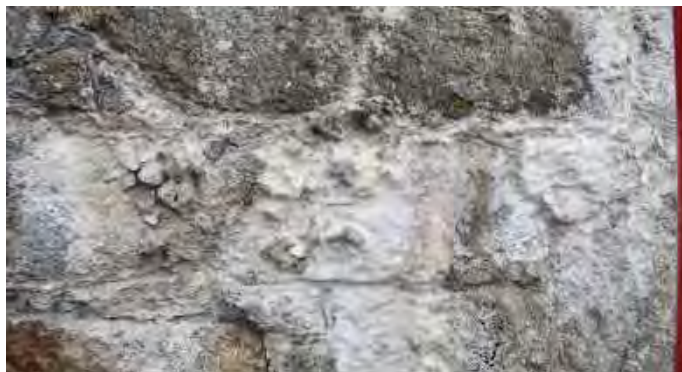
Calcium build-up on
wall.

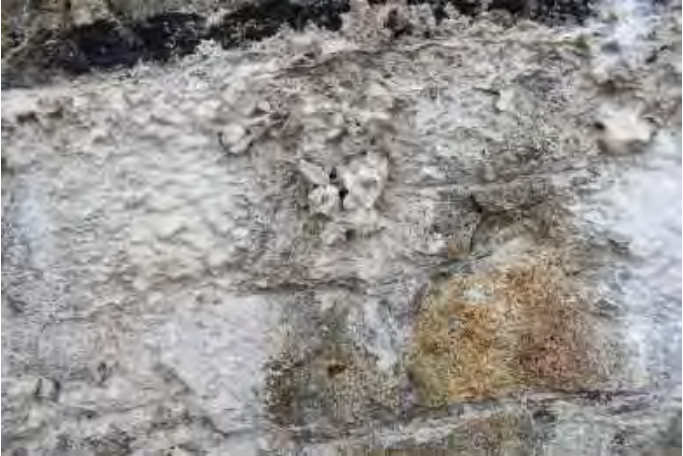
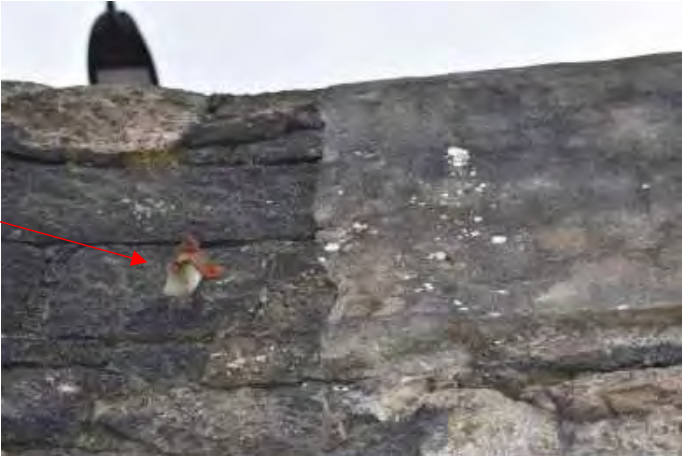
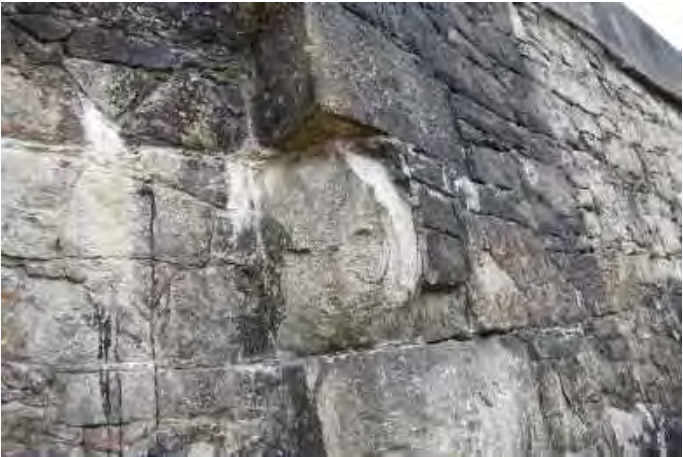
Location Ref:	BMD Elevation – Section 2
<p>Wall section width approx. 3.0m</p> <p>200mm step in wall for gate recess.</p> <p>Rounded coping top.</p> <p>Render applied to top of the wall.</p> <p>Missing / damaged stone to corner.</p> <p>Cracking to mortar at higher levels.</p> <p>Concrete plinth.</p>

<p>Condition:</p>	<p>Generally stable with some cracking around stonework especially at the higher levels. Calcium deposits at low level and later fitted concrete plinth to base of wall. Coping stones partly covered with render (BMD side only).</p> <p>Pollution staining to face of the wall.</p> <p>Proposed treatment:</p> <p>Remove later concrete plinth to base of wall.</p> <p>Re-point areas of cracked mortar</p> <p>Remove render to upper section of wall and make good stonework.</p> <p>Remove / treat staining to rear of wall.</p>

<p>Additional notes and photographs:</p> <p>Calcium deposits at low level.</p> <p>Render applied to coping of wall.</p> <p>Electrical bracket.</p> <p>Damaged stone to corner.</p>

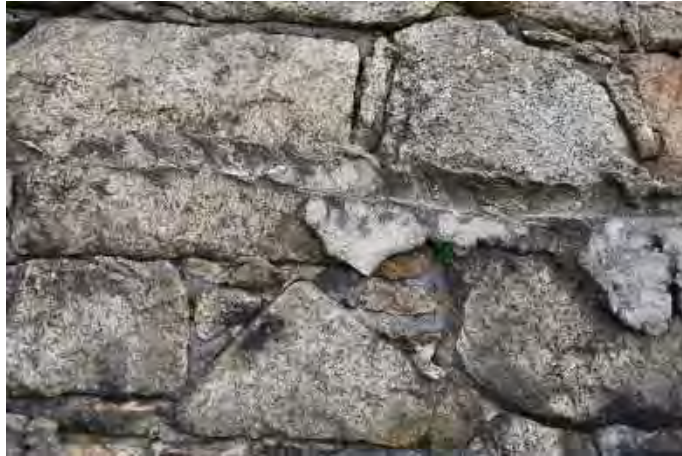
Cracking of mortar
around stones.

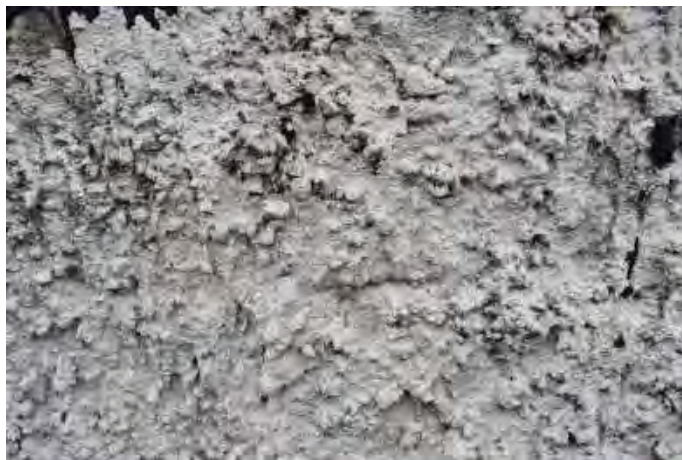
Concrete on the face
of the wall.

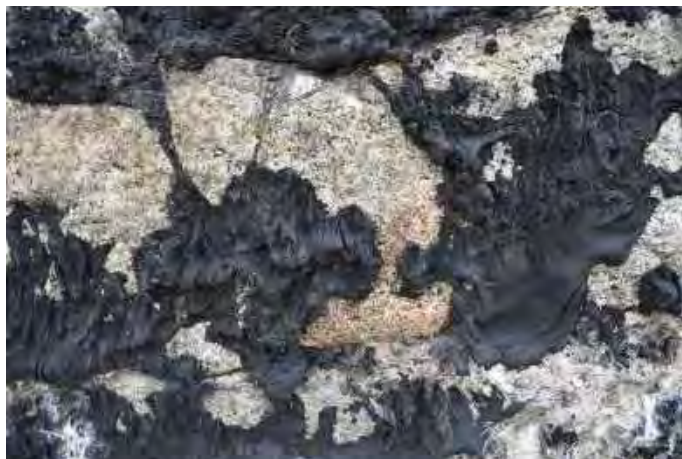
Thick tar deposits to
face of the wall.

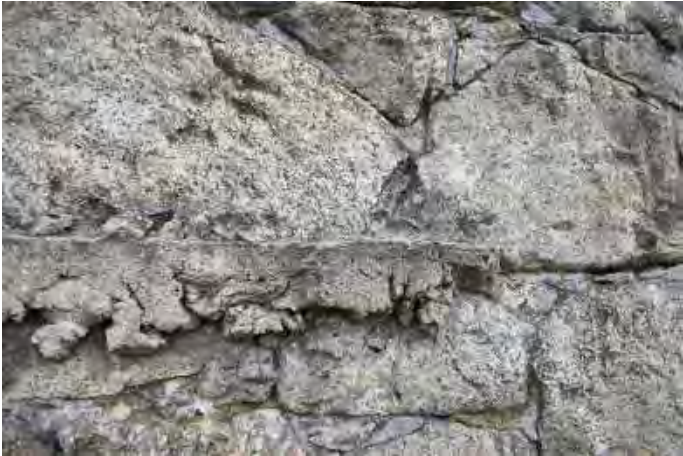
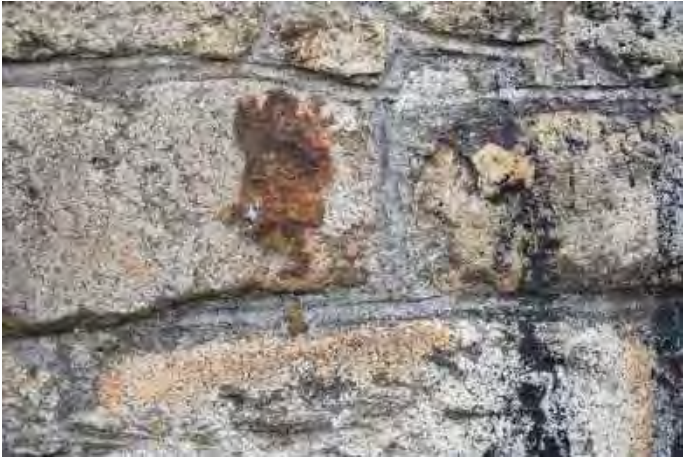
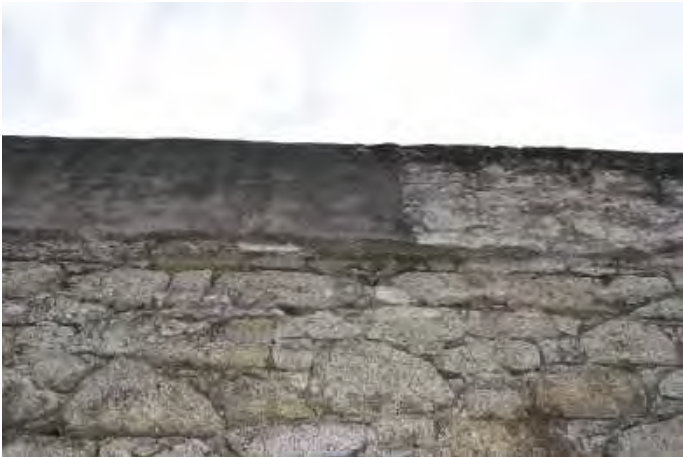
<p>Additional notes and photographs:</p> <p>Cracking of mortar around stonework.</p> <p>Later mortar on face of wall.</p> <p>Rust staining to wall.</p> <p>Render coating applied to BMD side of the wall.</p>	<p>9</p>

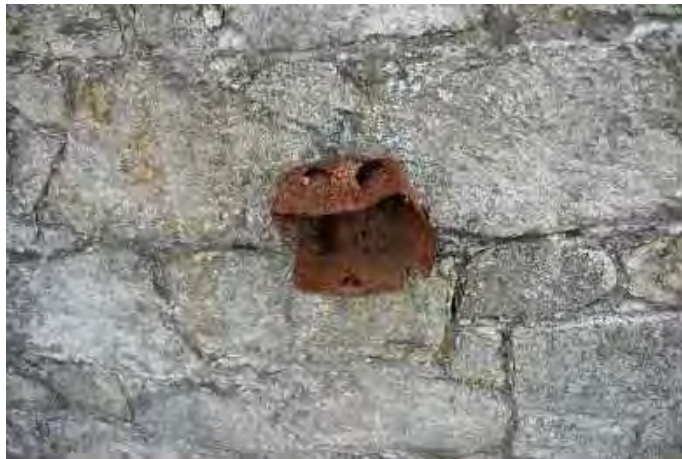
Electrical conduit box
fitted to wall.

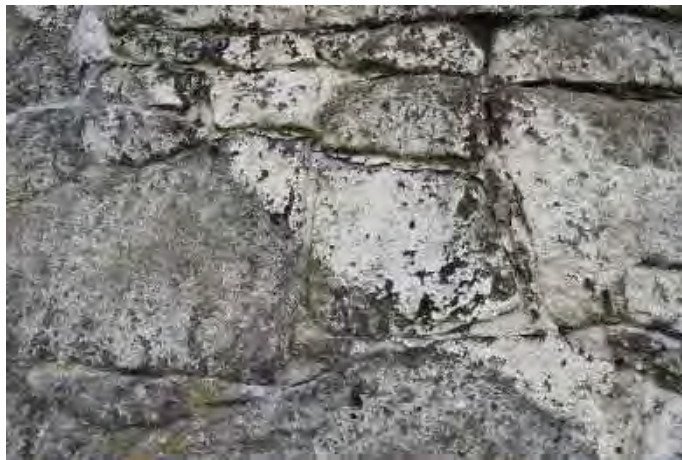
White paint on face of
wall.

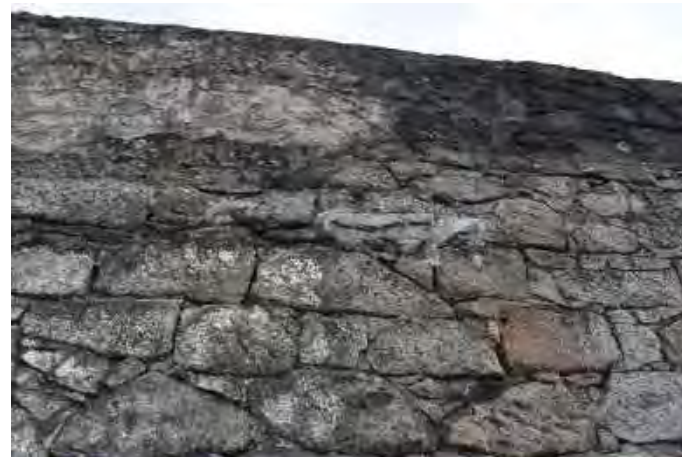
Render to top of the
wall.

Cracking of mortar
around upper
stonework.

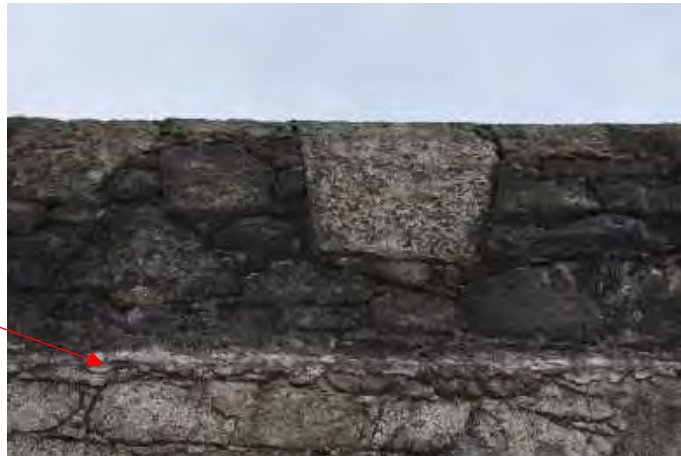
Pollution staining of upper stonework.

Line of render.

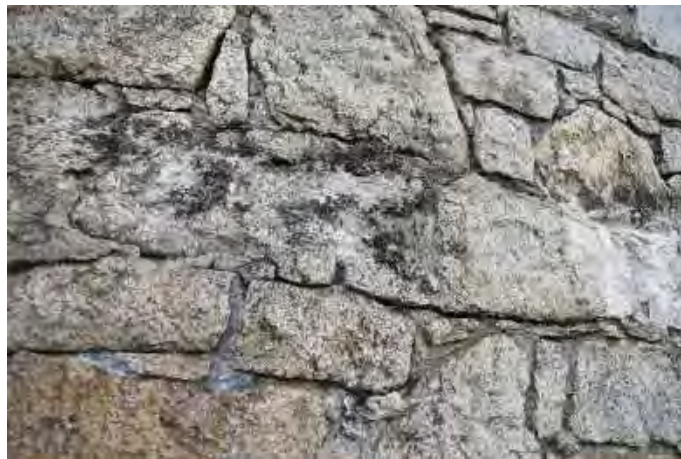
Some cracking and mortar loss at upper level.

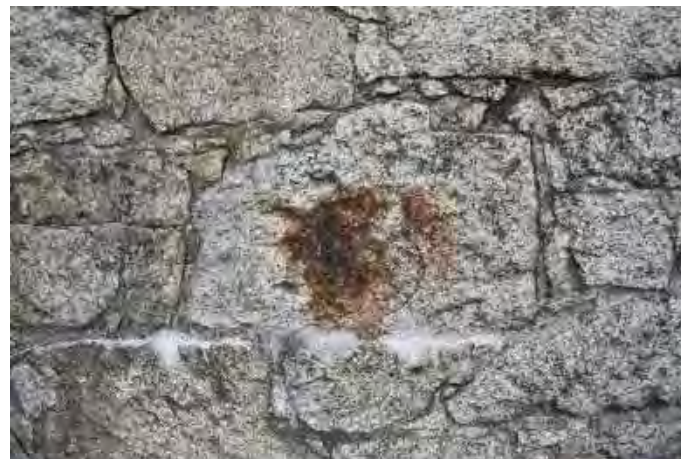
Rust staining to face of wall.

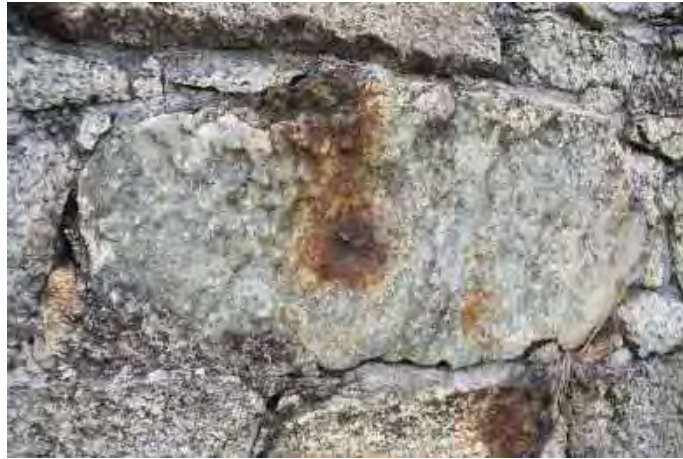
Rust staining – ferrous fixings.

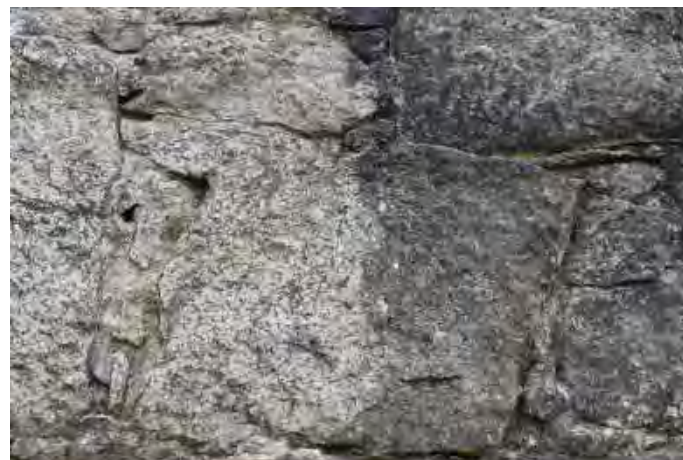
Pollution staining on face of wall – stark difference with areas that have been protected.

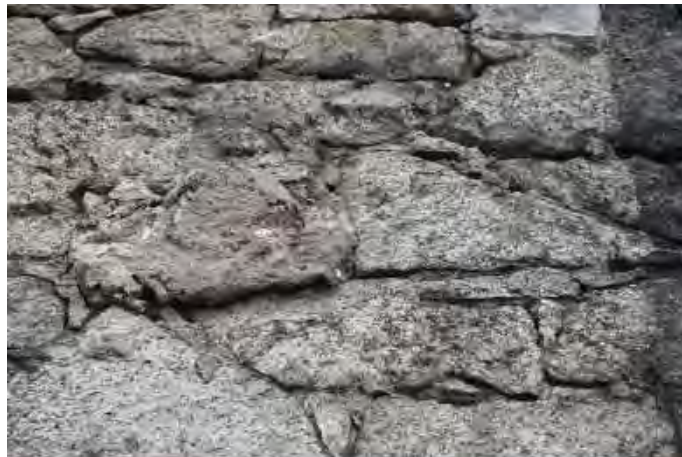
Cracking and some loss of mortar around stones.

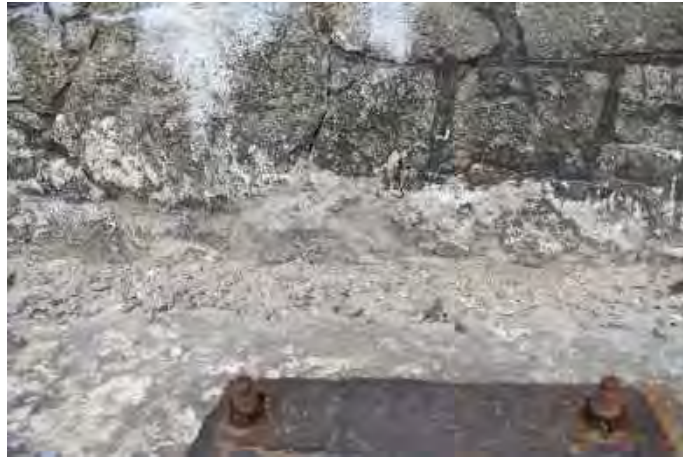
Concrete marking to wall from plinth.

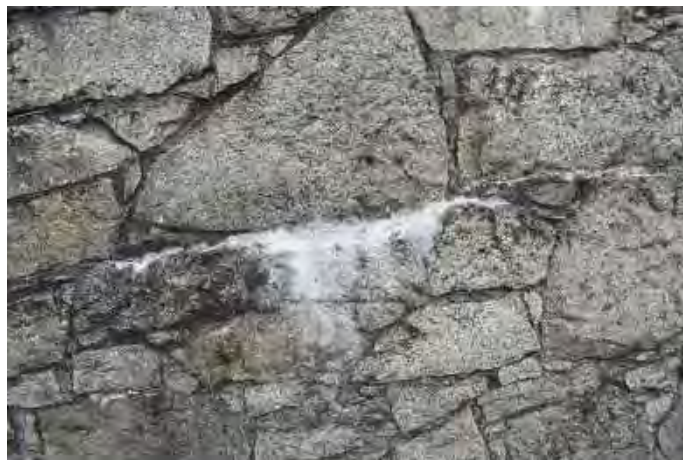
Cracking around stones and calcium deposits.

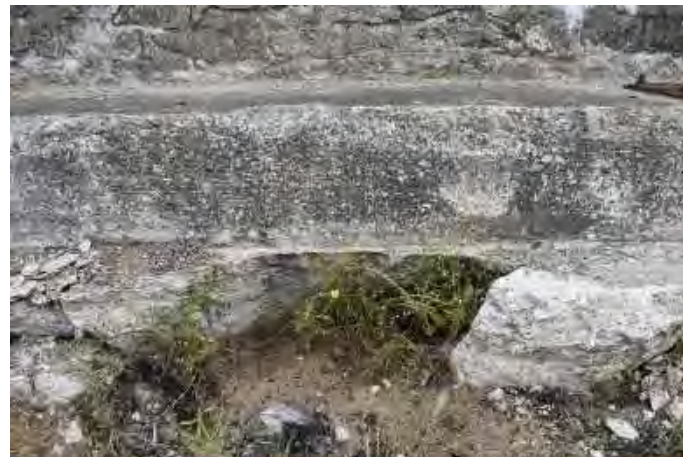
Concrete plinth to base of wall – 600mm deep.

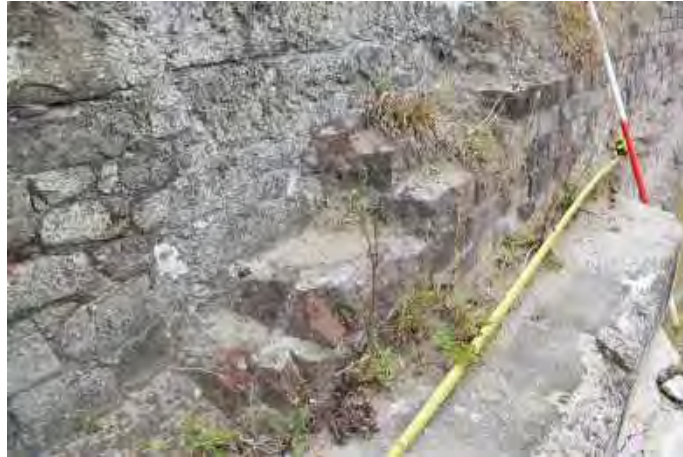
Brickwork fitted to rear of wall. (240mm from face of stonework)

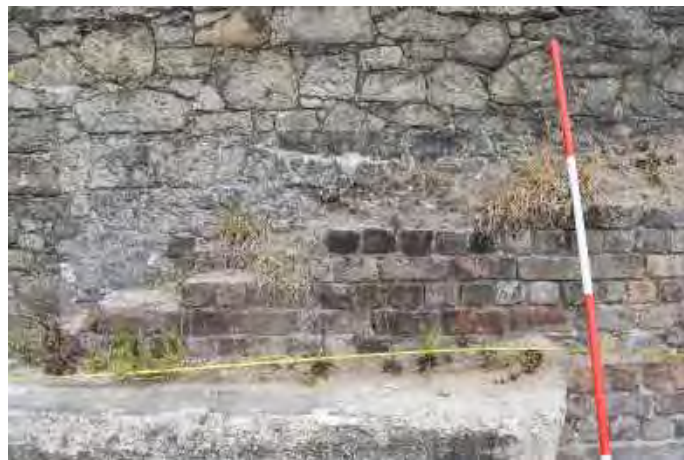
Brickwork steps and some captive behind the concrete plinth.

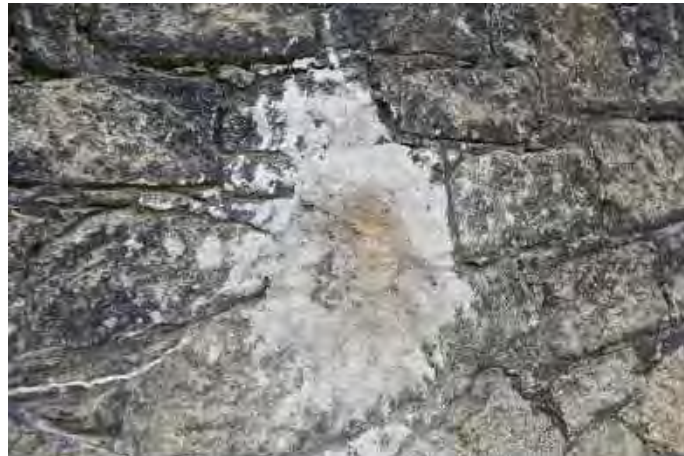
Previous core hole position – poor repair to face.

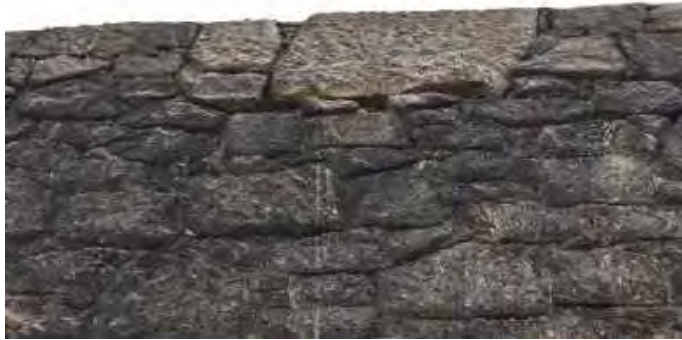
Mortar loss below coping stones and loose stonework.

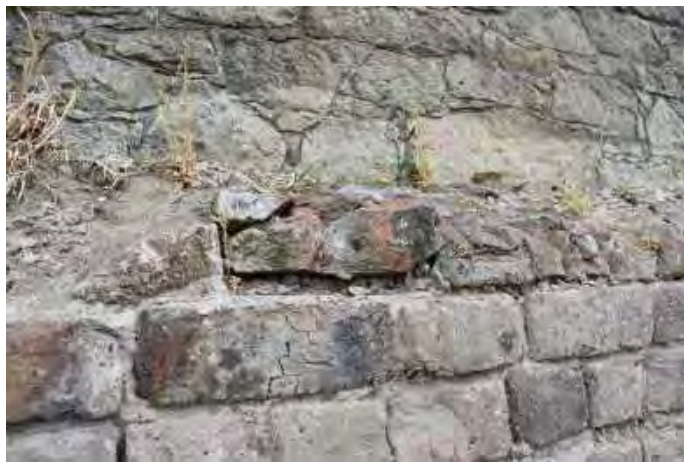
Loose brickwork and build-up of sand from previous storage.

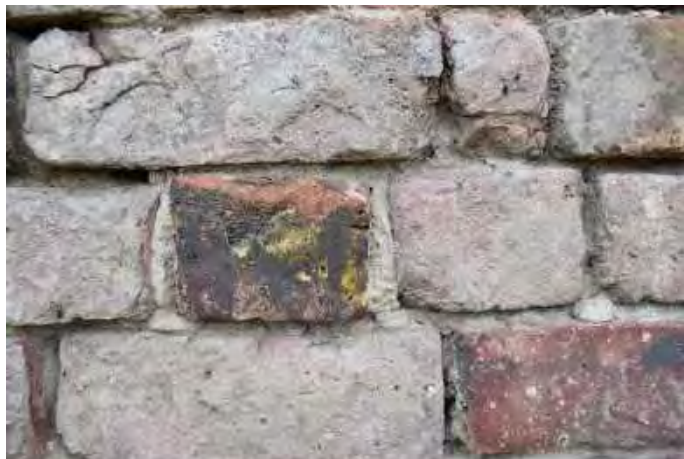
Bricks are common quality with a light-coloured mortar.

Bricks are laid in English Bond.

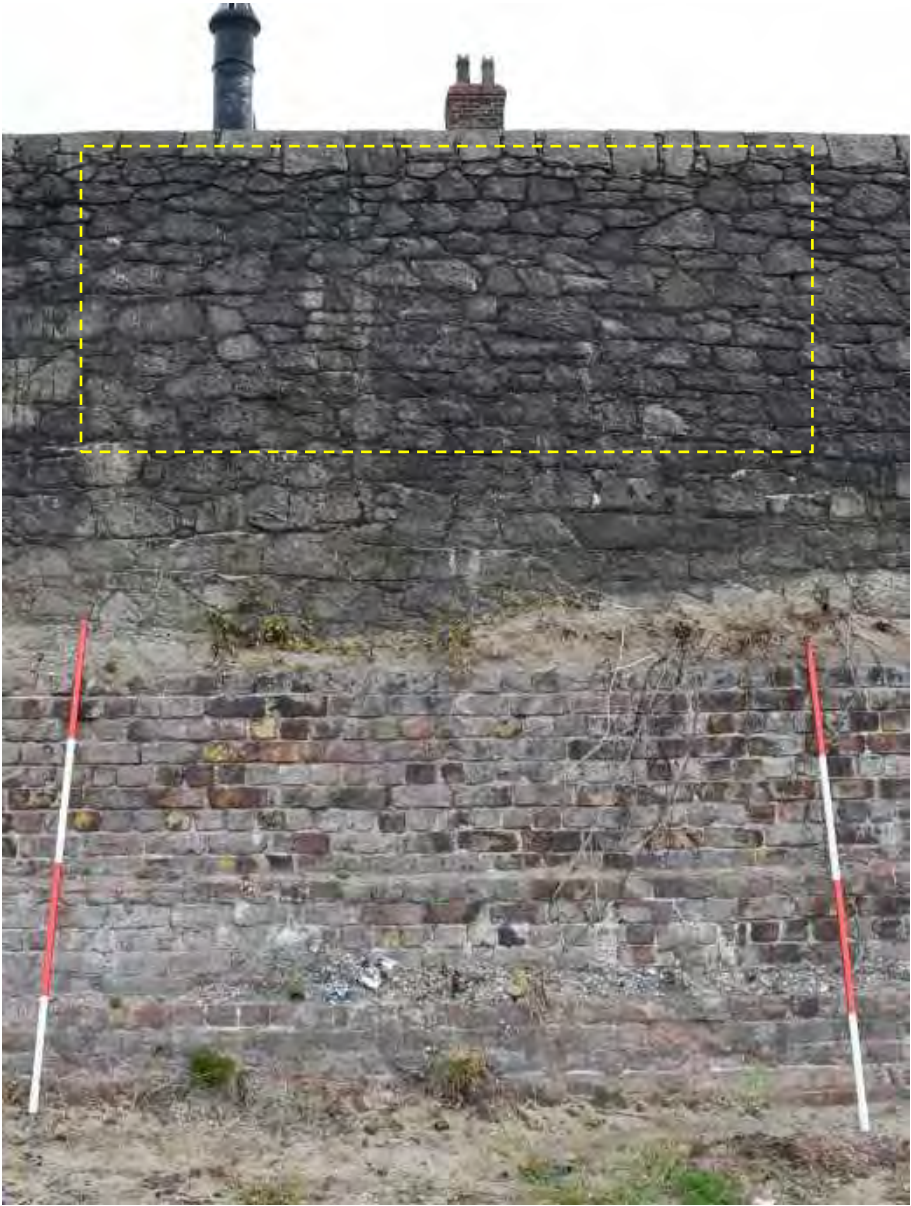
Location Ref:	BMD Elevation – Section 11
<p>Wall section width approx. 3.0m</p> <p>Cracking and mortar loss to upper wall areas.</p> <p>Some paint marking on wall.</p> <p>Sand build-up on brickwork.</p> <p>Corbelled brickwork with 2No steps.</p>

<p>Condition:</p>	<p>Wall is generally stable but with some cracking and mortar loss around stones especially at higher levels. Paint and calcium deposits to the face of the wall.</p> <p>Brickwork corbelled against the stonework to height of approx. 1700mm with 2No steps.</p> <p>Proposed treatment:</p> <p>Re-point areas of cracked and missing mortar</p> <p>Remove / treat staining to rear of wall.</p> <p>Remove sand build-up on brickwork and stabilise condition where loose.</p>

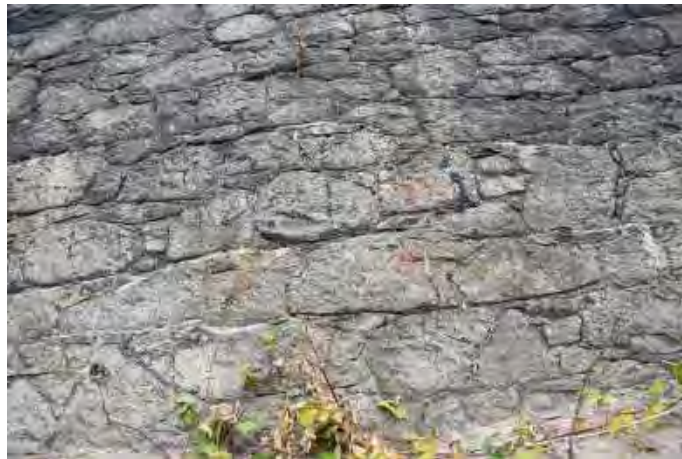
Cracking to mortar at higher levels.

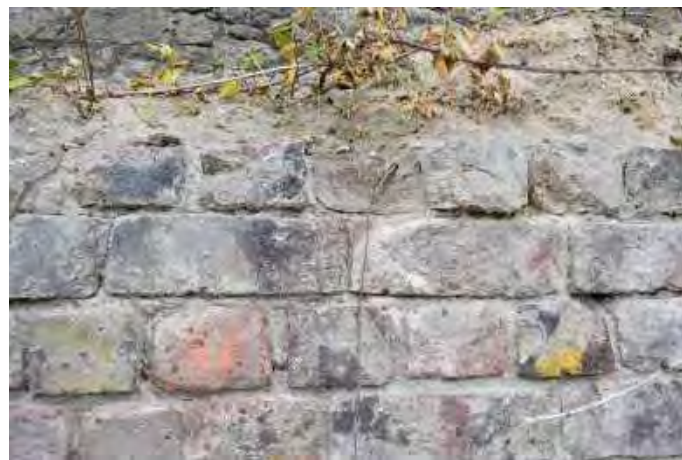
Sand build-up to top of brickwork. Some bricks to upper level are loose.

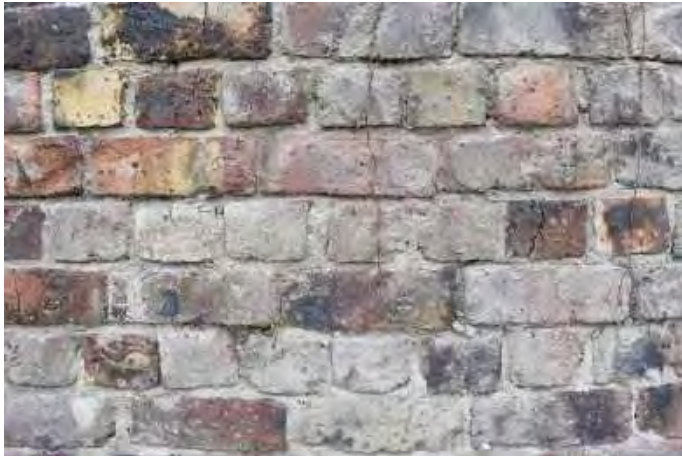
Common bricks with misshapen and burnt elements.

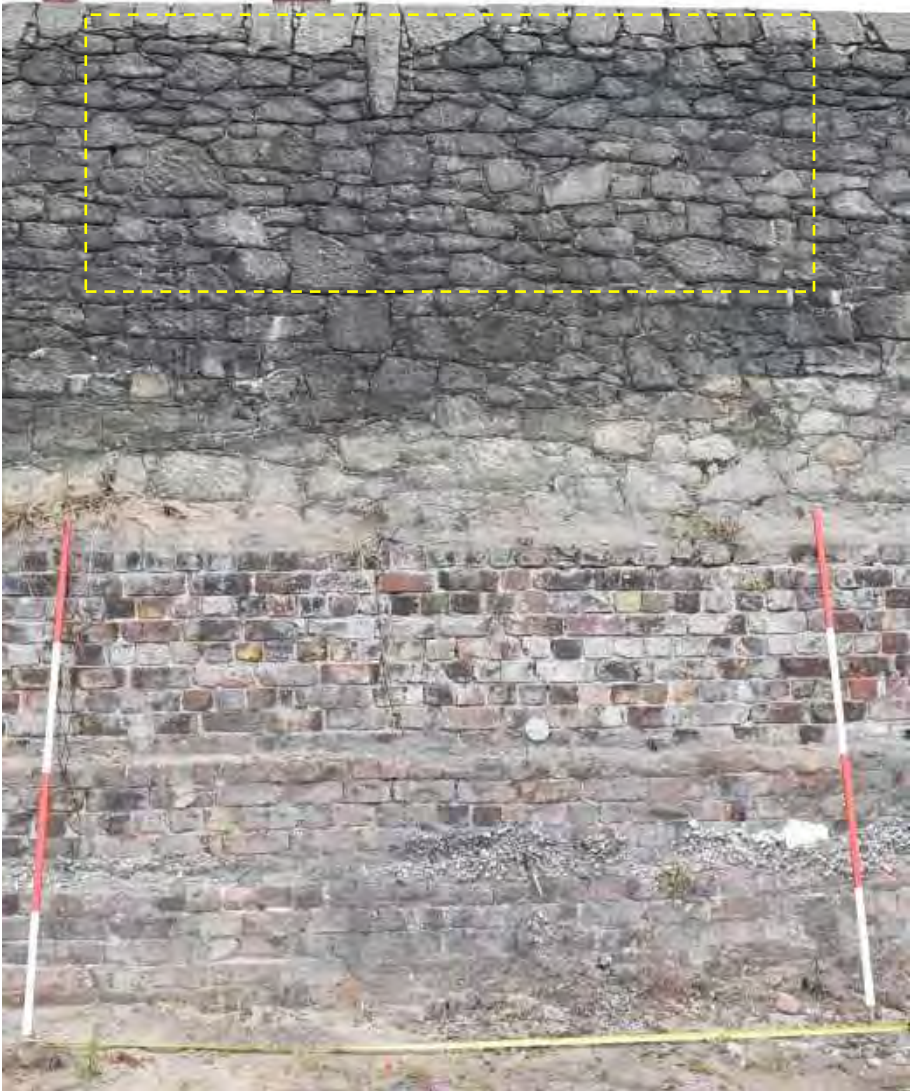
Location Ref:	BMD Elevation – Section 12
<p>Wall section width approx. 3.0m</p> <p>Cracking of mortar and some loss at high level.</p> <p>Loose brickwork.</p> <p>Corbelled brickwork approx. 1700mm high – 2No steps.</p>

<p>Condition:</p>	<p>Wall is generally stable but with some cracking and mortar loss around stones especially at higher levels. Paint and calcium deposits to the face of the wall.</p> <p>Brickwork corbelled against the stonework to height of approx. 1700mm with 2No steps.</p> <p>Proposed treatment:</p> <p>Re-point areas of cracked and missing mortar</p> <p>Remove / treat staining to rear of wall.</p> <p>Remove sand build-up on brickwork and stabilise condition where loose.</p>

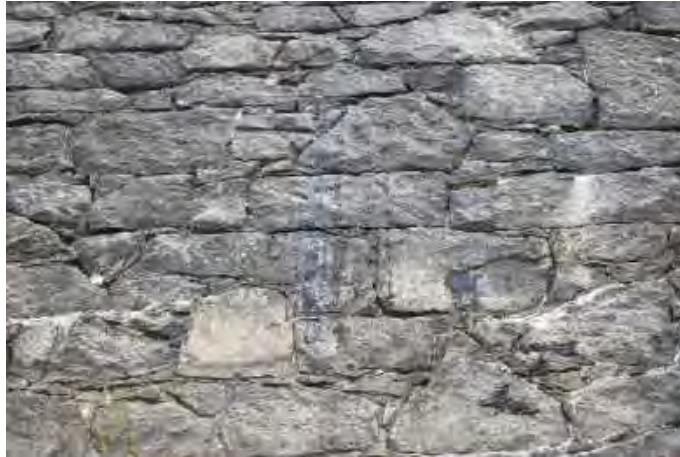
Cracking and mortar loss to upper stonework.

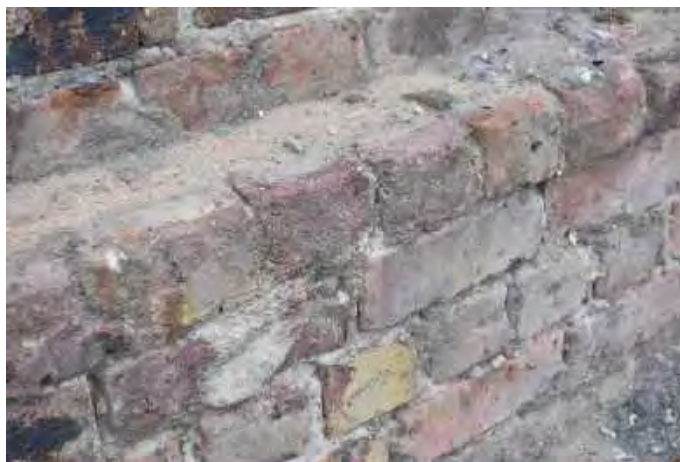
Corbelled steps brickwork.

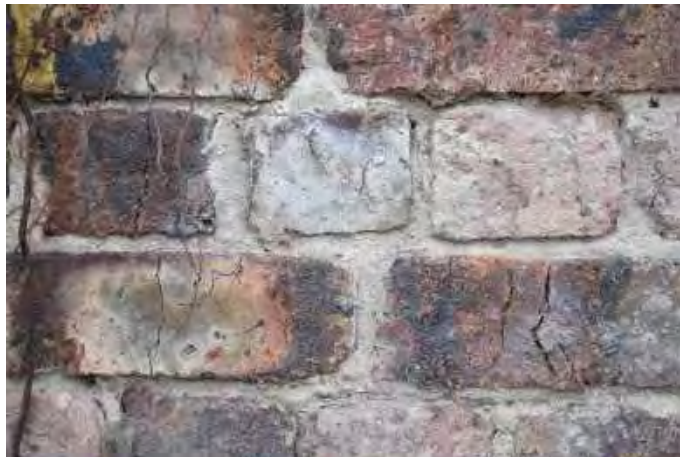
Brickwork mortar generally in good condition – no adverse cracking.

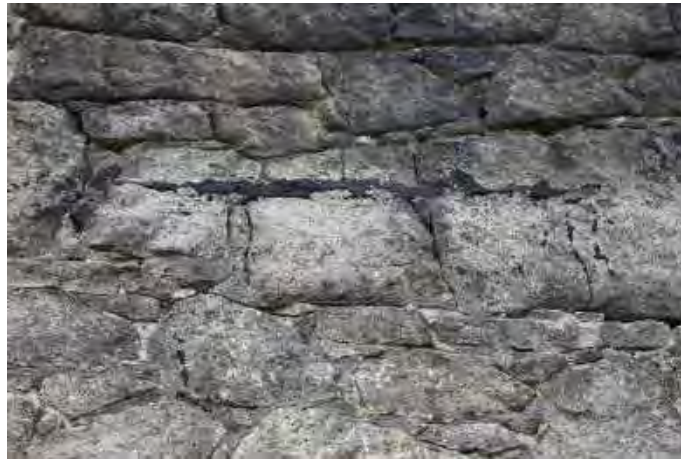
Cracking of mortar.

Paint and tar on face of wall.

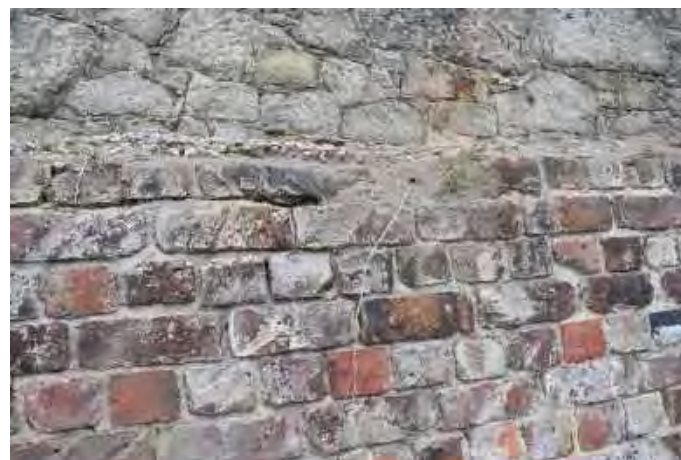
Gravel build-up on brickwork.

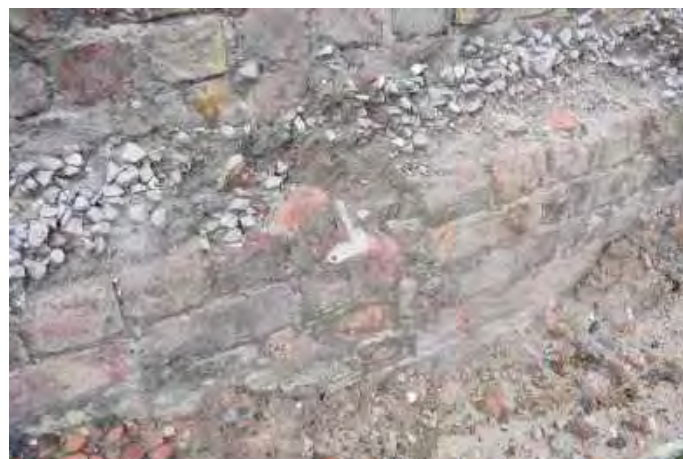
Damage to wall possibly during removal of gravel and sand.

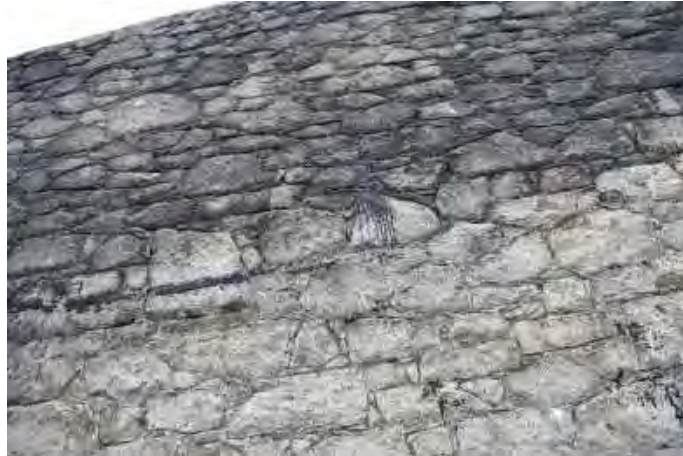
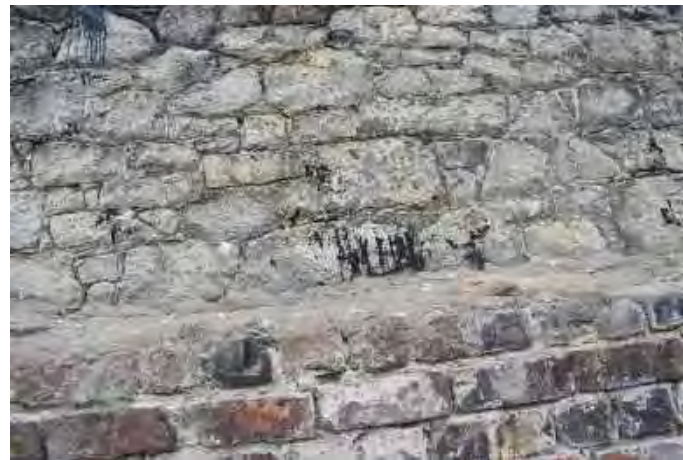
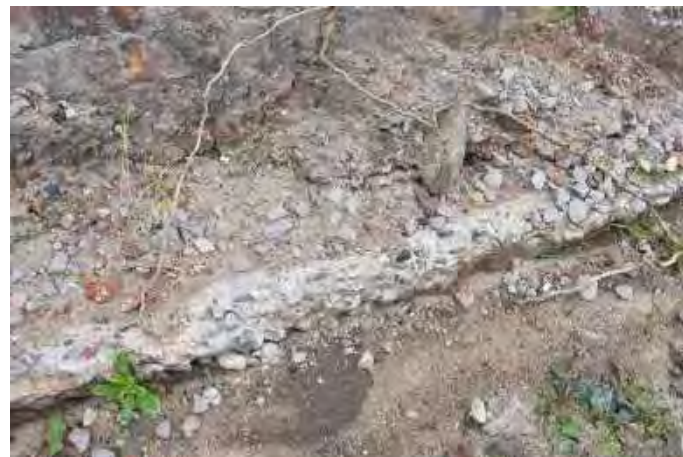
Cracking within the mortar.

Some loose brickwork to top of the brickwork wall.

Concrete plinth cast against the brickwork wall.

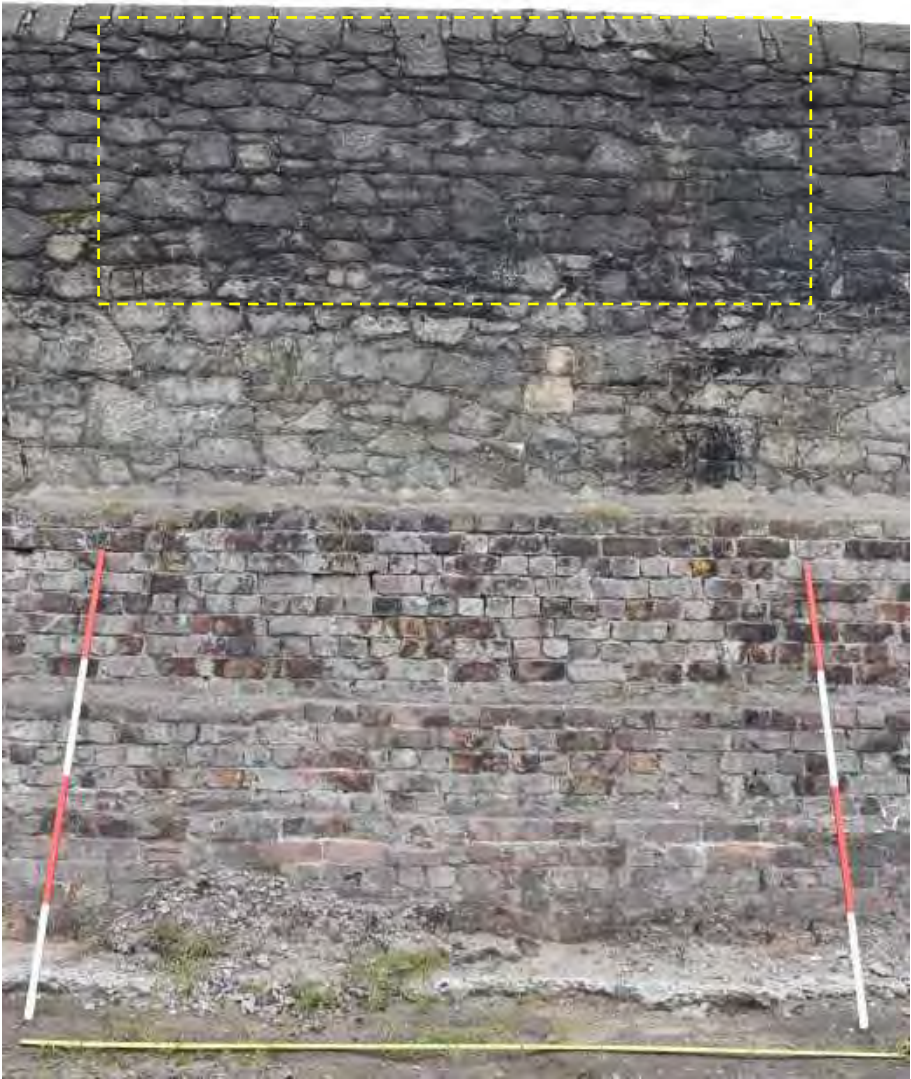
Location Ref:	BMD Elevation – Section 15
<p>Wall section width approx. 3.0m</p> <p>Cracking / loose mortar to upper wall.</p> <p>Brickwork height approx. 1700mm.</p> <p>Concrete plinth.</p>

<p>Condition:</p>	<p>Wall is generally stable but with some cracking and mortar loss around stones especially at higher levels. Brickwork corbelled against the stonework to height of approx. 1700mm with 2No steps. Concrete plinth at base of the wall.</p> <p>Proposed treatment:</p> <p>Remove concrete plinth and make good.</p> <p>Re-point areas of cracked and missing mortar</p> <p>Remove sand build-up on brickwork and stabilise condition where loose.</p>

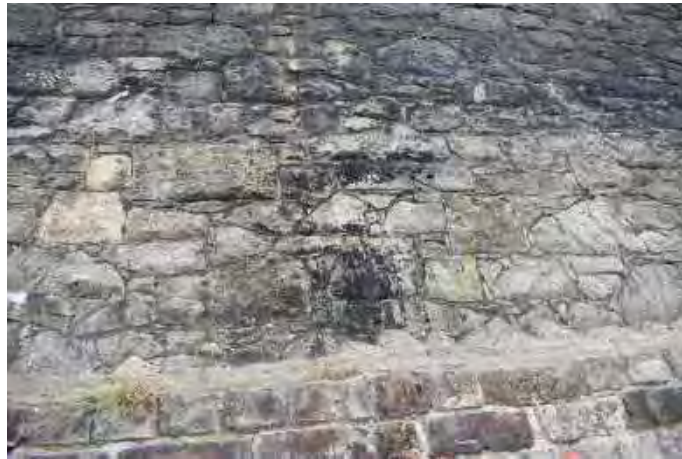
Cracking of mortar at
upper levels.

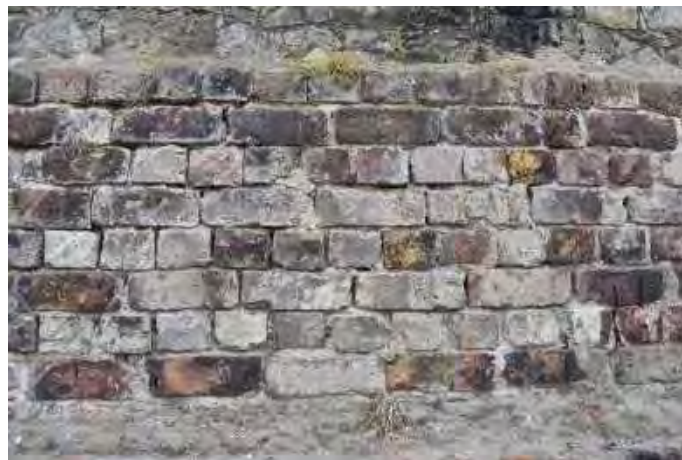
Some mortar loss
from brickwork at
higher levels.

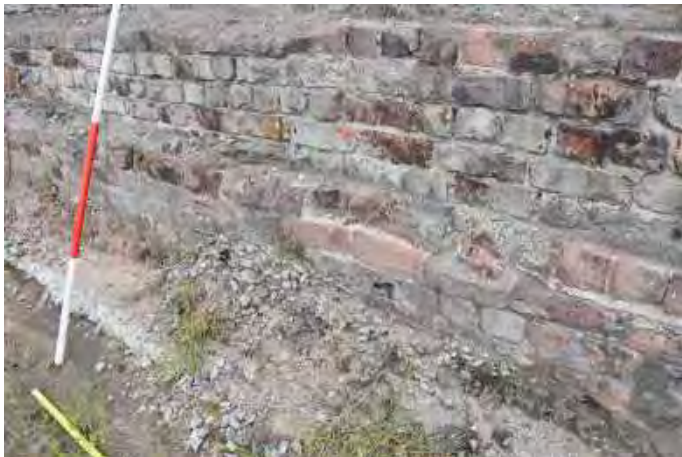
Concrete plinth with
some gravel.
