Bramley Moore Dock - Regent Road Wall

Wall Condition Survey

June 2020

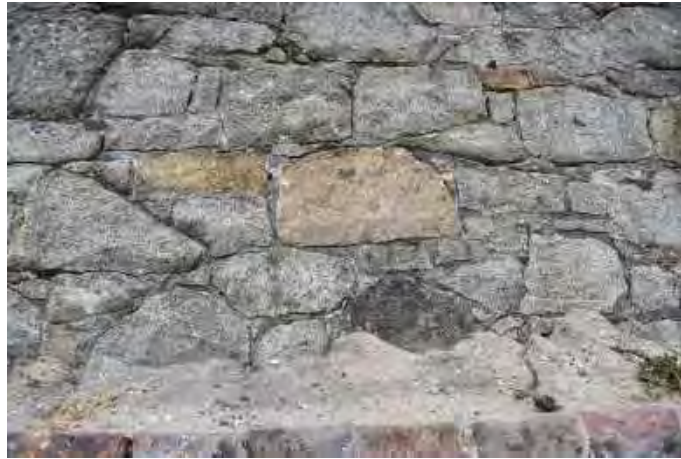
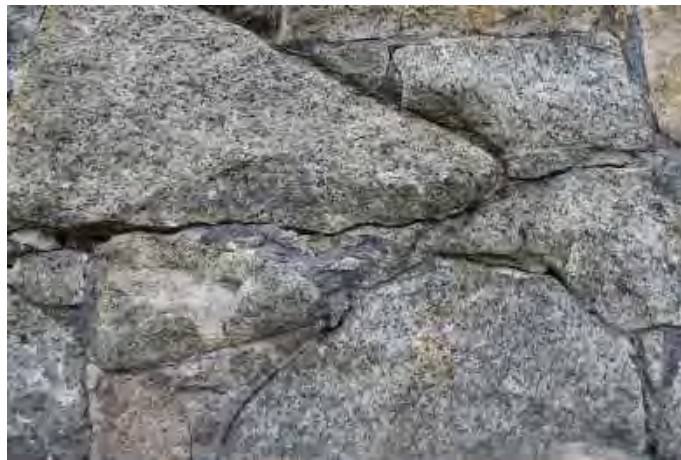
Cracking around
stones,

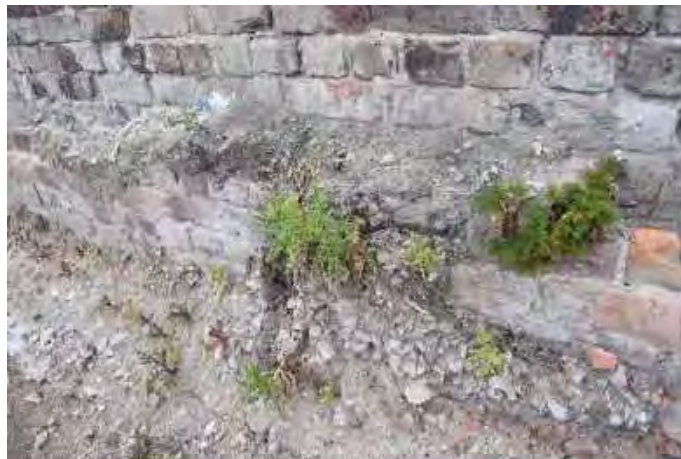
Gravel and sand over
concrete plinth.

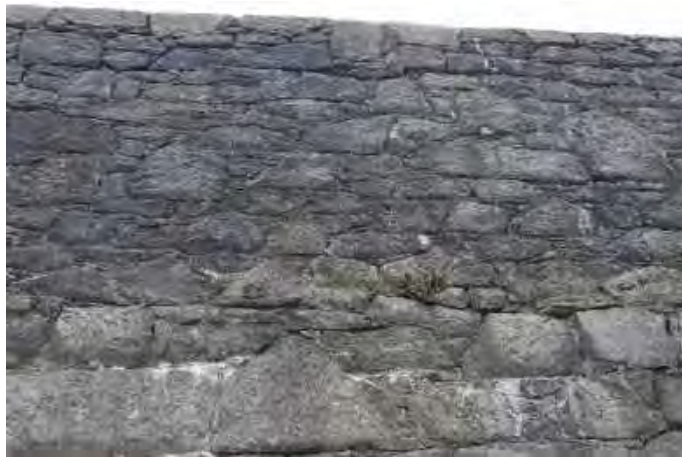
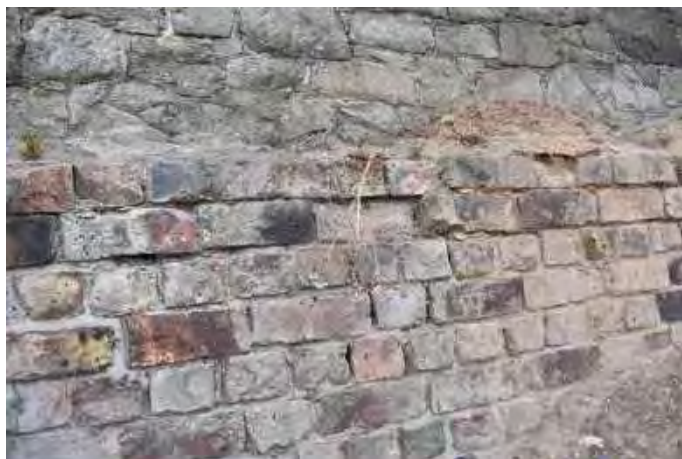
Cracking to upper wall
areas.

Cracking to mid level.

Loose brickwork to
upper courses.

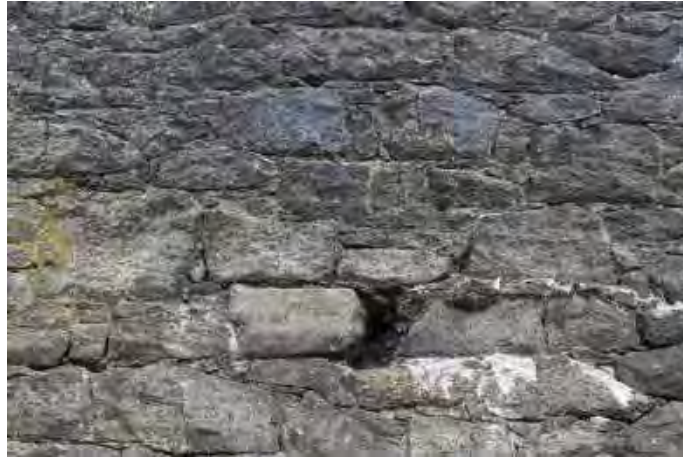
Cracking and mortar
loss.

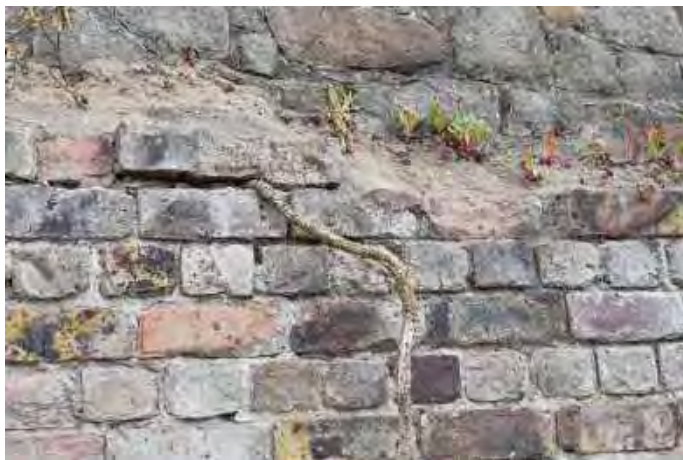
Buddleia growth in
wall.

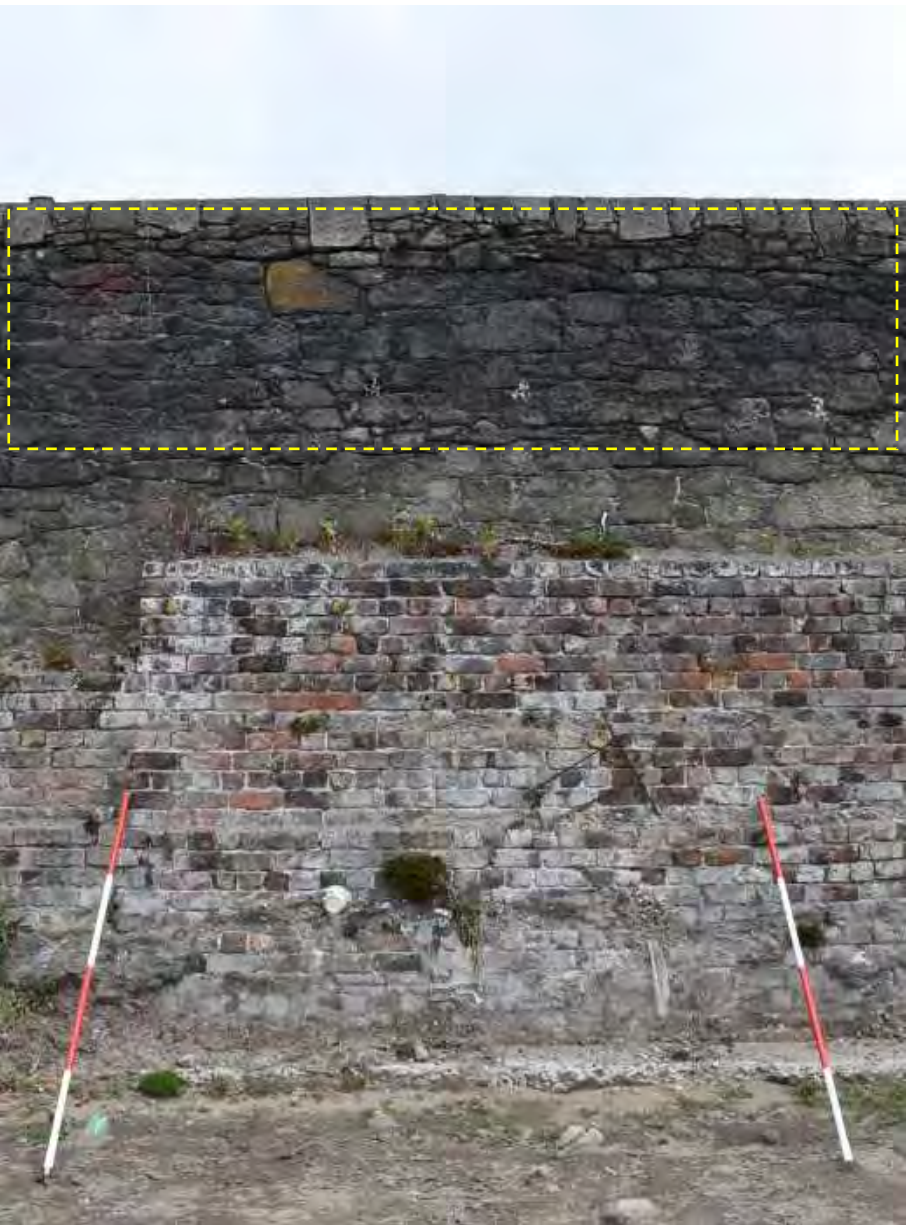
Location Ref:	BMD Elevation – Section 19
<p>Wall section width approx. 3.0m</p> <p>Cracking and mortar loss to upper wall.</p> <p>Brickwork wall height increased to approx. 2150mm.</p> <p>Concrete plinth.</p>

<p>Condition:</p>	<p>Wall is generally stable but with some cracking and mortar loss around stones especially at higher levels. Paint and calcium deposits to the face of the wall. Brickwork corbelled against the stonework to height of approx. 1700mm with 2No steps. Concrete plinth to base.</p> <p>Proposed treatment:</p> <p>Remove concrete plinth.</p> <p>Re-point areas of cracked and missing mortar - additional grouting of the upper core areas may be required.</p> <p>Remove / treat staining to rear of wall.</p> <p>Remove sand / gravel build-up on brickwork and stabilise condition where loose.</p>

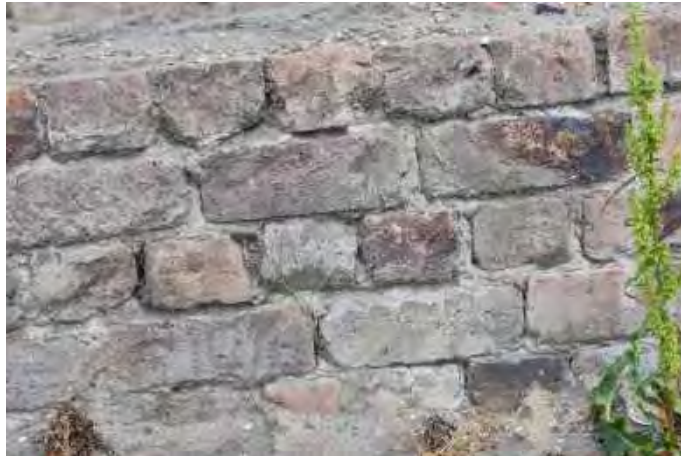
Weathered brickwork
– some loosened brick
to upper course.

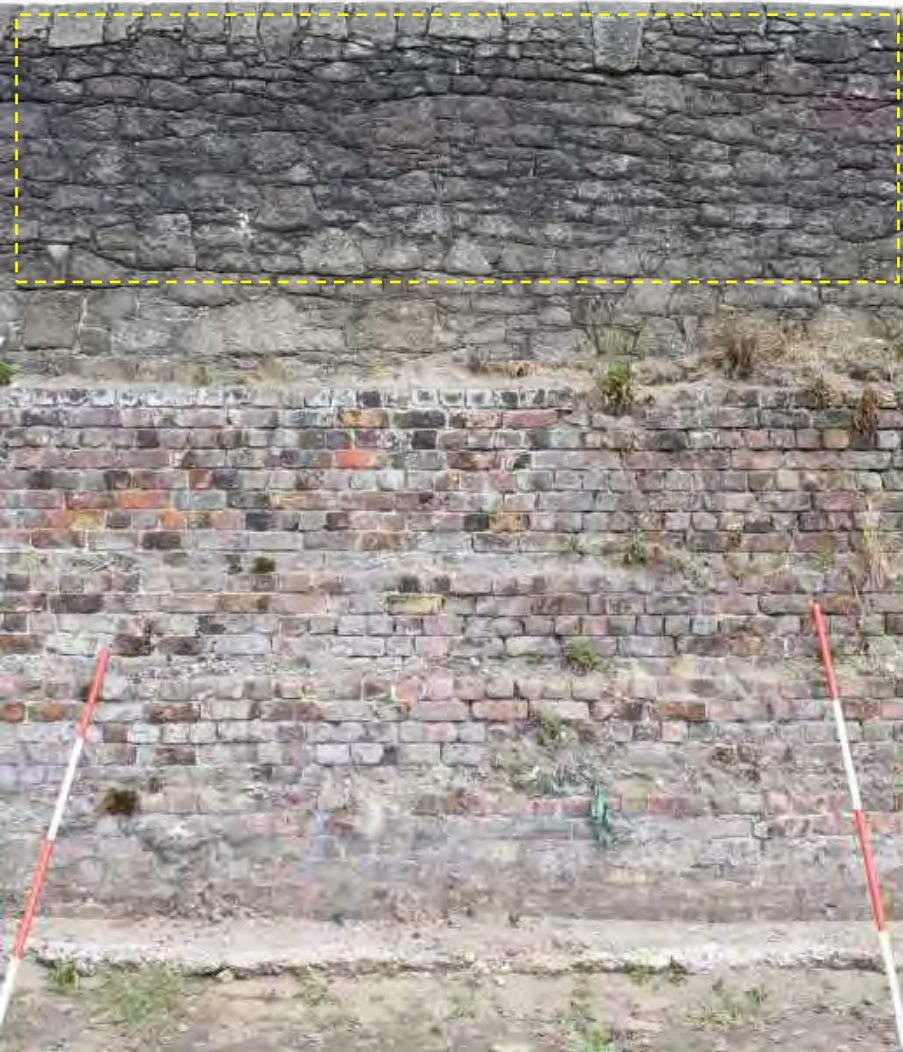
Location Ref:	BMD Elevation – Section 20
<p>Wall section width approx. 3.0m</p> <p>Cracking and mortar loss to upper wall area.</p> <p>Brickwork wall height approx. 2150mm corbelled in 3No steps.</p> <p>Concrete plinth.</p>

<p>Condition:</p>	<p>Wall is generally stable but with some cracking and mortar loss around stones especially at higher levels which requires repair. Brickwork corbelled against the stonework to height of approx. 2150mm with 3No steps. Concrete plinth to base.</p> <p>Proposed treatment: Remove concrete plinth. Re-point areas of cracked and missing mortar - additional grouting of the upper core areas may be required. Remove / treat staining to rear of wall.</p> <p>Remove sand / gravel build-up on brickwork and stabilise condition where loose.</p>

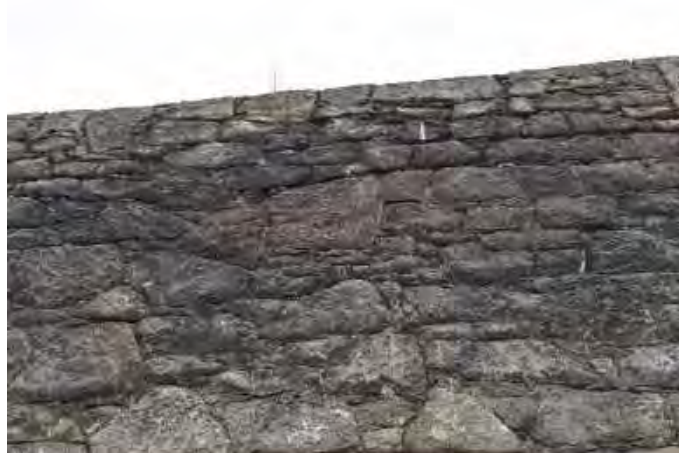
Cracking and mortar loss at high level.

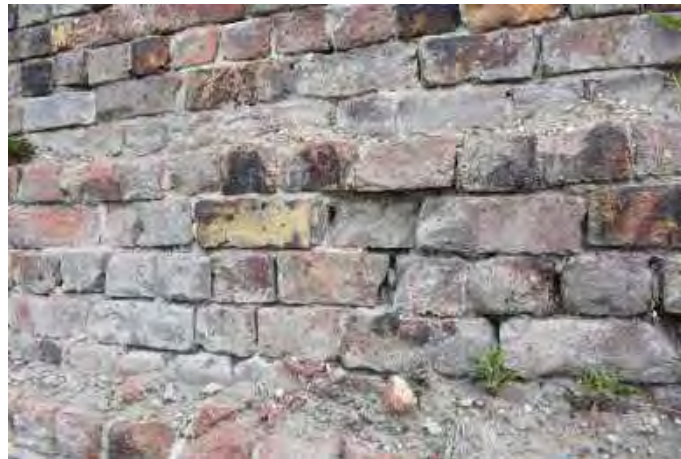
Damage to face of brickwork – possible frost damage and loss of face.

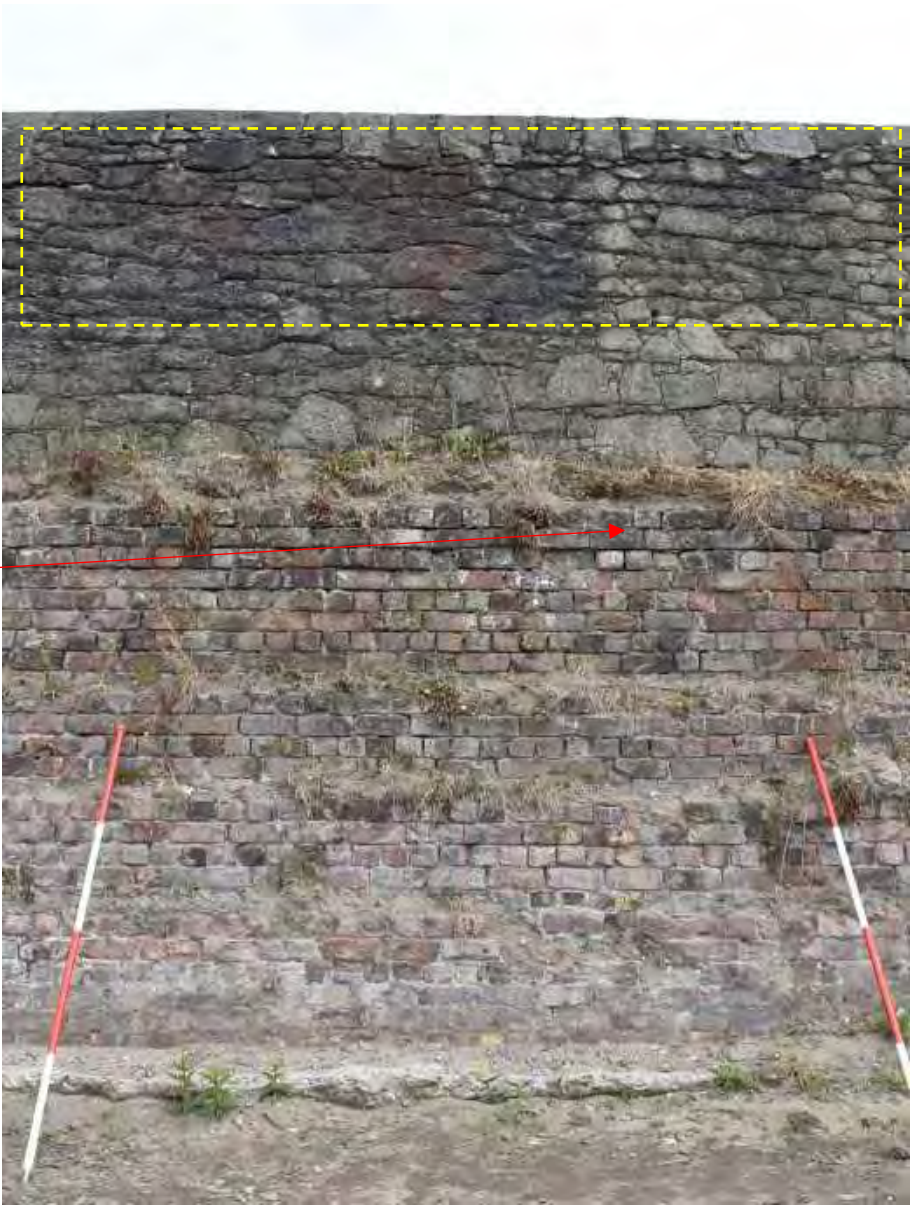
Location Ref:	BMD Elevation – Section 21
<p>Wall section width approx. 3.0m</p> <p>Cracking and mortar loss to upper wall areas.</p> <p>Sand / gravel on brickwork.</p> <p>Loose brickwork</p> <p>Concrete plinth.</p>

<p>Condition:</p>	<p>Wall is generally stable but with some cracking and mortar loss around stones especially at higher levels which requires repair. Brickwork corbelled against the stonework to height of approx. 2150mm with 3No steps. Concrete plinth to base.</p> <p>Proposed treatment:</p> <p>Remove concrete plinth.</p> <p>Re-point areas of cracked and missing mortar - additional grouting of the upper core areas may be required.</p> <p>Remove / treat staining to rear of wall.</p> <p>Remove sand / gravel build-up on brickwork and stabilise condition where loose.</p>

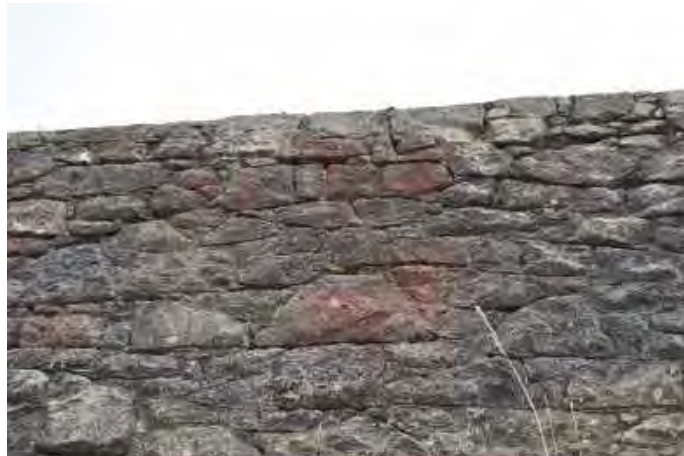
Cracking to upper wall
areas.

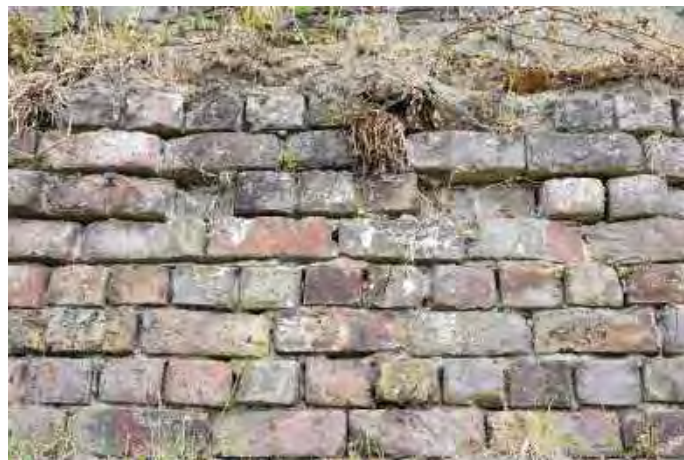
Loose brickwork to
upper courses.

Some loss of bricks.

Plant growth between
courses.

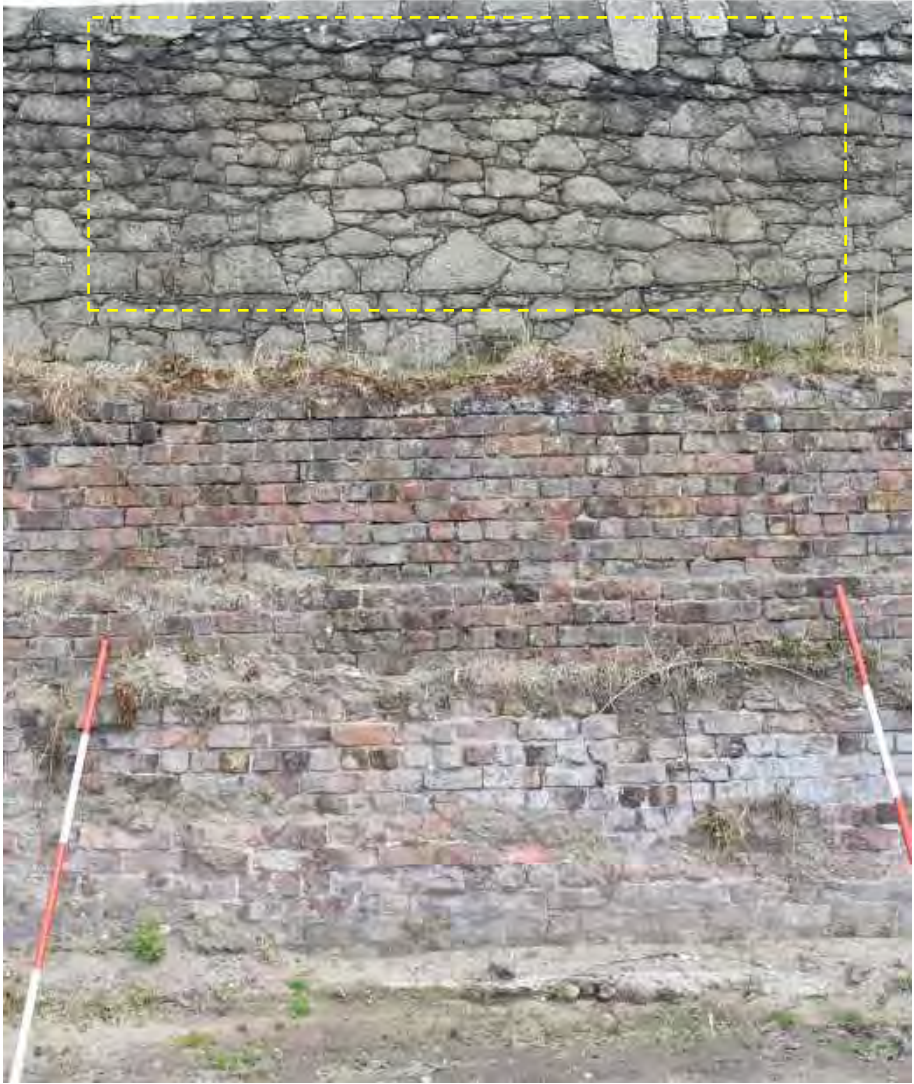
Location Ref:	BMD Elevation – Section 22
<p>Wall section width approx. 3.0m</p> <p>Cracking and mortar loss to upper wall.</p> <p>Concrete plinth.</p>

<p>Condition:</p>	<p>Wall is generally stable but with some cracking and mortar loss around stones especially at higher levels which requires repair. Brickwork corbelled against the stonework to height of approx. 2150mm with 3No steps. Concrete plinth to base.</p> <p>Proposed treatment:</p> <p>Remove concrete plinth.</p> <p>Re-point areas of cracked and missing mortar - additional grouting of the upper core areas may be required.</p> <p>Remove / treat staining to rear of wall.</p> <p>Remove sand / gravel build-up on brickwork and stabilise condition where loose.</p>

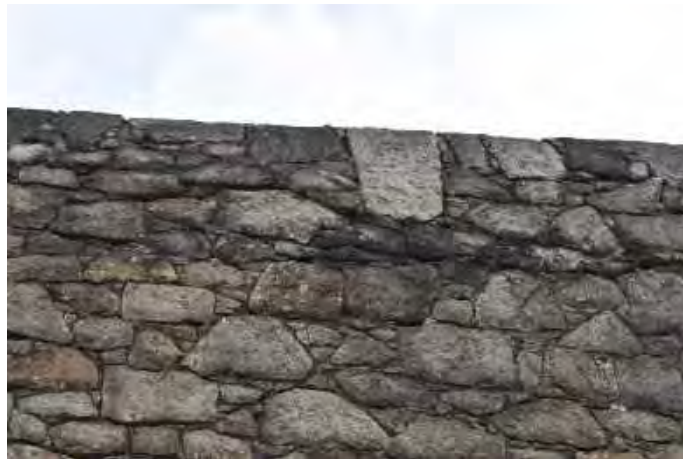
Cracking of mortar to
upper wall area.

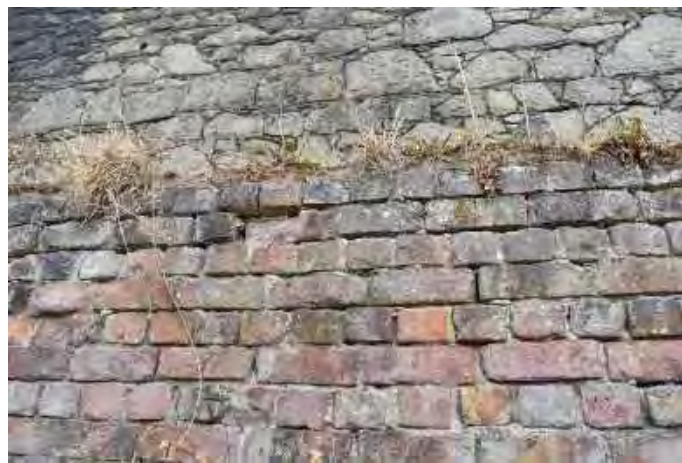
Plant growth within
upper brick courses
and loose bricks.

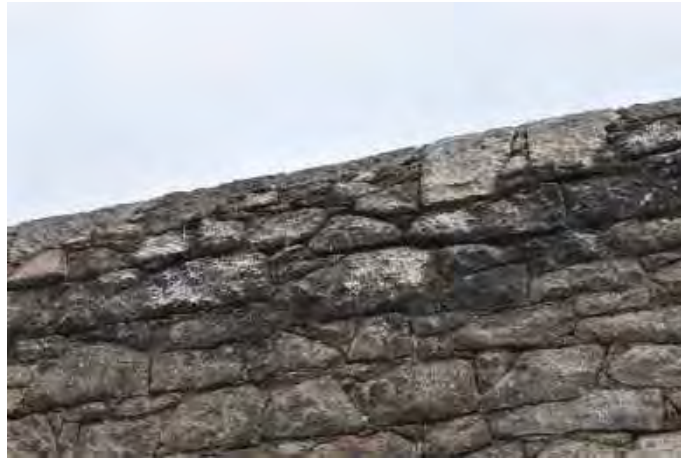
Mortar loss to stonework under coping.

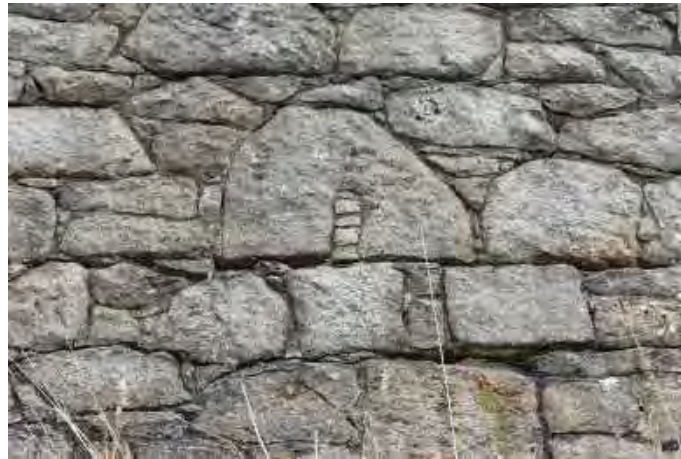
Tight fitting stonework with cracking evident around stones.

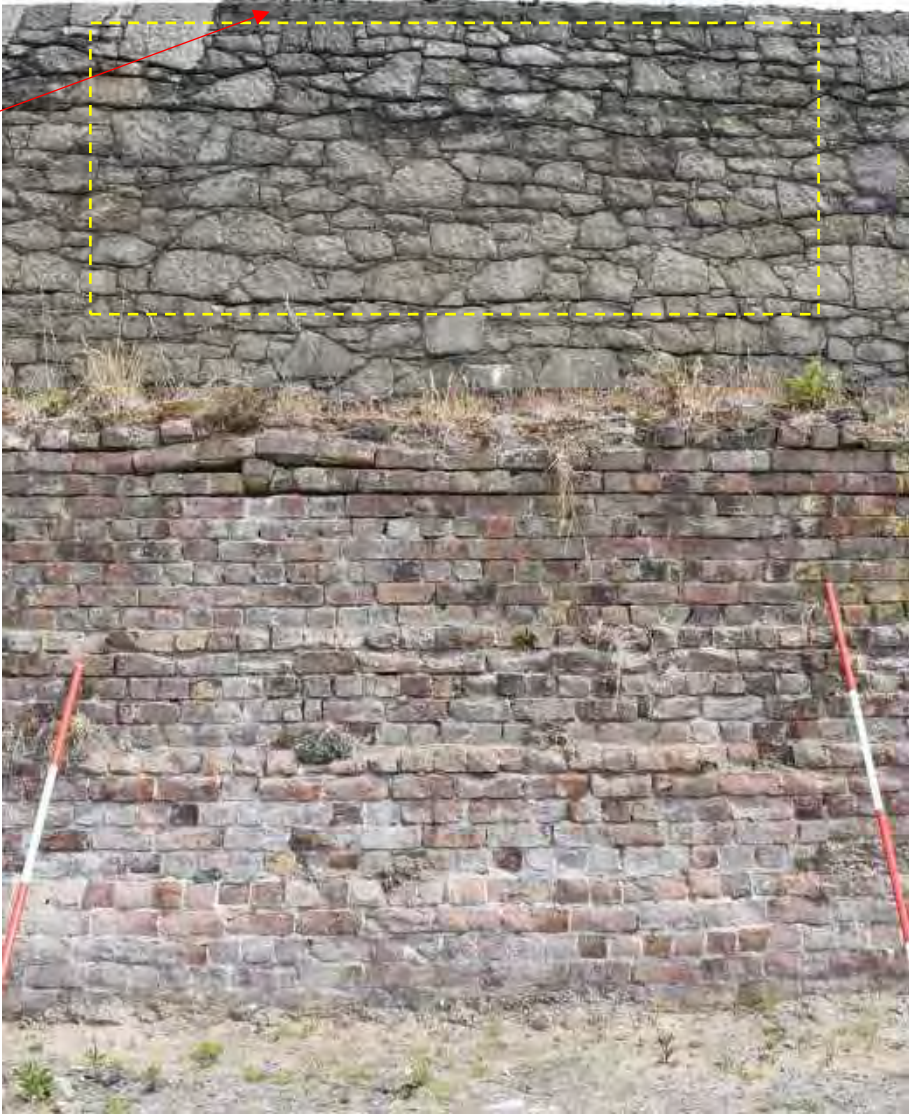
Location Ref:	BMD Elevation – Section 24
<p>Wall section width approx. 3.0m</p> <p>Render and broken glass to top of wall also coping detail changes in this area ie less large stones.</p> <p>Loose brickwork.</p> <p>Damaged brickwork at stepped courses.</p>

<p>Condition:</p>	<p>Wall is generally stable but with some cracking and mortar loss around stones especially at higher levels which requires repair. Brickwork corbelled against the stonework to height of approx. 2150mm with 3No steps.</p> <p>Proposed treatment:</p> <p>Re-point areas of cracked and missing mortar - additional grouting of the upper core areas may be required.</p> <p>Remove / treat staining to rear of wall.</p> <p>Remove render and broken glass to top of coping and make good.</p> <p>Remove sand / gravel build-up on brickwork and stabilise condition where loose.</p>

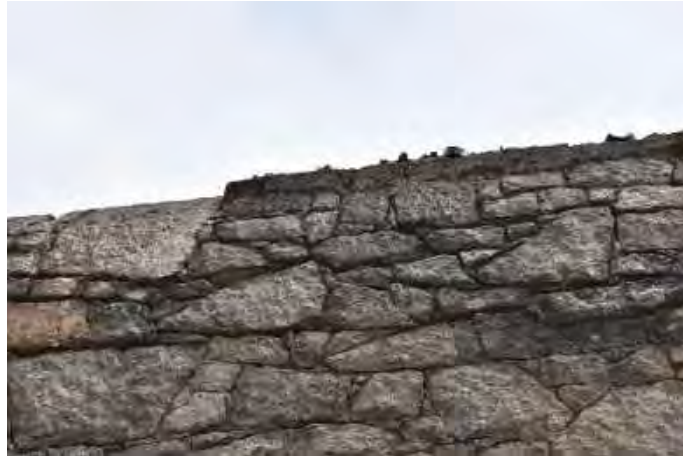
Change in coping detail – additional render and broken glass over section of smaller stones (possible rebuild area).

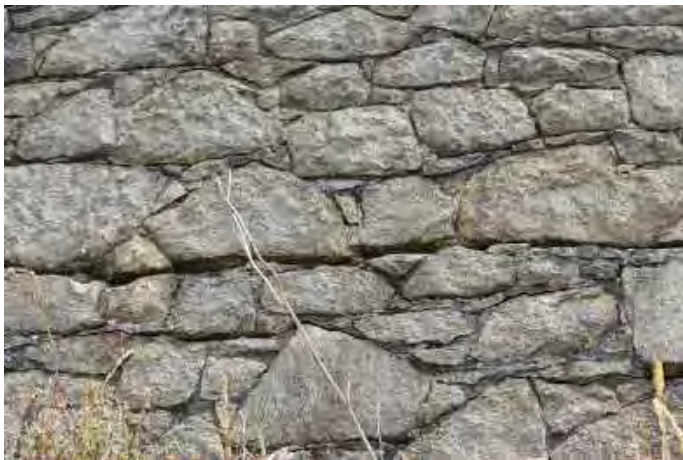
Cracking to wall at mid height.

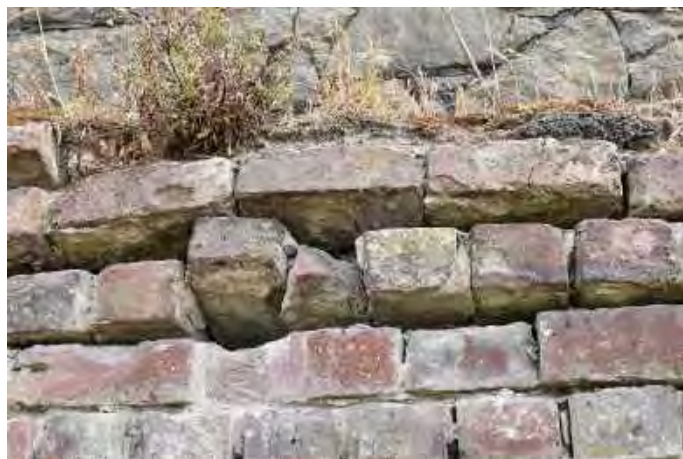
Loose brickwork to upper courses.

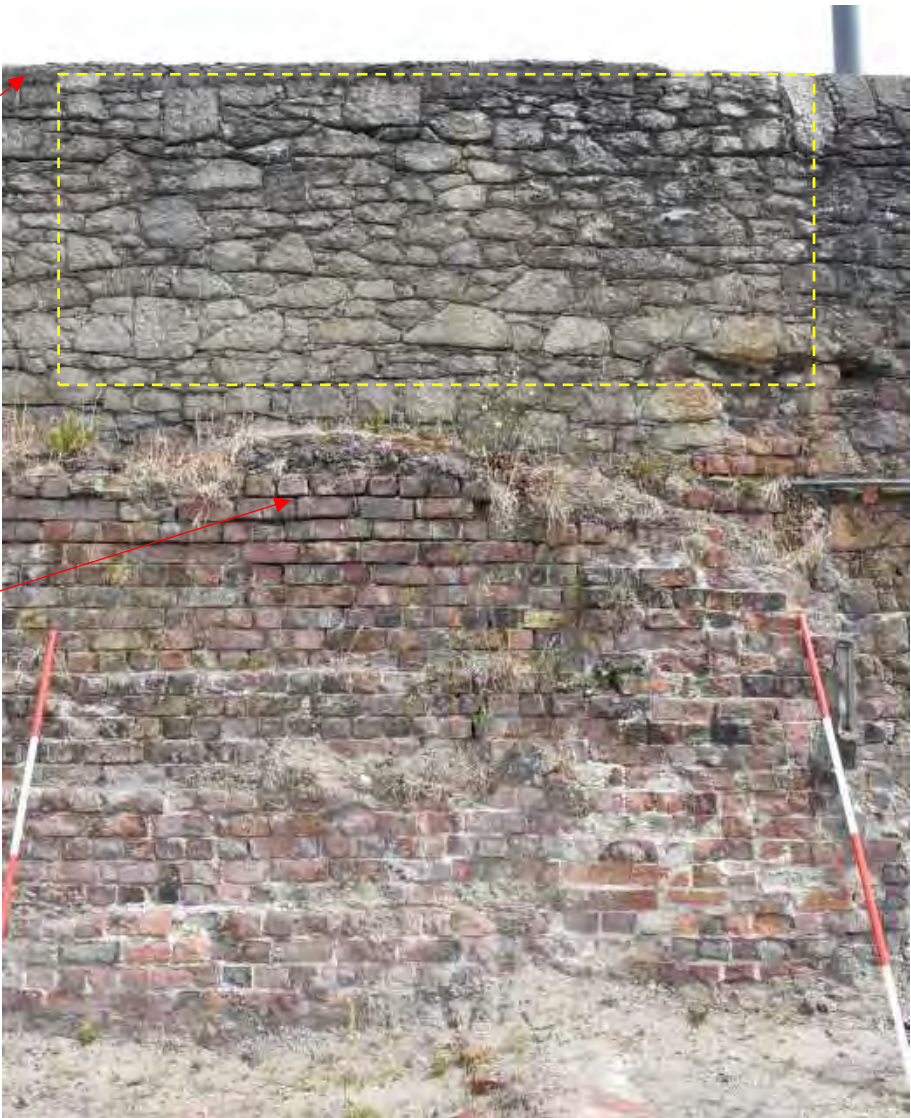
Location Ref:	BMD Elevation – Section 25
<p>Wall section width approx. 3.0m</p> <p>Render and broken glass.</p> <p>Cracking to upper wall elements.</p> <p>Return pier of brickwork wall – face has glazed bricks.</p> <p>Loose brickwork</p>

<p>Condition:</p>	<p>Wall is generally stable but with some cracking and mortar loss around stones especially at higher levels which requires repair. Brickwork corbelled against the stonework to height of approx. 2150mm with 3No steps. Render and broken glass to top of wall.</p> <p>Return pier of wall to RHS.</p> <p>Proposed treatment: Re-point areas of cracked and missing mortar - additional grouting of the upper core areas may be required. Repair loose brickwork. Remove sand / gravel build-up on brickwork and stabilise condition.</p>

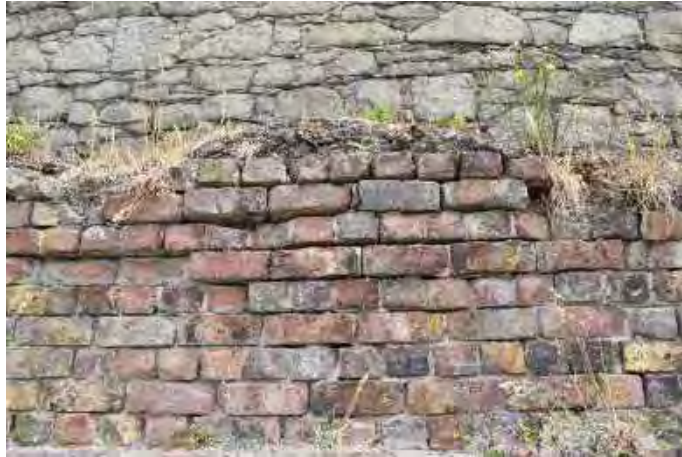
Loose brickwork – wall partly displaced.

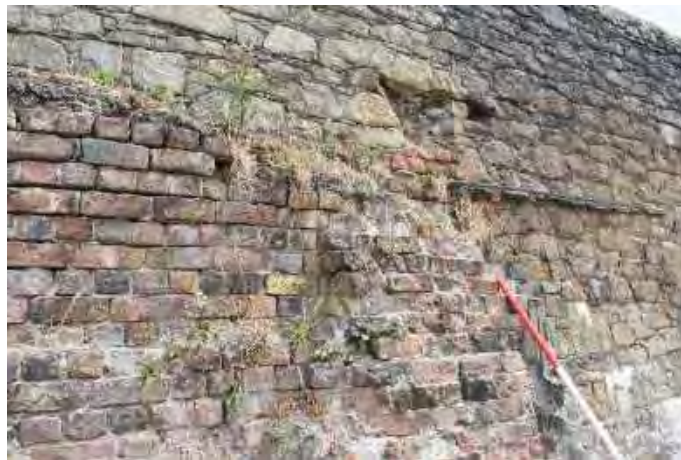
Return pier to brickwork wall.

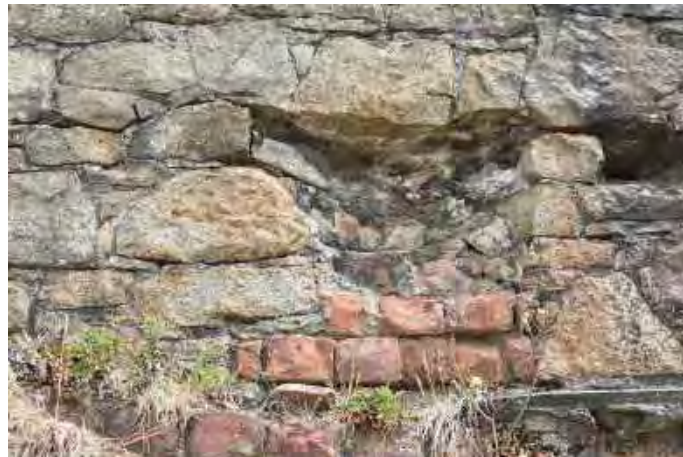
Pier is indented into the stonework wall.

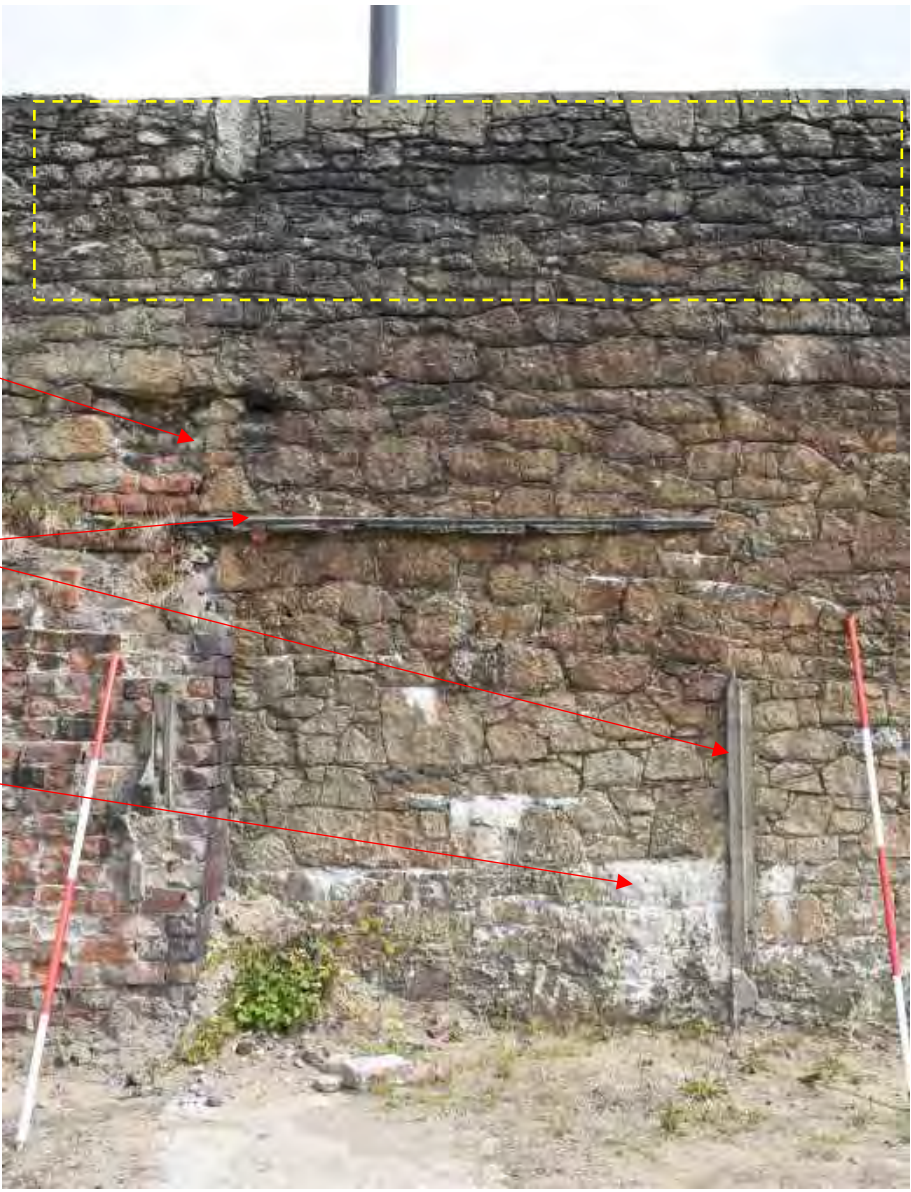
Location Ref:	BMD Elevation – Section 26
<p>Wall section width approx. 3.0m</p> <p>Cracked and missing mortar to wall.</p> <p>Return of brickwork wall.</p> <p>Render strip applied to wall. (Packer).</p> <p>Calcium deposits</p>

<p>Condition:</p>	<p>Wall is generally stable but with some cracking and mortar loss around stones especially at higher levels which requires repair. Brickwork corbelled against the stonework to height of approx. 2150mm with 3No steps.</p> <p>Return pier of wall to LHS.</p> <p>Proposed treatment:</p> <p>Re-point areas of cracked and missing mortar - additional grouting of the upper core areas may be required.</p> <p>Make good brickwork pier return into stonework.</p> <p>Remove render strips from wall.</p>

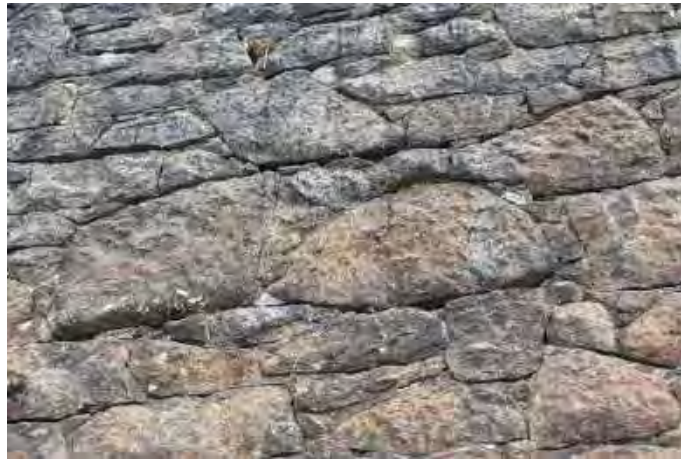
Cracking to mortar around stonework elements.

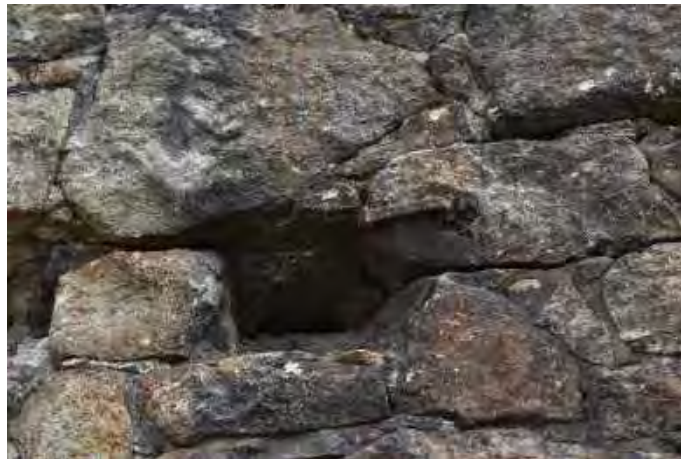
Missing stone and iron pin to RHS.

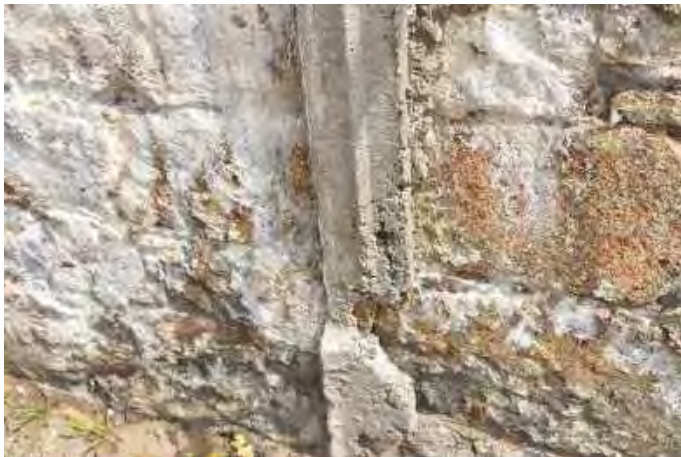
Applied render strip to wall. Calcium deposits to wall.

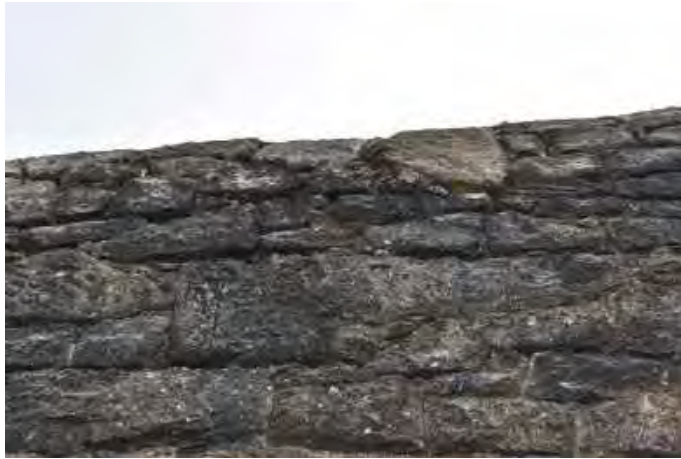
Very dark pollution
staining to wall.

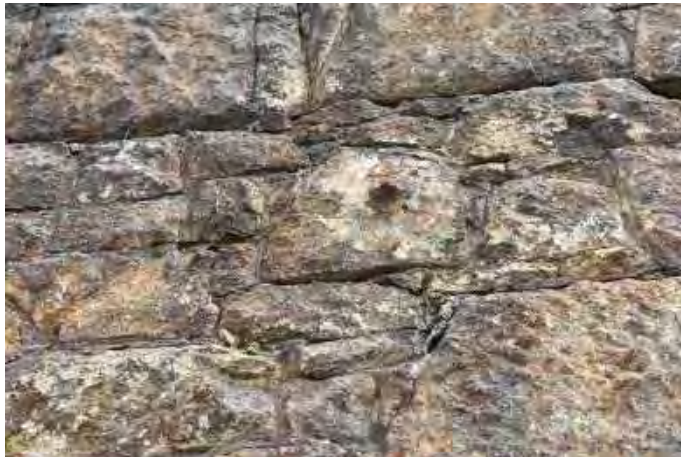
Fixings to wall. (some
removed).

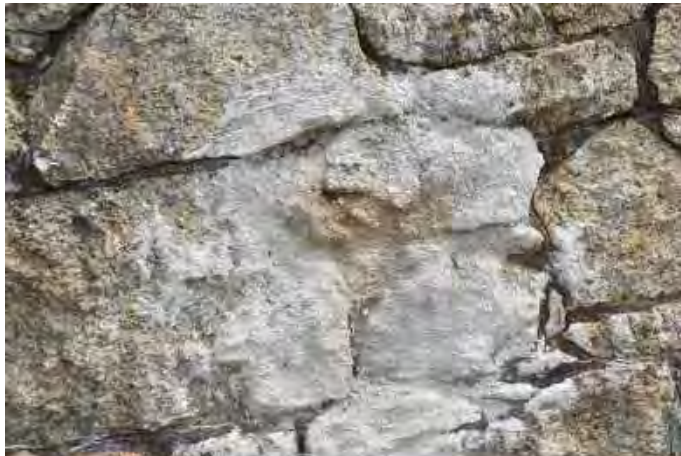
Previous core hole
position.

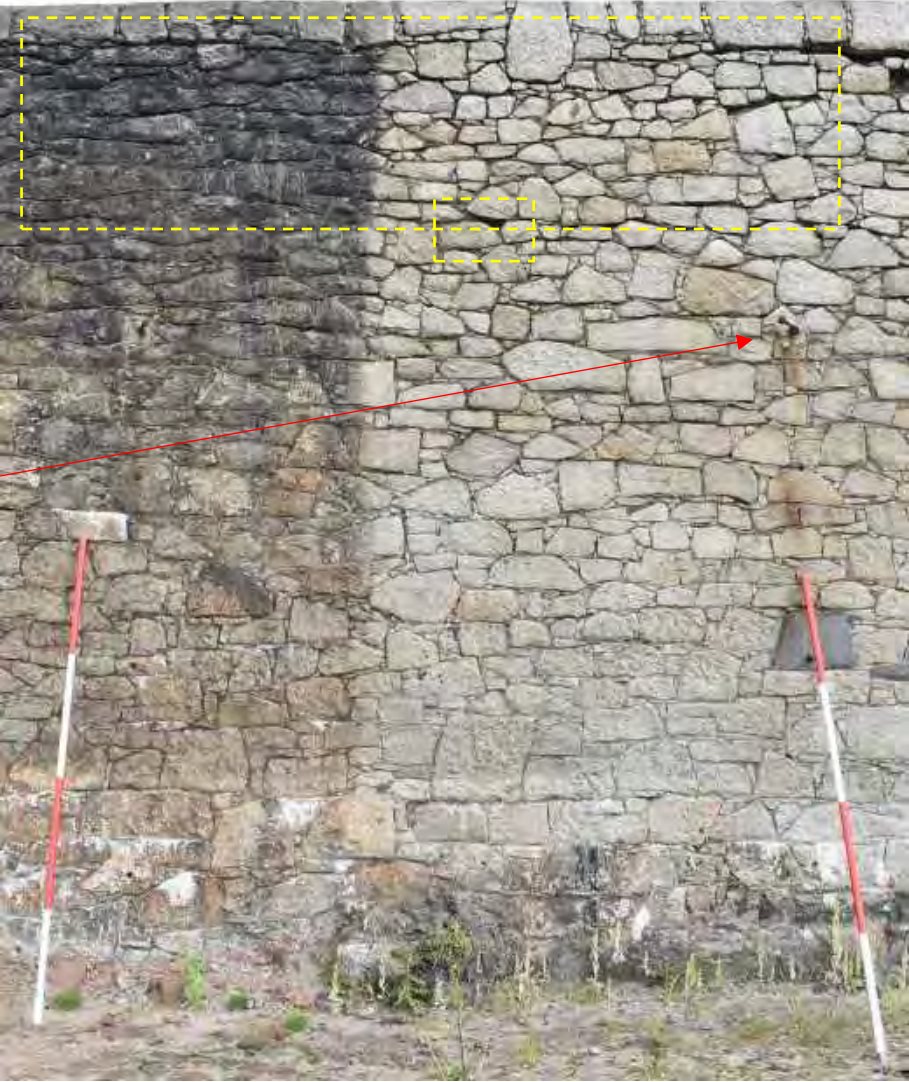
Location Ref:	BMD Elevation – Section 28
<p>Wall section width approx. 3.0m</p> <p>Cracks and mortar loss at high level.</p> <p>Mortar loss</p> <p>Dark pollution staining on wall.</p> <p>Fixings</p> <p>Minor cracking to mortar at lower levels.</p>

<p>Condition:</p>	<p>Wall is generally stable but with some cracking and mortar loss around stones especially at higher levels which requires repair. Mechanical fixings applied to wall and calcium deposits at low level.</p> <p>Proposed treatment:</p> <p>Re-point areas of cracked and missing mortar - additional grouting of the upper core areas may be required.</p> <p>Remove areas of large calcium deposits.</p>

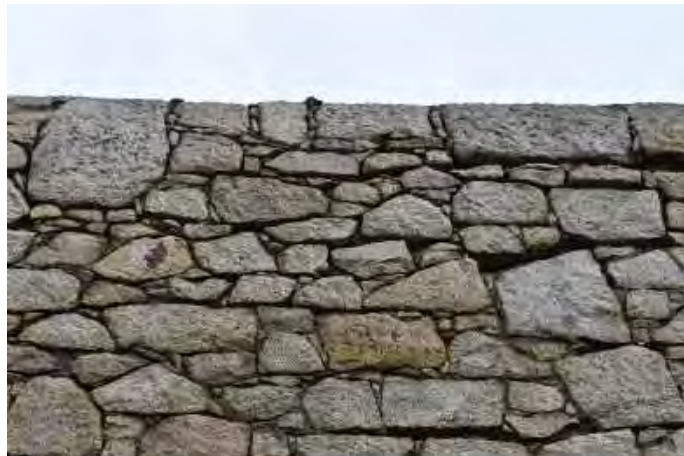
Cracking , mortar loss
and some small stones
missing to upper wall.

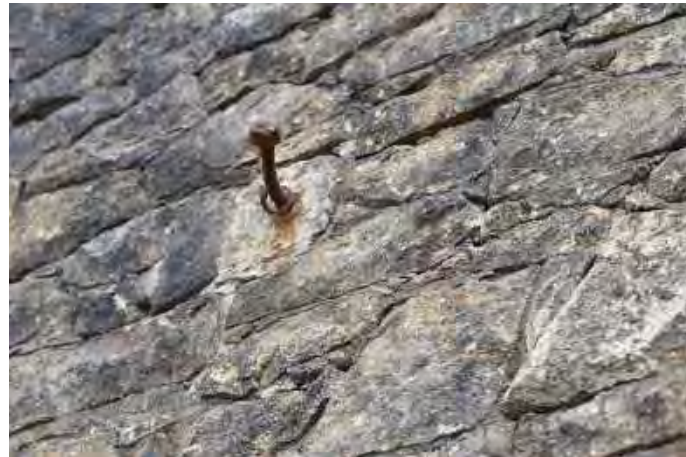
Fixings in wall.

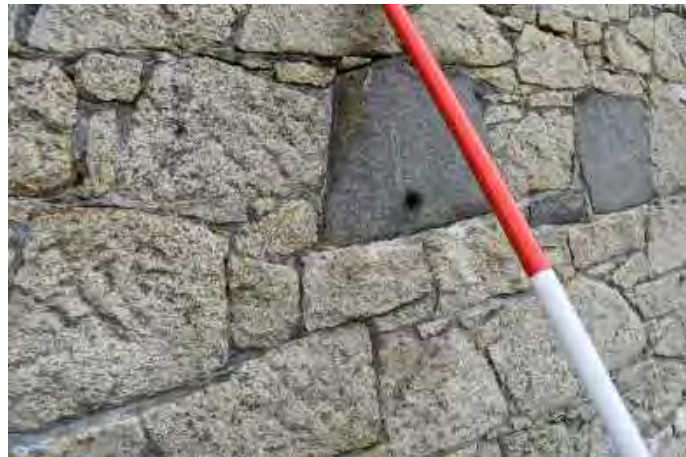
Limestone
replacement stones.

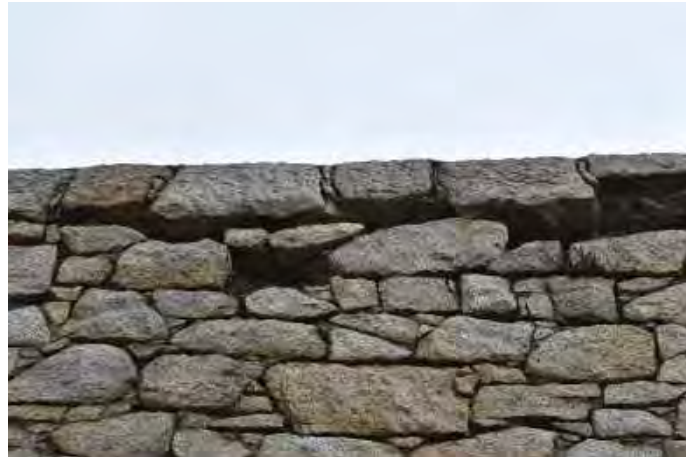
Cracking and mortar
loss to upper wall
areas.

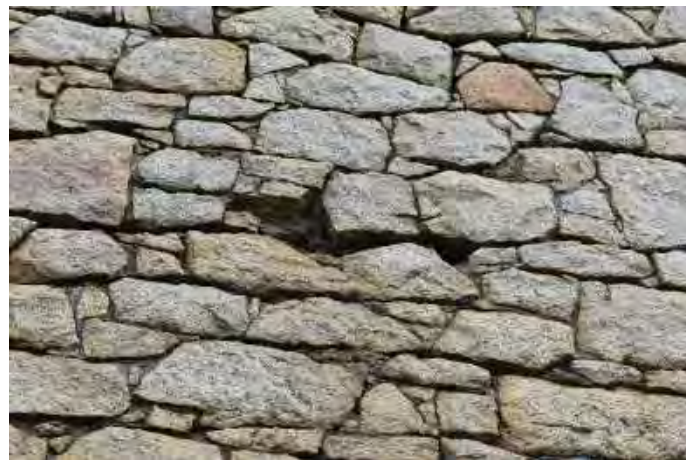
Mortar and small
stone loss.

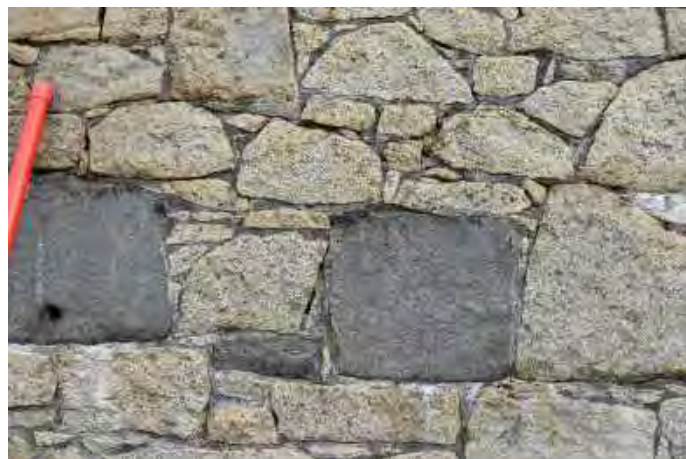
Limestone blocks.

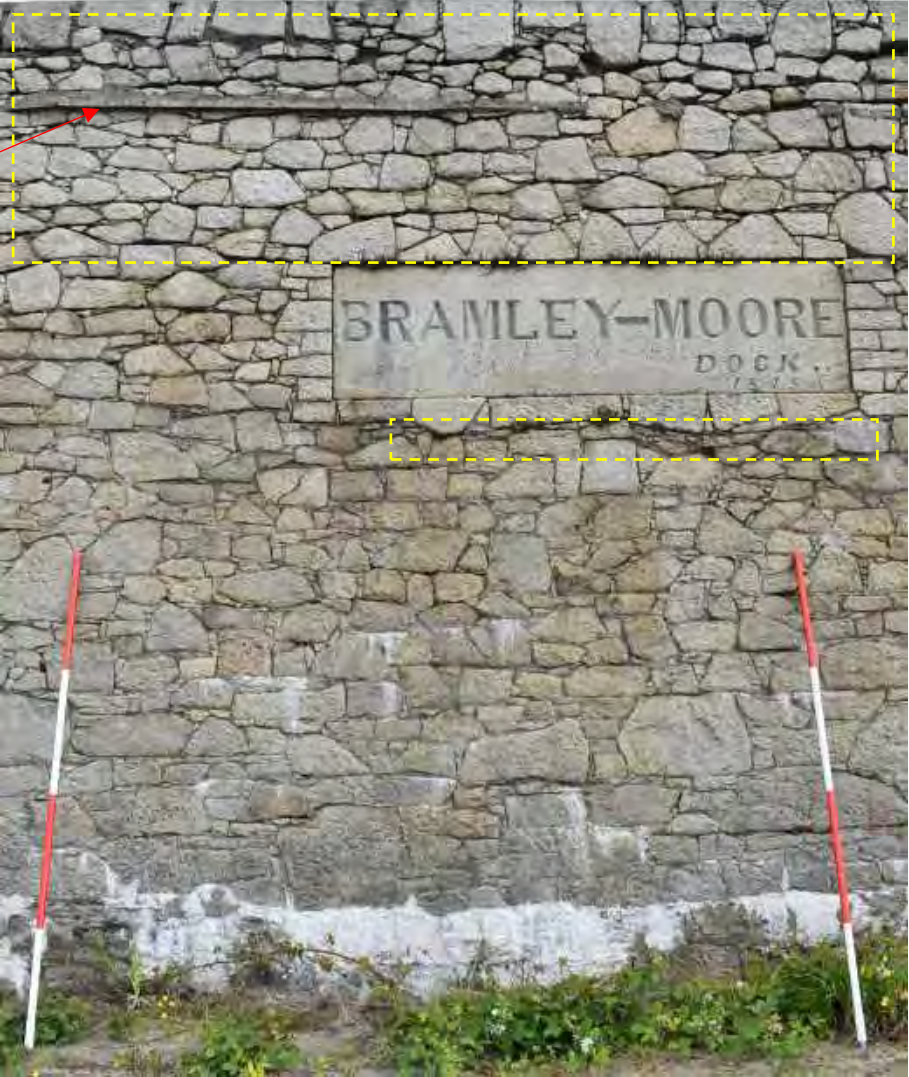
Location Ref:	BMD Elevation – Section 30
<p>Wall section width approx. 3.0m</p> <p>Mortar loss and loose stones to upper wall.</p> <p>Render drip.</p> <p>Stone displacement over sign.</p> <p>Cracking under sign.</p> <p>Calcium deposits at low level.</p>

<p>Condition:</p>	<p>Wall is generally stable but with some cracking and mortar loss around stones especially at higher levels which requires repair. Mechanical fixings applied to wall and calcium deposits at low level.</p> <p>Proposed treatment: Re-point areas of cracked and missing mortar - additional grouting of the upper core areas may be required. Remove areas of large calcium deposits. Investigate overall stability of sign element and make good mortar joints around.</p>

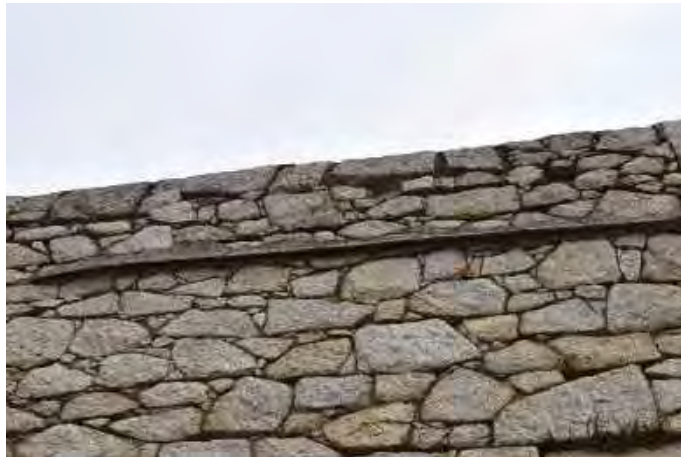
Render drip and cracking / mortar loss at high level.

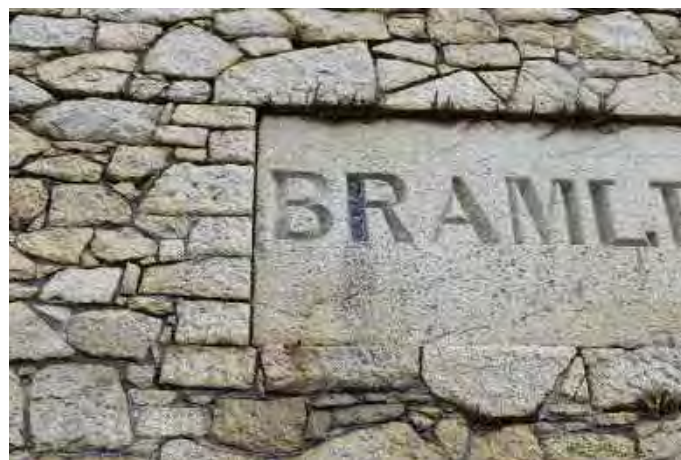
Plant growth over sign.

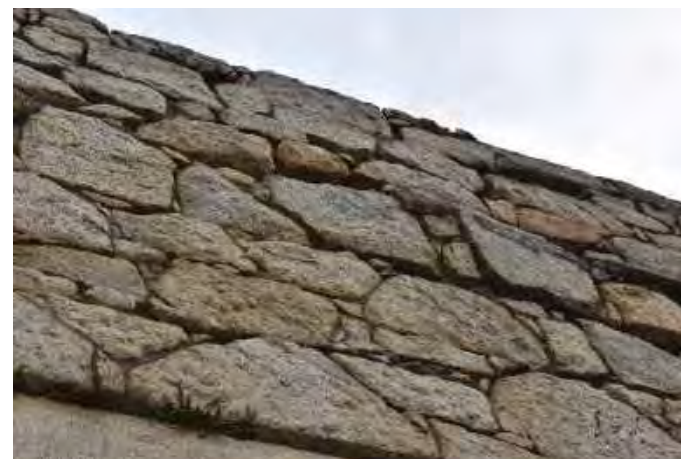
Mortar loss and displaced stonework around sign.
