Bramley Moore Dock - Regent Road Wall

Wall Condition Survey

June 2020

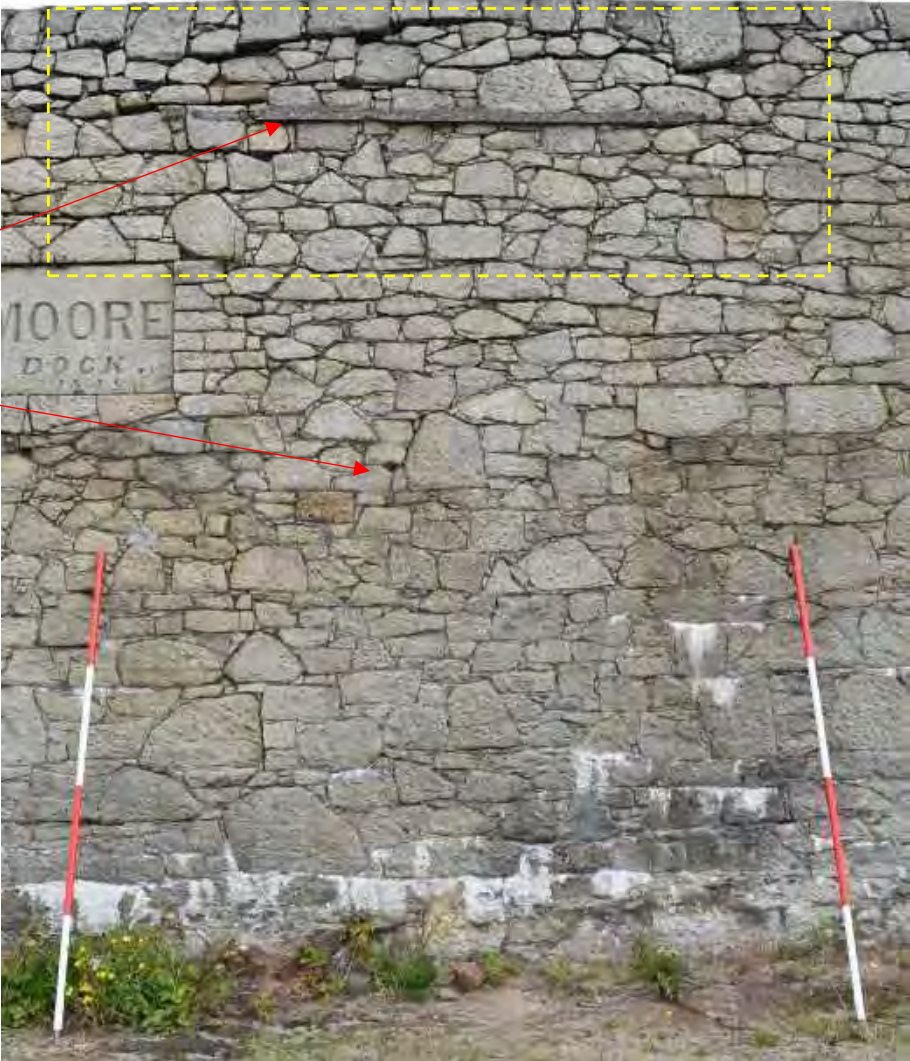
Location Ref:	BMD Elevation – Section 31
<p>Wall section width approx. 3.0m</p> <p>Loose mortar under coping.</p> <p>Cracked mortar joints.</p> <p>Render drip.</p> <p>Fixing hole.</p> <p>Minor cracking to mortar at lower levels</p>

<p>Condition:</p>	<p>Wall is generally stable but with some cracking and mortar loss around stones especially at higher levels which requires repair. Mechanical fixings applied to wall and calcium deposits at low level.</p> <p>Proposed treatment:</p> <p>Re-point areas of cracked and missing mortar - additional grouting of the upper core areas may be required.</p> <p>Remove areas of large calcium deposits.</p>

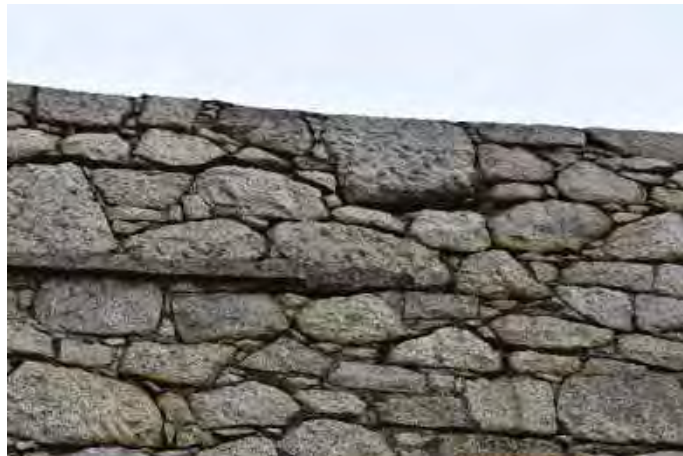
Cracking and mortar
loss to high level.

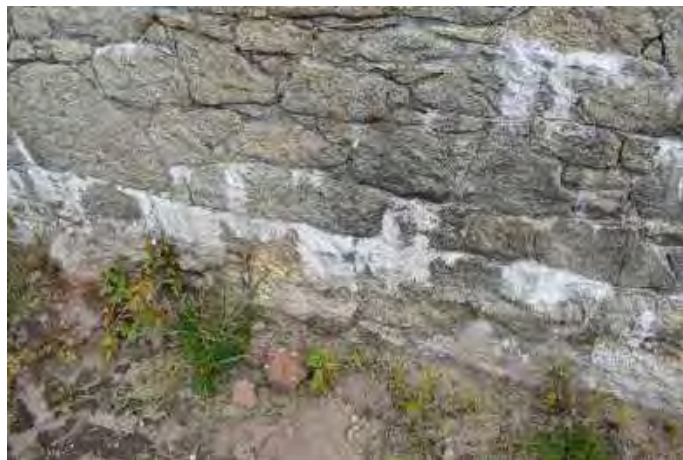
Calcium deposits at
low level.

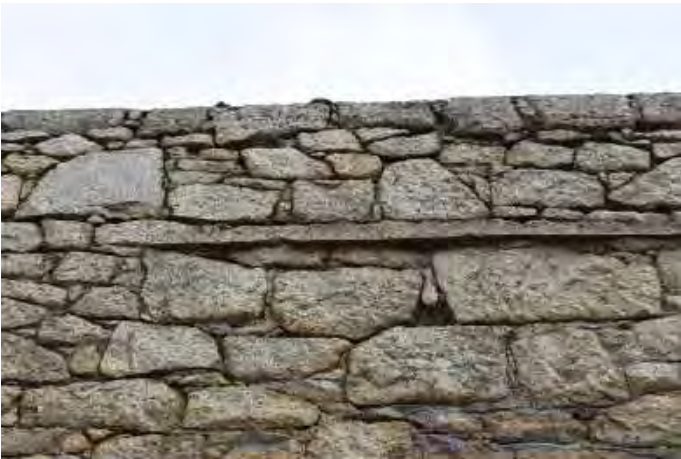
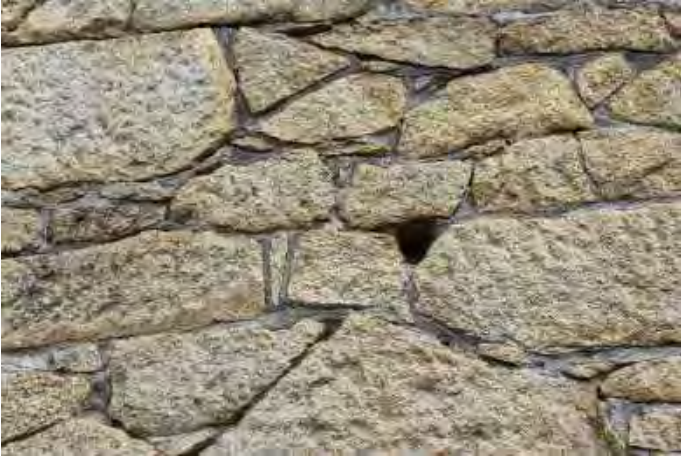
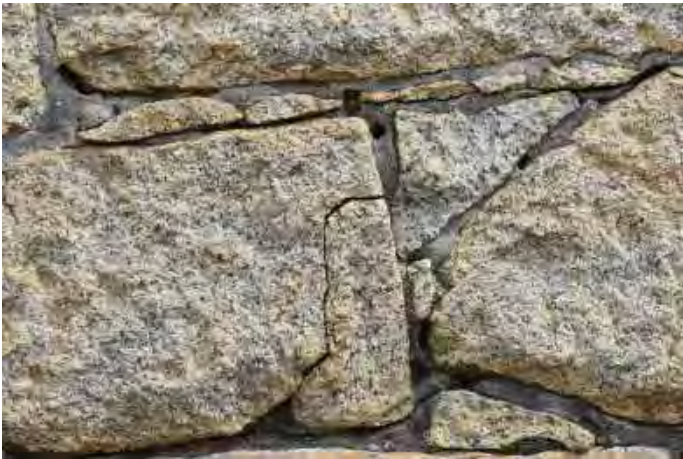
<p>Additional notes and photographs:</p> <p>Render drip.</p> <p>Mortar loss to joints at top of wall.</p> <p>Fixing hole.</p> <p>Weathered pointing mortar.</p>

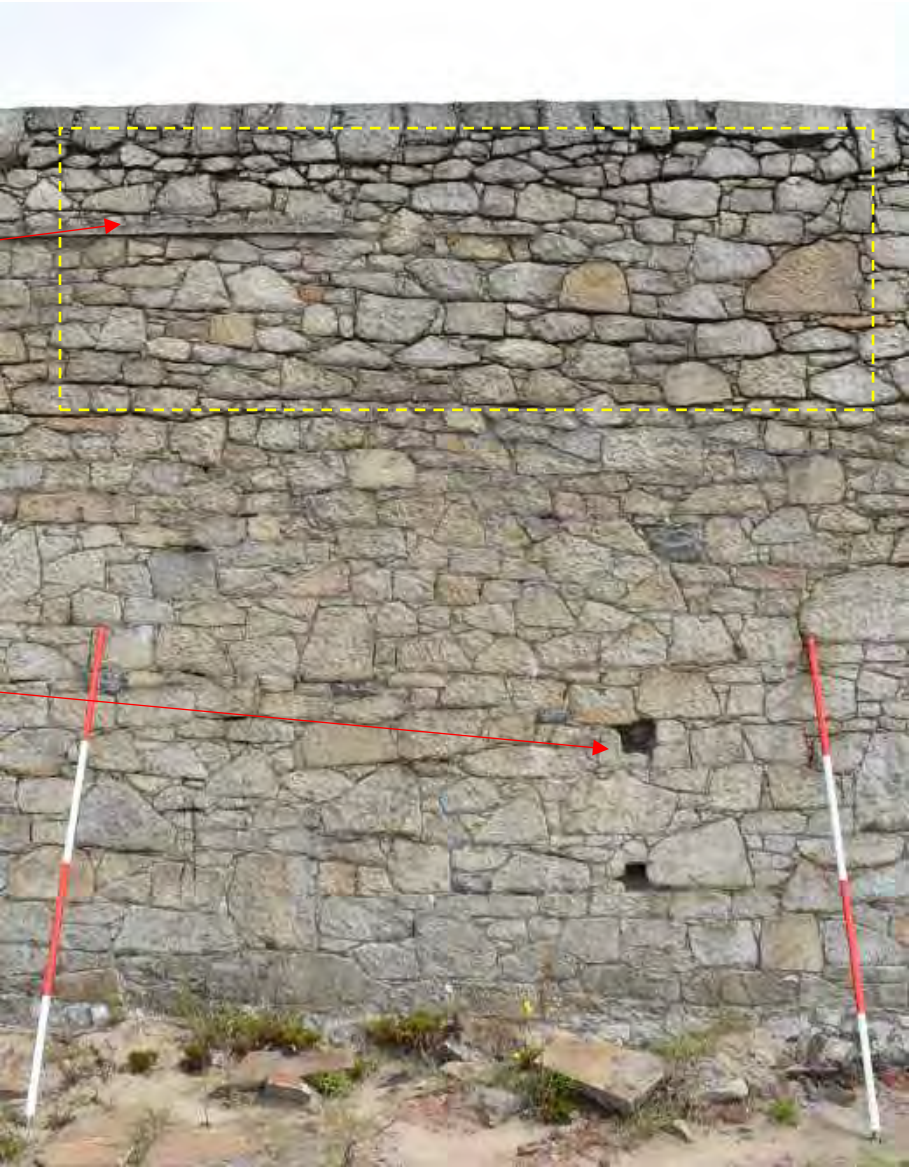
Location Ref:	BMD Elevation – Section 33
<p>Wall section width approx. 3.0m</p> <p>Mortar loss and cracking to top of wall.</p> <p>Render drip.

</p> <p>Cracking to mortar around stonework.</p> <p>Minor cracking to mortar at lower levels</p> <p>2No holes.

<p>Condition:</p>	<p>Wall is generally stable but with some cracking and mortar loss around stones especially at higher levels which requires repair. 2No holes require filling.</p> <p>Proposed treatment: Re-point areas of cracked and missing mortar - additional grouting of the upper core areas may be required. Stone repair to 2No void areas. Remove fixings and make good mortar.</p>

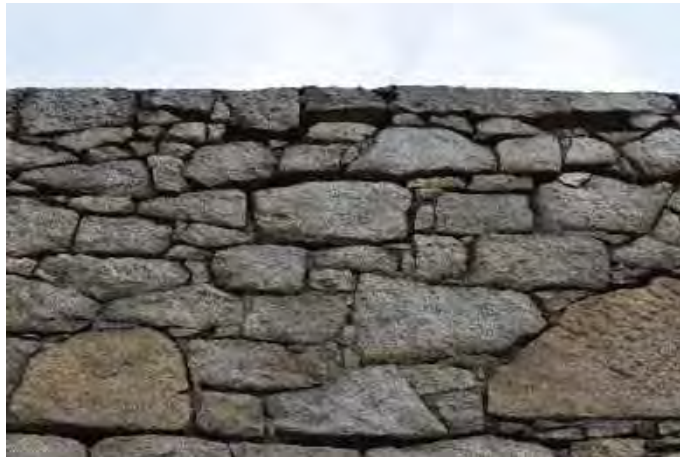
Mortar loss at top of wall.

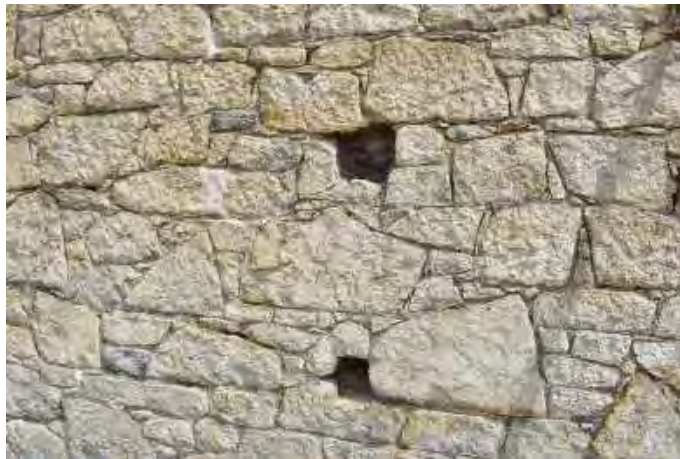
2No void areas.

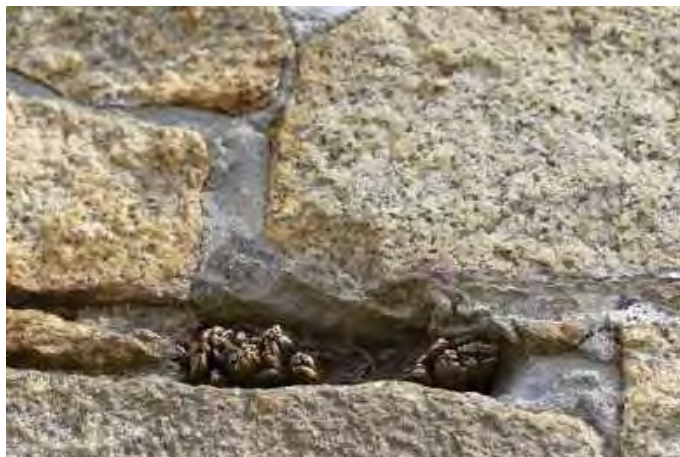
Timber packers for fixing positions.

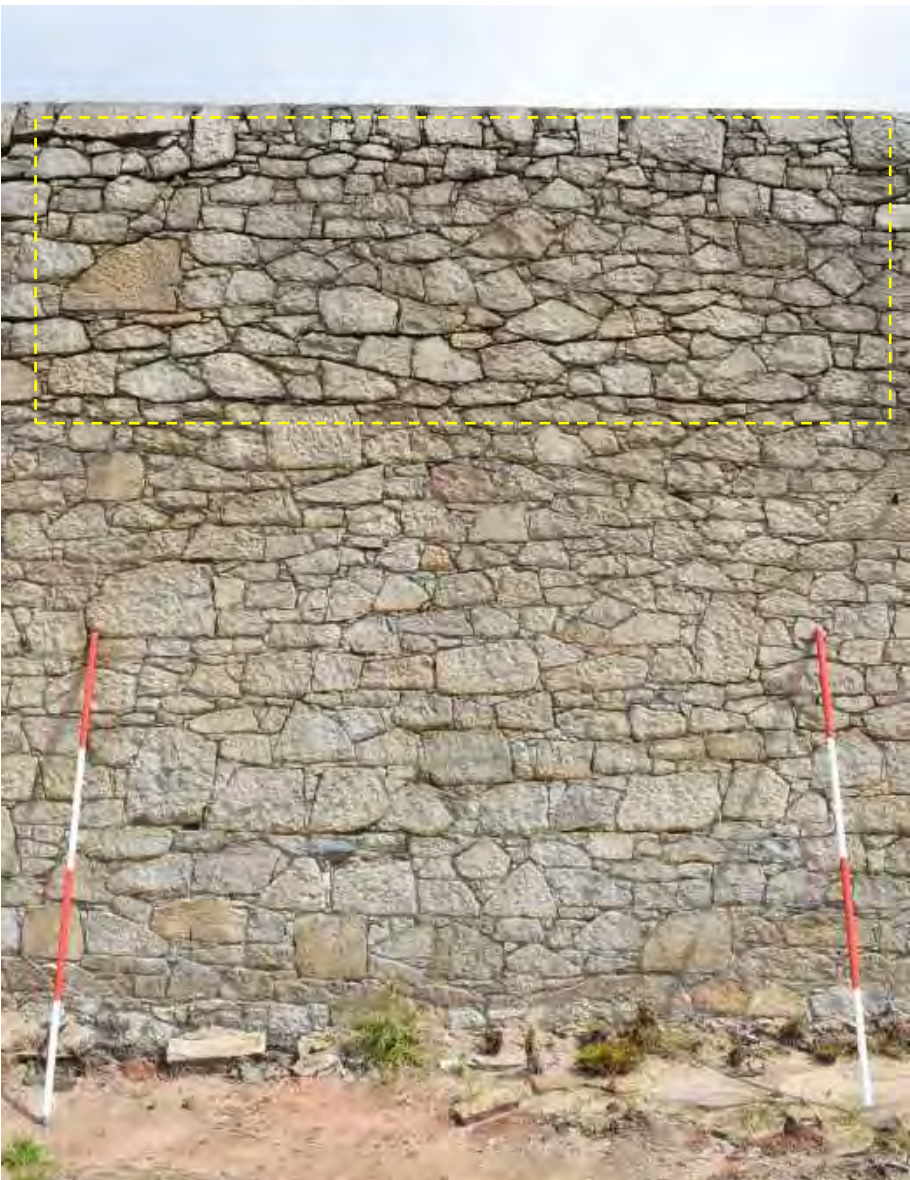
Location Ref:	BMD Elevation – Section 34
<p>Wall section width approx. 3.0m</p> <p>Mortar loss under coping.</p> <p>Cracked and missing mortar at high level.</p> <p>Minor cracking to mortar at lower levels</p>

<p>Condition:</p>	<p>Wall is generally stable but with some cracking and mortar loss around stones especially at higher levels which requires repair. Mechanical fixings applied to wall.</p> <p>Proposed treatment: Re-point areas of cracked and missing mortar - additional grouting of the upper core areas may be required.</p>

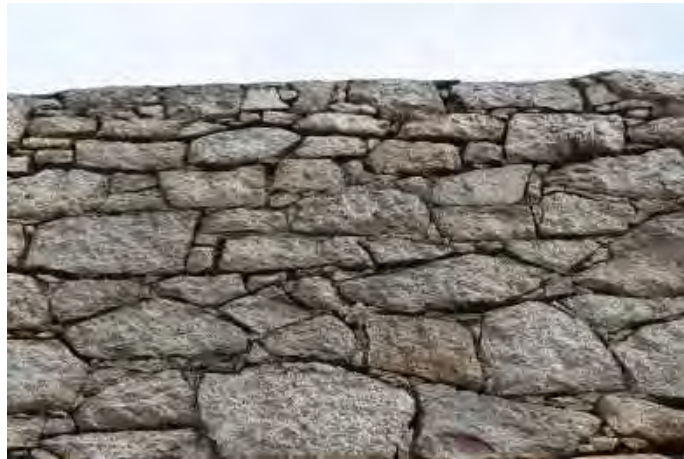
Mortar loss and
cracking to upper wall
areas.

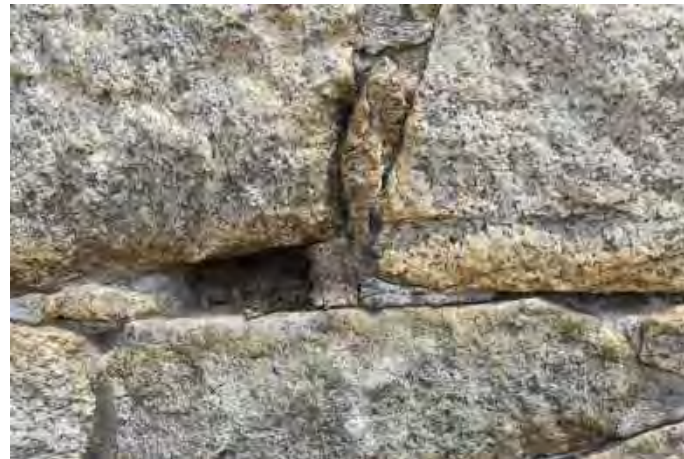
Staining around fixing
positions.

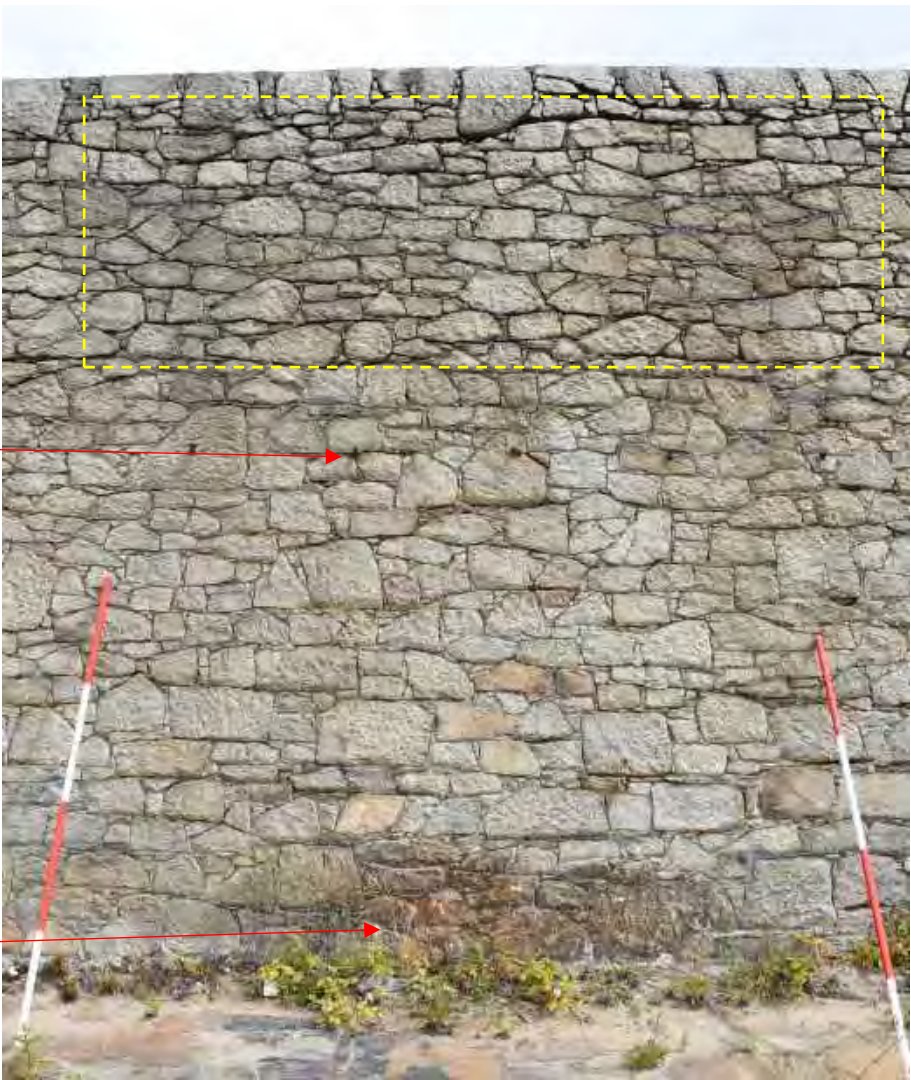
Location Ref:	BMD Elevation – Section 35
<p>Wall section width approx. 3.0m</p> <p>Mortar loss and cracking to upper wall areas.</p> <p>Fixings.

</p> <p>Minor cracking to mortar at lower levels</p> <p>Rust staining.

<p>Condition:</p>	<p>Wall is generally stable but with some cracking and mortar loss around stones especially at higher levels which requires repair. Mechanical fixings applied to wall and calcium deposits at low level.</p> <p>Proposed treatment: Re-point areas of cracked and missing mortar - additional grouting of the upper core areas may be required. Remove fixings and make good.</p>

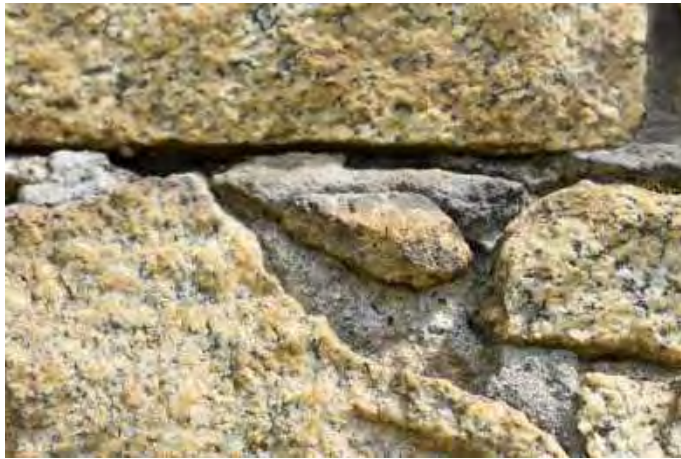
Weathered pointing
mortar – cracking
under stones.

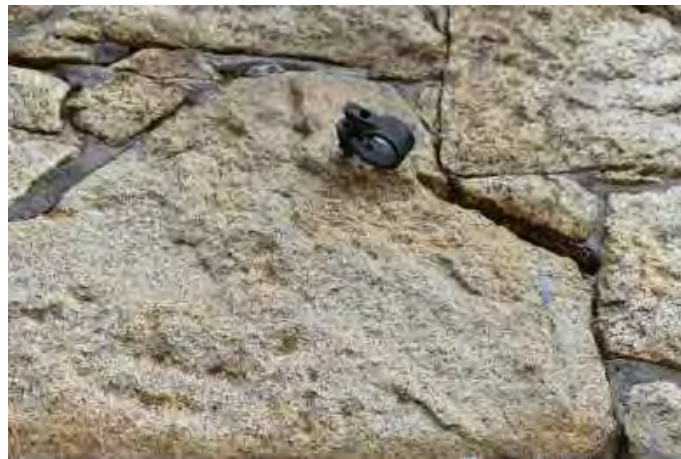
Fixings on face of
stonework.

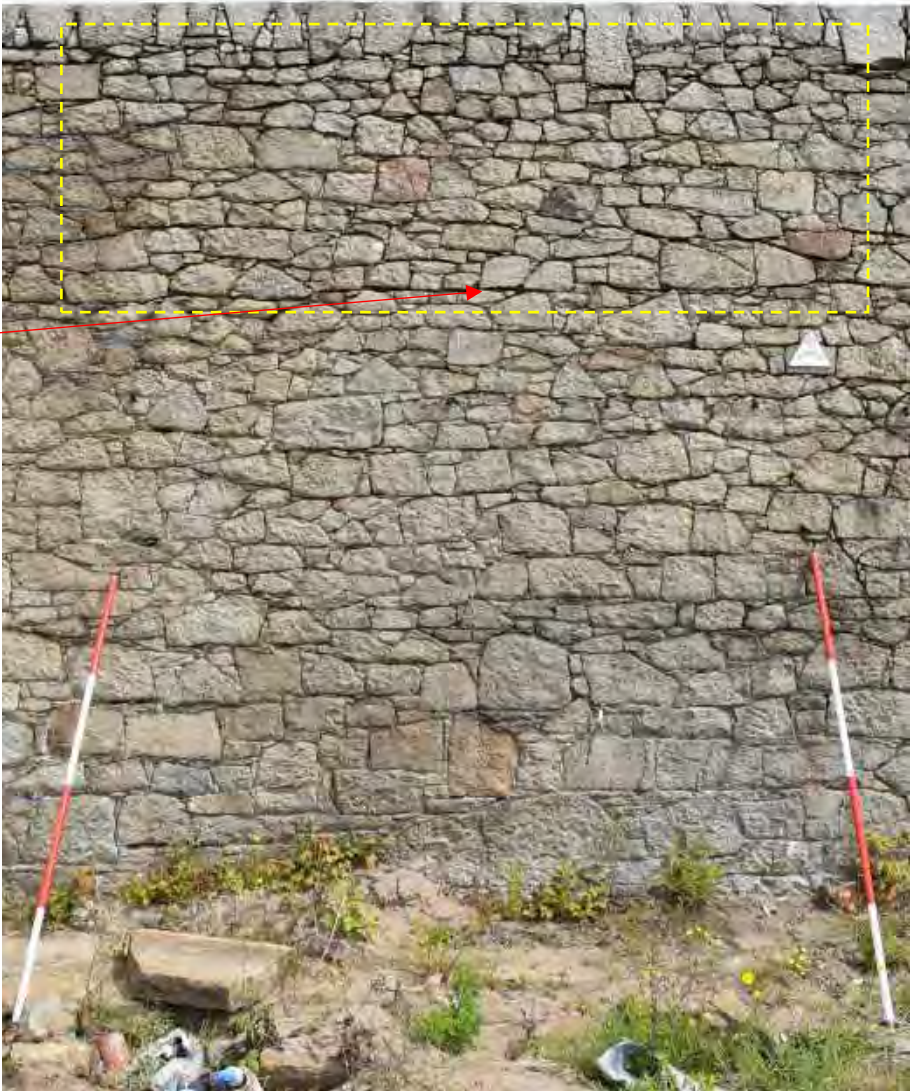
Location Ref:	BMD Elevation – Section 36
<p>Wall section width approx. 3.0m</p> <p>Mortar loss and cracking to upper wall areas.</p> <p>Fixings</p> <p>Minor cracking to mortar at lower levels</p>

<p>Condition:</p>	<p>Wall is generally stable but with some cracking and mortar loss around stones especially at higher levels which requires repair. Mechanical fixings applied to wall.</p> <p>Proposed treatment: Re-point areas of cracked and missing mortar - additional grouting of the upper core areas may be required. Remove fixings and make good. Remove sign and make good.</p>

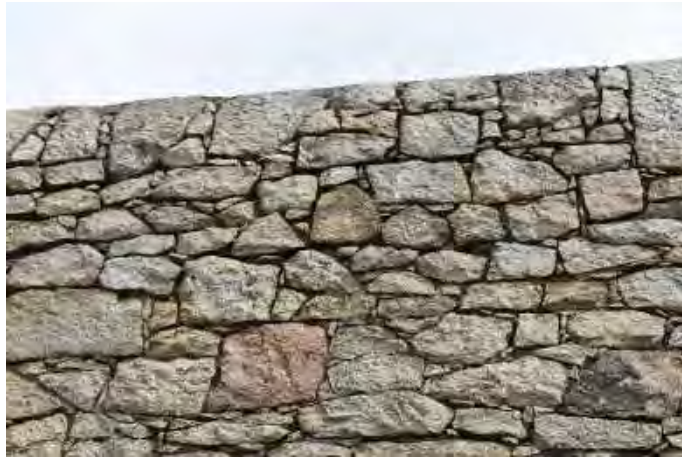
Mortar loss and
cracking to upper wall.

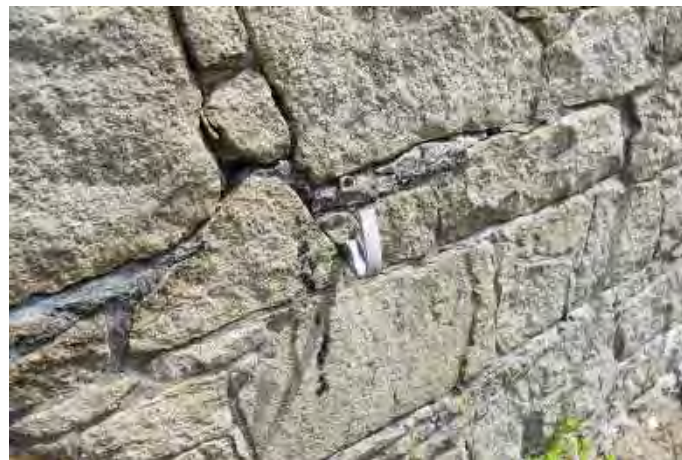
Fixings.

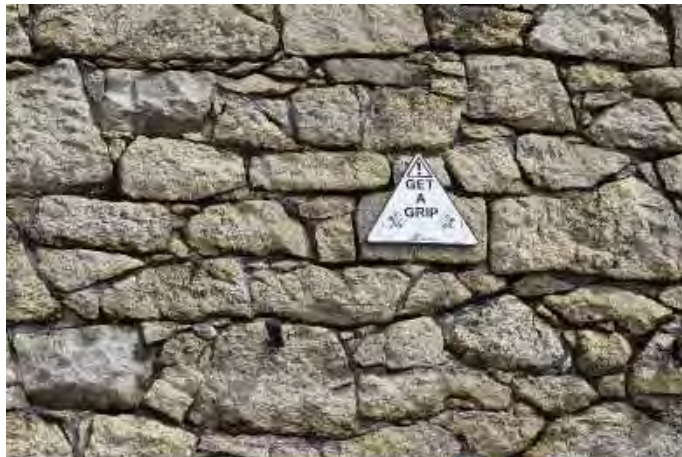
Sign fixed to wall.

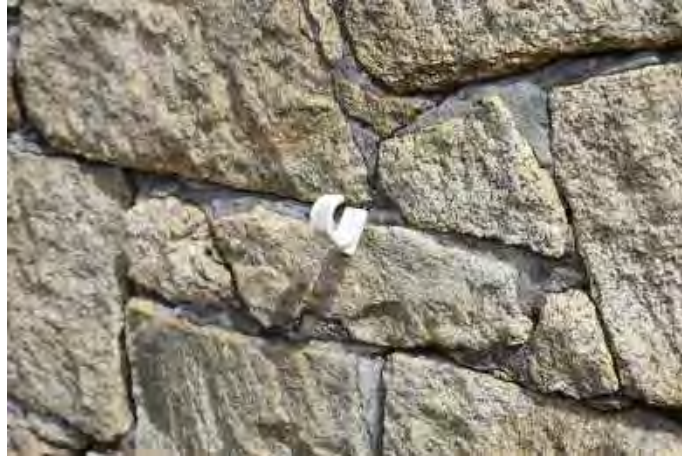
Fixings applied to wall.

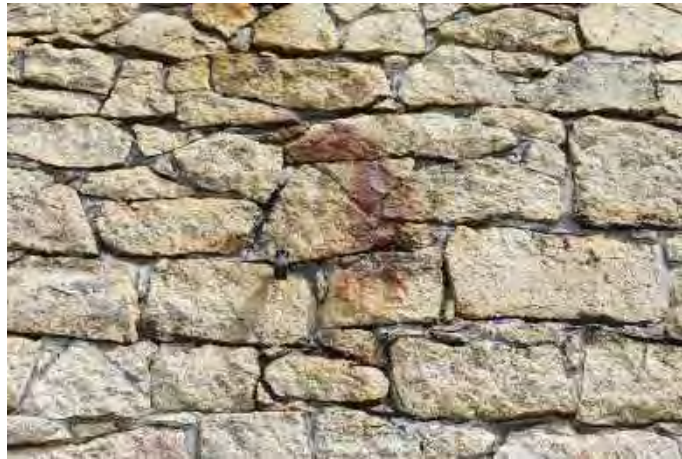
Rust staining to wall.

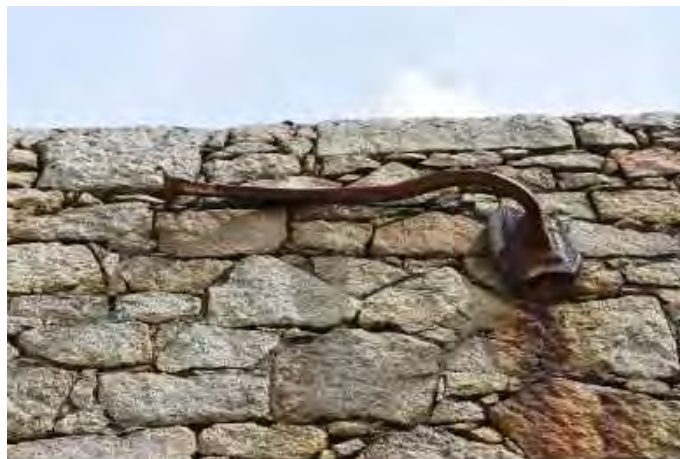
Old lamp bracket.

Mortar loss to upper
wall areas.

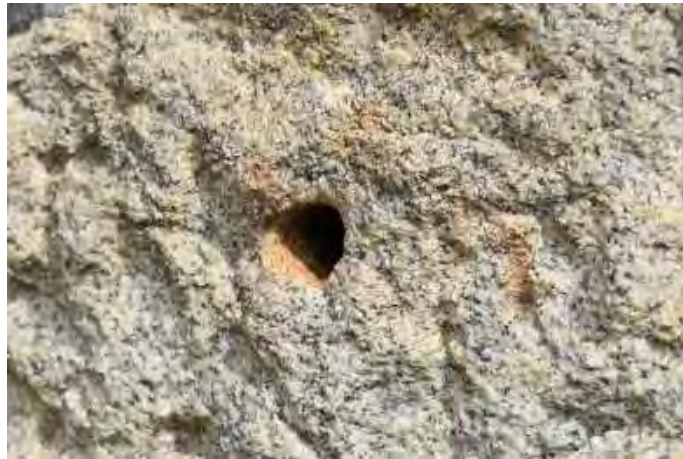
Fixing hole.

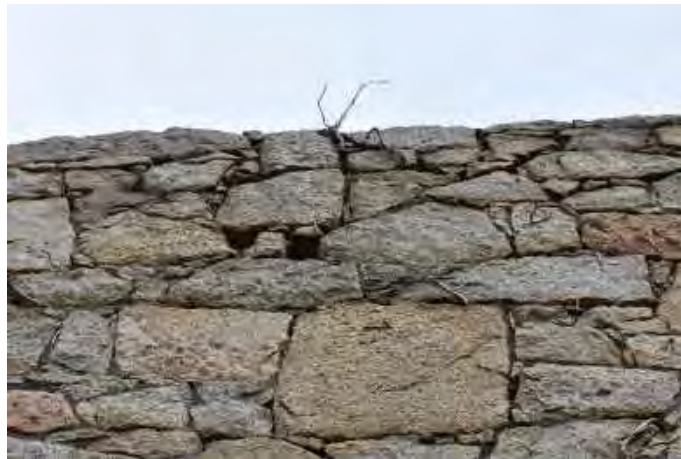
Mortar loss and cracking to upper wall areas.

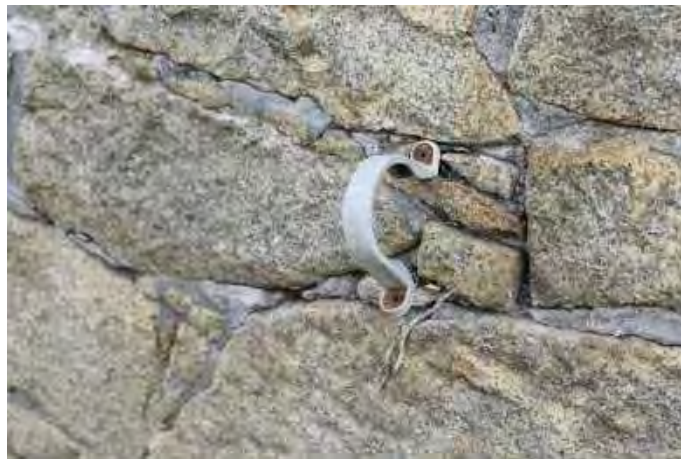
Fixings on face of wall.

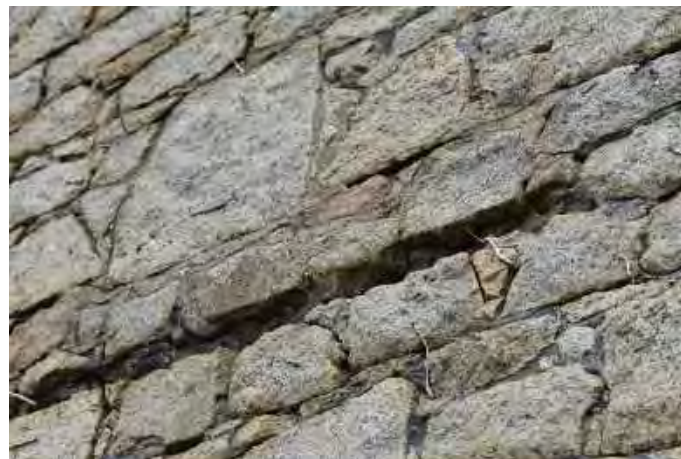
Rebate cut into wall.

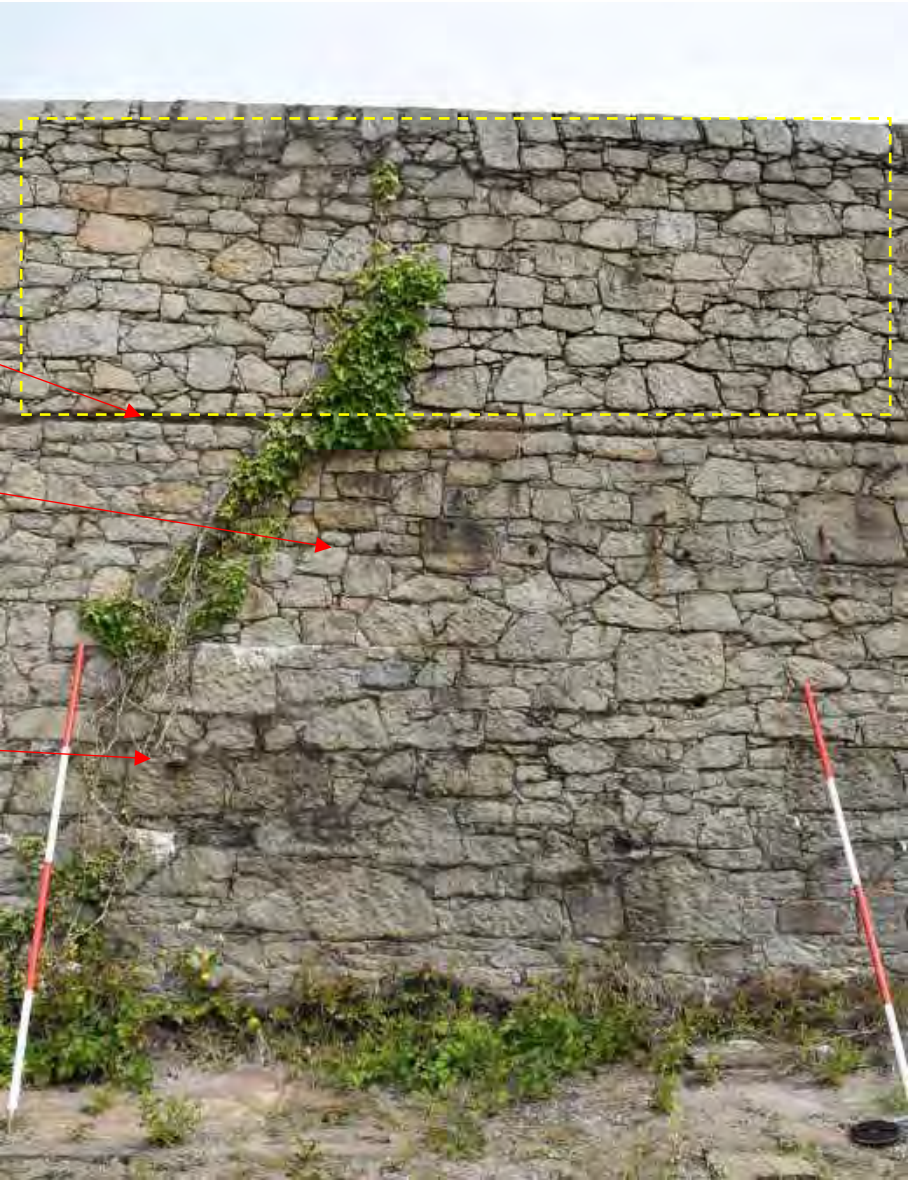
Location Ref:	BMD Elevation – Section 40
<p>Wall section width approx. 3.0m</p> <p>Mortar loss and cracking to upper wall areas.</p> <p>Rebate cut in wall</p> <p>Fixings.</p> <p>Buddleia growth.</p> <p>Minor cracking to mortar at lower levels</p> <p>Iron bar</p>

<p>Condition:</p>	<p>Wall is generally stable but with some cracking and mortar loss around stones especially at higher levels which requires repair. Mechanical fixings applied to wall, rebate cut into wall and plant growth.</p> <p>Proposed treatment:</p> <p>Re-point areas of cracked and missing mortar - additional grouting of the upper core areas may be required.</p> <p>Remove areas of plant growth.</p> <p>Remove fixings and iron bar and make good.</p>

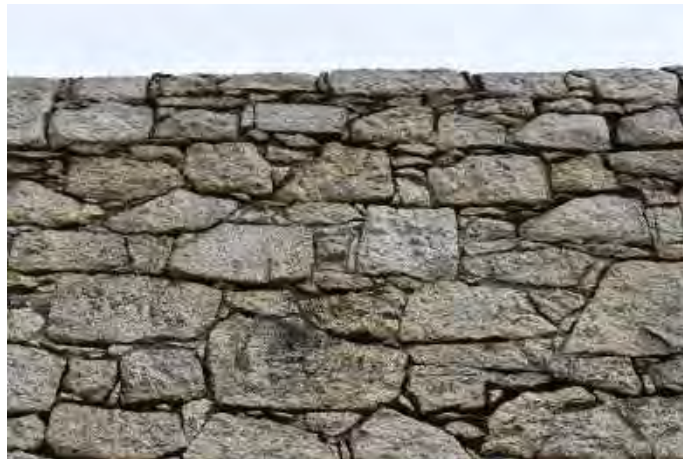
Mortar loss and cracking to upper areas.

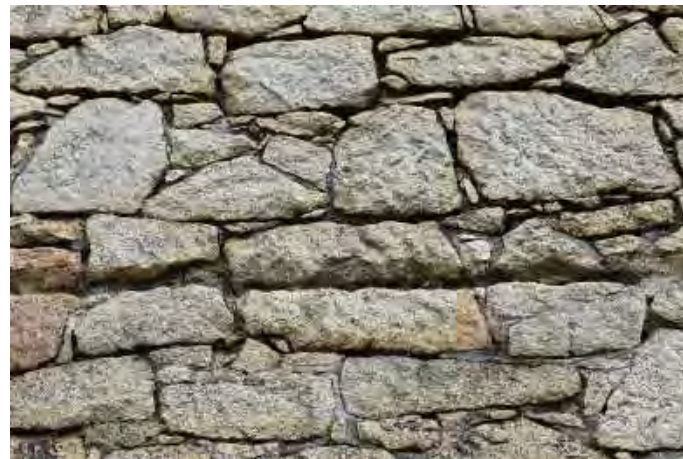
Rebate cut into wall.

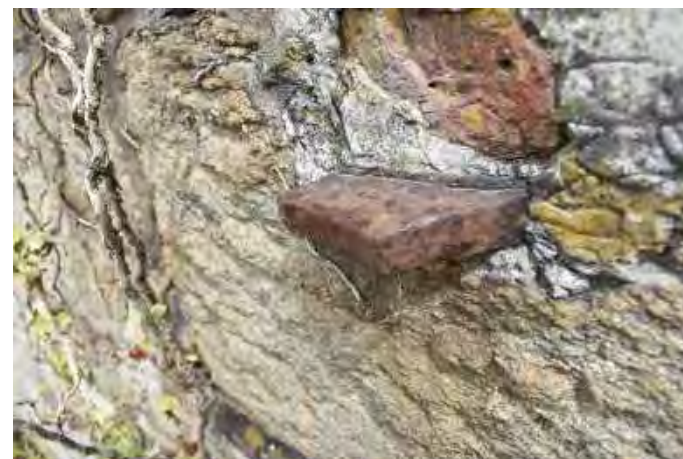
Iron bar embedded in wall.

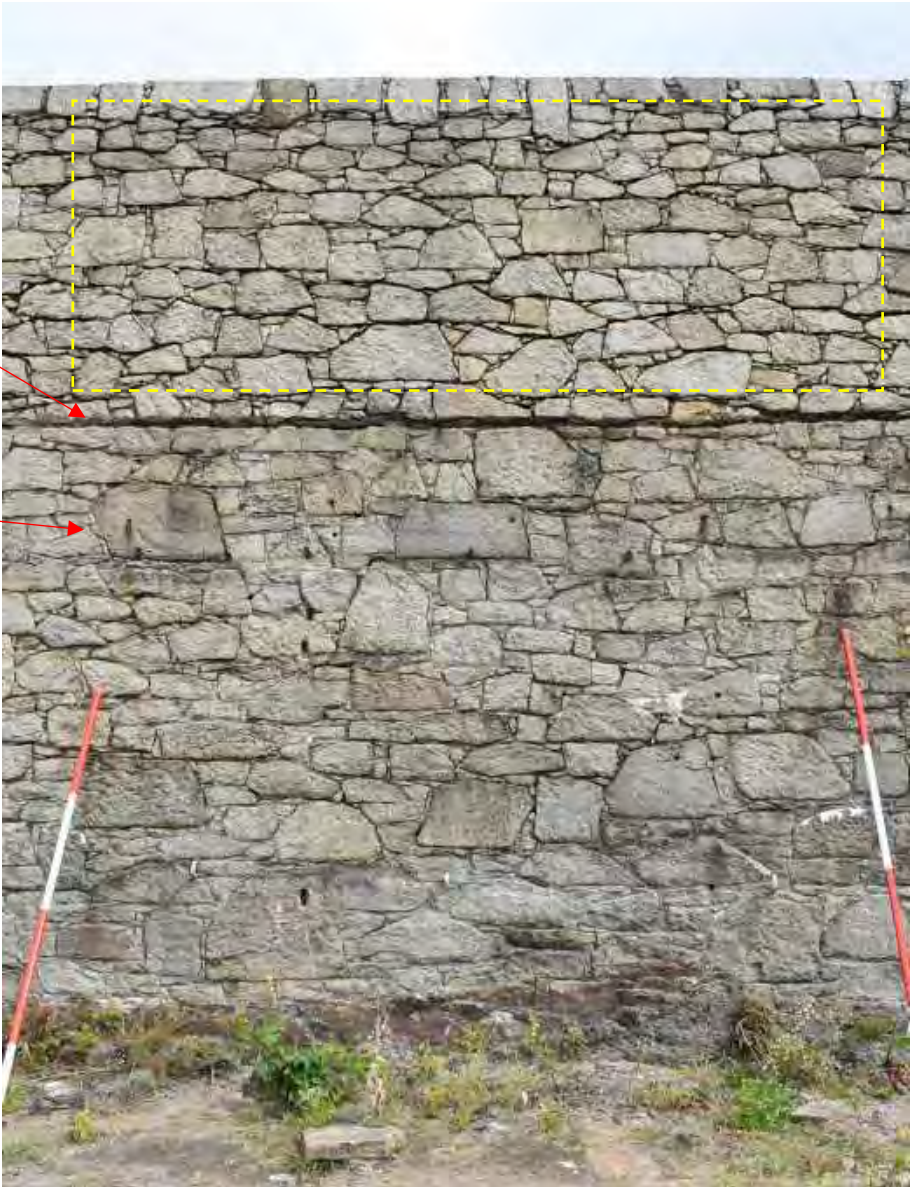
Location Ref:	BMD Elevation – Section 41
<p>Wall section width approx. 3.0m</p> <p>Mortar loss and cracking to upper areas.</p> <p>Rebate cut into wall.</p> <p>Fixings</p> <p>Minor cracking to mortar at lower levels</p>

<p>Condition:</p>	<p>Wall is generally stable but with some cracking and mortar loss around stones especially at higher levels which requires repair. Mechanical fixings applied to wall and rebate cut into wall.</p> <p>Proposed treatment: Re-point areas of cracked and missing mortar - additional grouting of the upper core areas may be required. Remove fixings and make good. Mortar repair to rebate.</p>

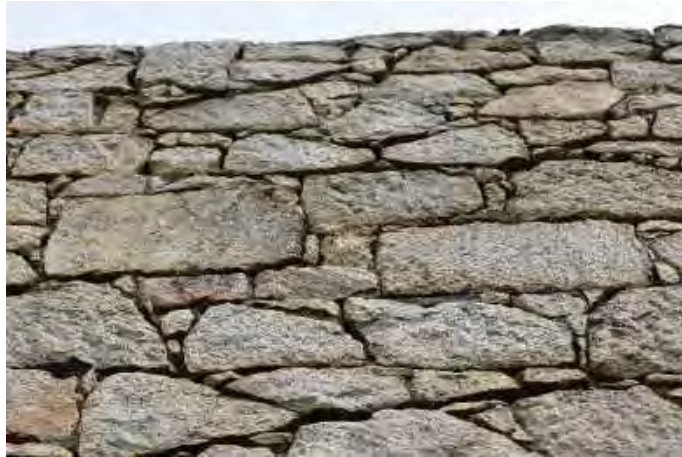
Mortar loss and cracking to upper wall areas.

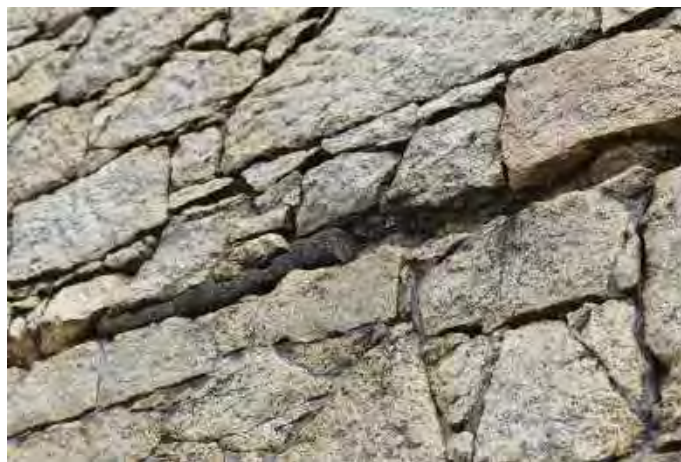
Rebate cut into wall.

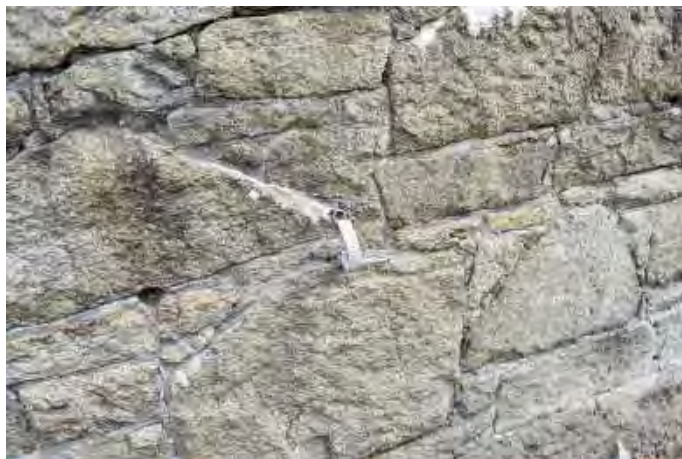
Fixings to face of wall.

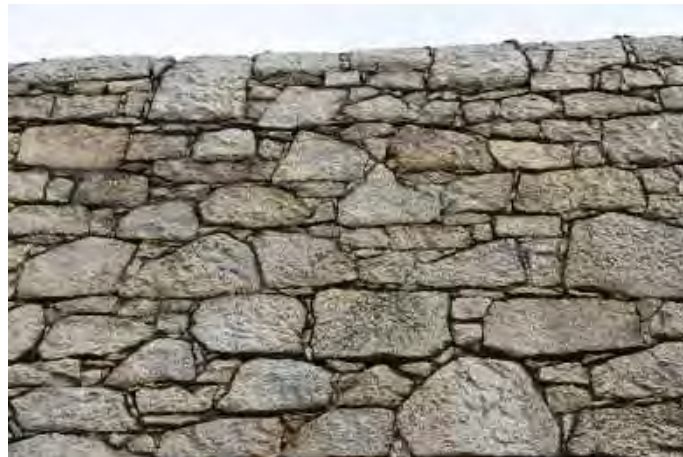
Mortar loss and
cracking to upper wall
areas.

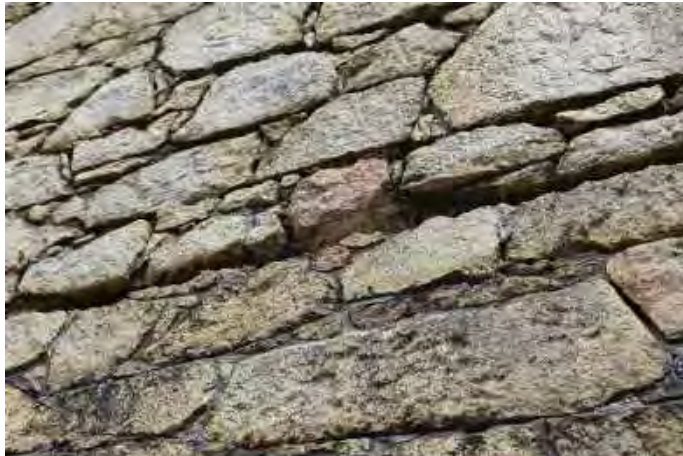
Rebate cut into wall.

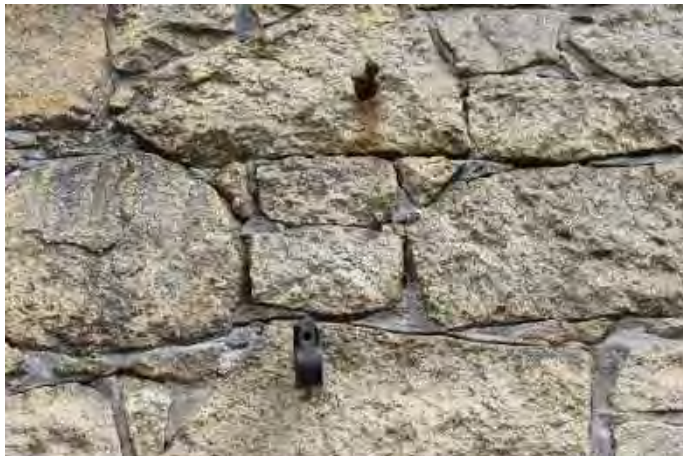
Fixings in wall.
