| Location Ref: | BMD Elevation – Section 44 |

| Location Ref: | RR Elevation – Section 01 |

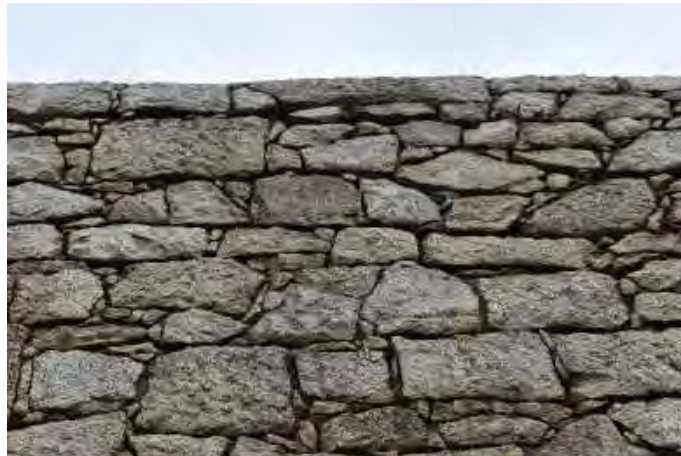
Mortar loss and
cracking to upper
areas.

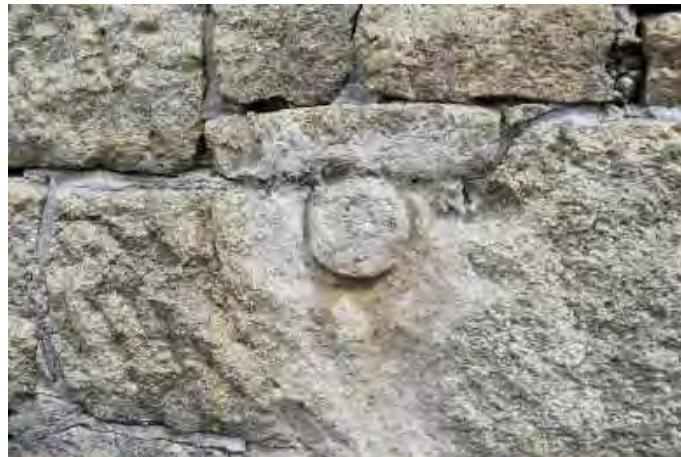
Core hole position.

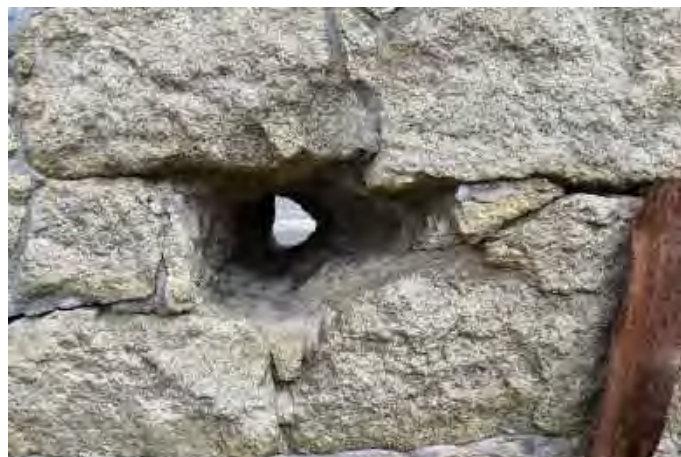
Hole through wall.

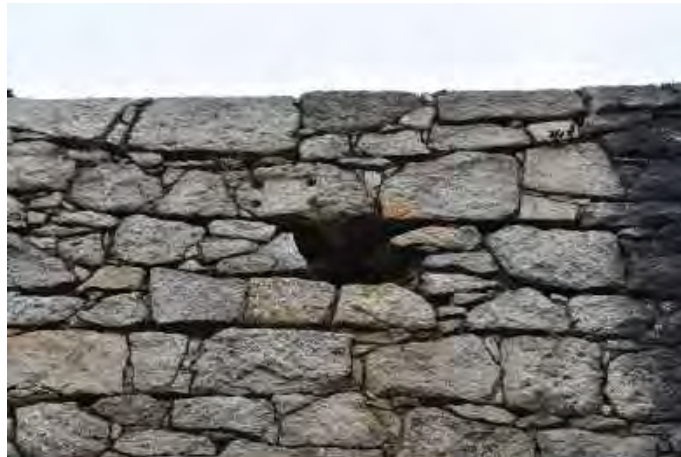
Mortar loss and cracking to upper wall areas.

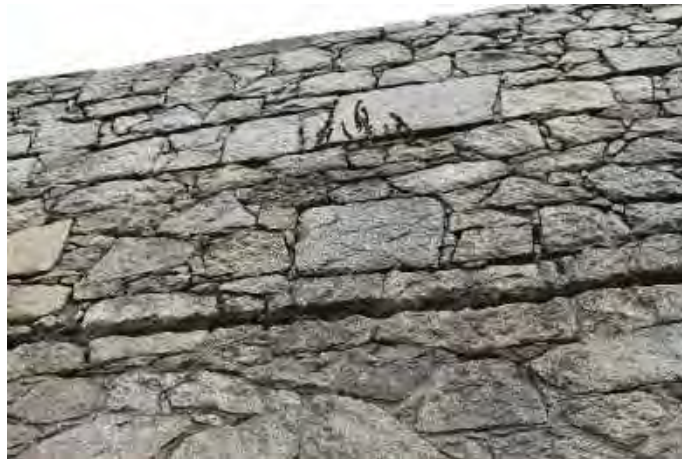
Rebate cut into wall.

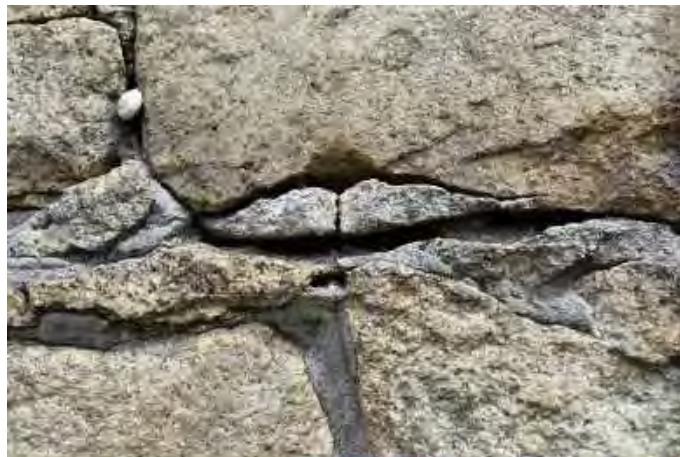
Cracking of mortar around stones.

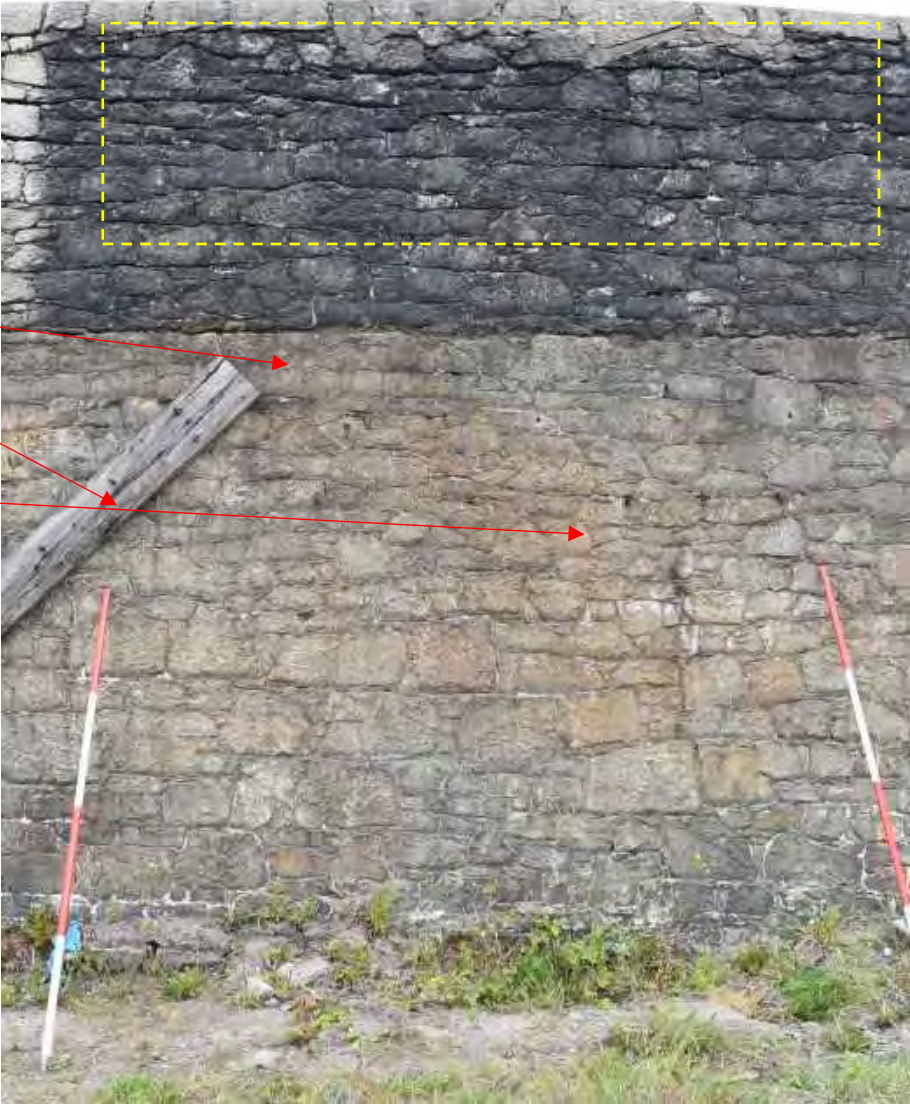
| Location Ref: | BMD Elevation – Section 45 |

| Location Ref: | BMD Elevation – Section 45 |
|--|---|
| <p>Wall section width approx. 3.0m</p> <p>Mortar loss and cracking to upper wall areas. Area of repair to coping.</p> <p>Rebate in wall.</p> <p>Timber fixed to wall.</p> <p>Fixings</p> <p>Minor cracking to mortar at lower levels</p> | |
| <p>Condition:</p> | <p>Wall is generally stable but with some cracking and mortar loss around stones especially at higher levels which requires repair. Mechanical fixings applied to wall and rebate cut into wall.</p> <p>Proposed treatment: Re-point areas of cracked and missing mortar - additional grouting of the upper core areas may be required. Remove fixings and make good. Mortar repair to rebate.</p> |

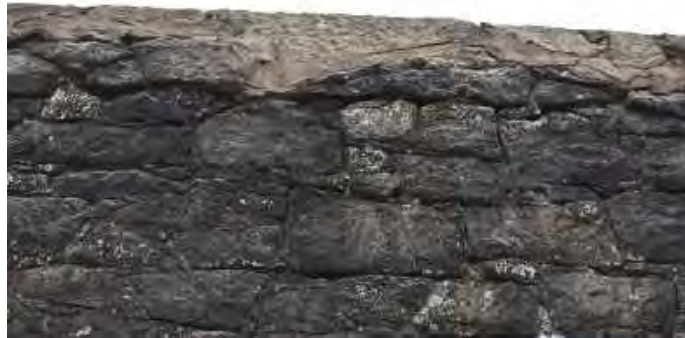
Render repair to
coping.

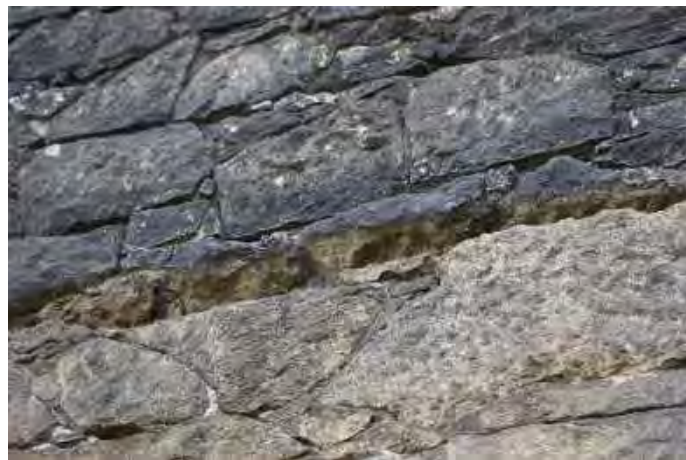
Rebate cut in wall.

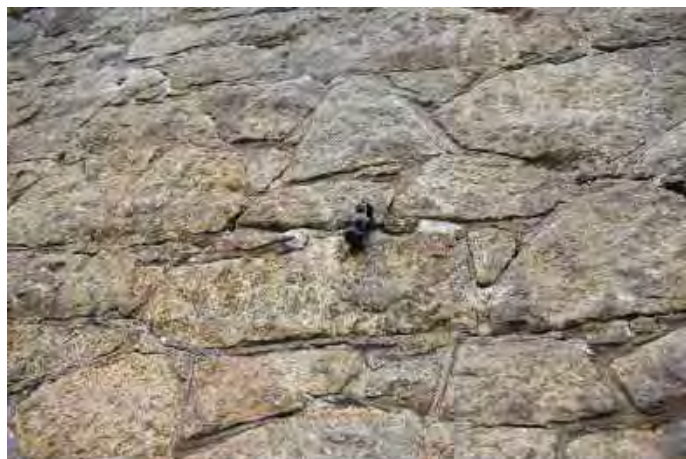
Fixings on face of wall.

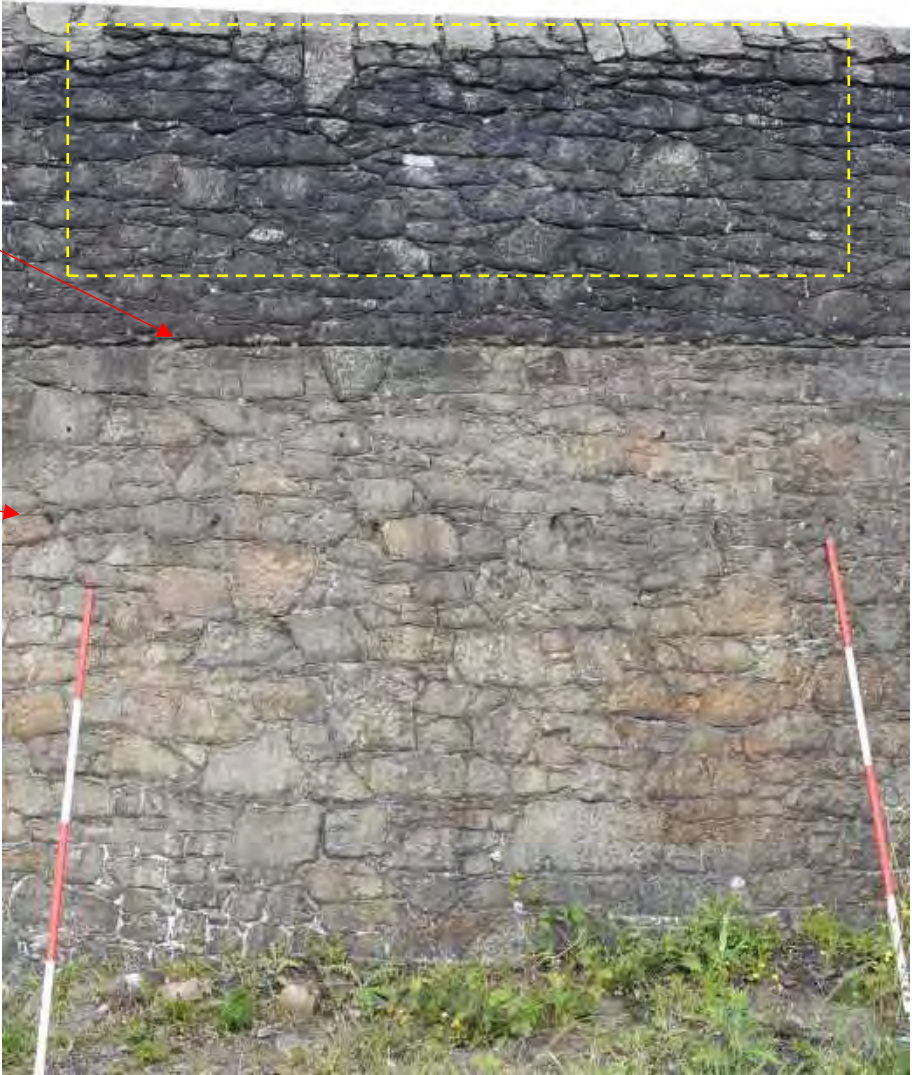
| Location Ref: | BMD Elevation – Section 46 |

| Location Ref: | BMD Elevation – Section 46 |
|--|--|
| <p>Wall section width approx. 3.0m</p> <p>Mortar loss and cracking to upper wall areas.</p> <p>Rebate cut into wall.</p> <p>Minor cracking to mortar at lower levels</p> <p>Fixings.</p> | |
| <p>Condition:</p> | <p>Wall is generally stable but with some cracking and mortar loss around stones especially at higher levels which requires repair. Mechanical fixings applied to wall and rebate cut into wall.</p> <p>Proposed treatment: Re-point areas of cracked and missing mortar - additional grouting of the upper core areas may be required. Remove fixings and make good. Mortar repair to rebate.</p> |

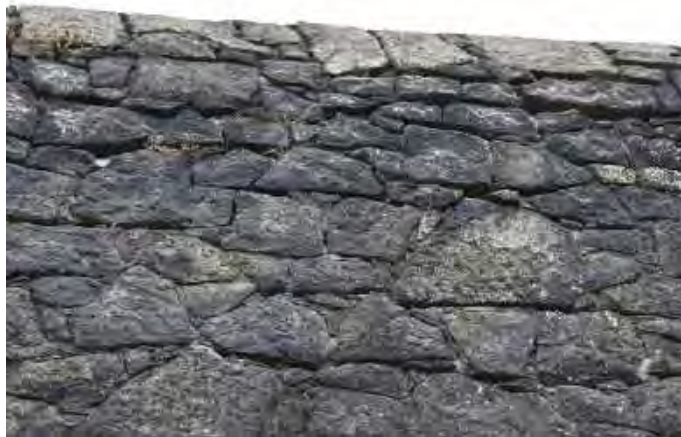
Mortar loss and
cracking to upper wall
areas.

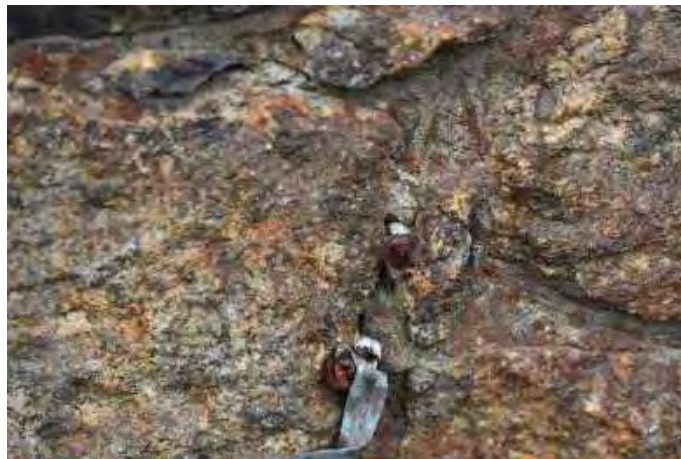
Fixings and rust
staining to face of
wall.

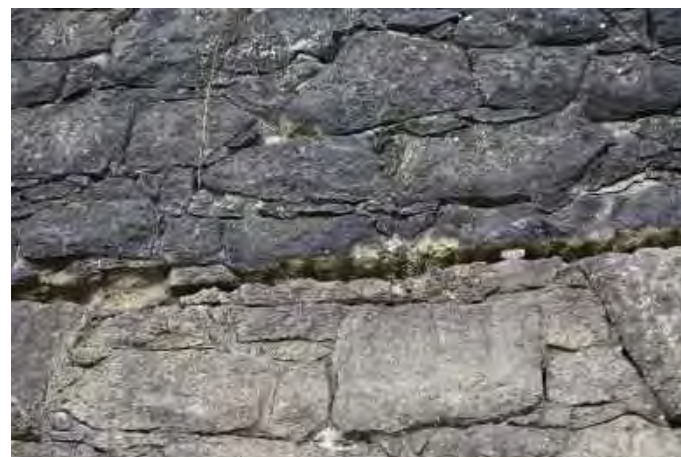
Rebate cut into wall.

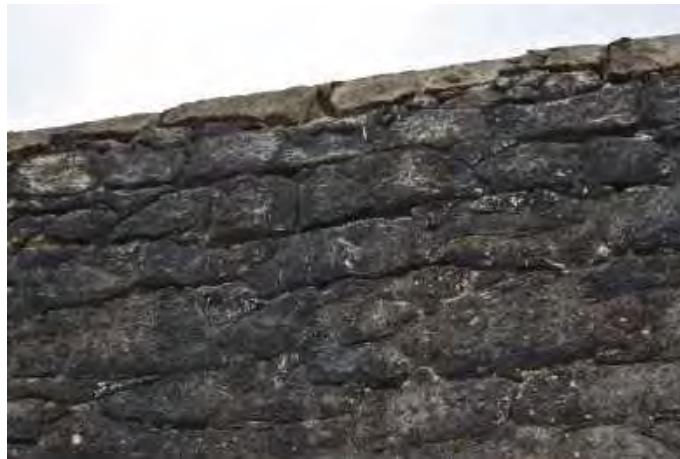
Mortar loss to upper wall areas.

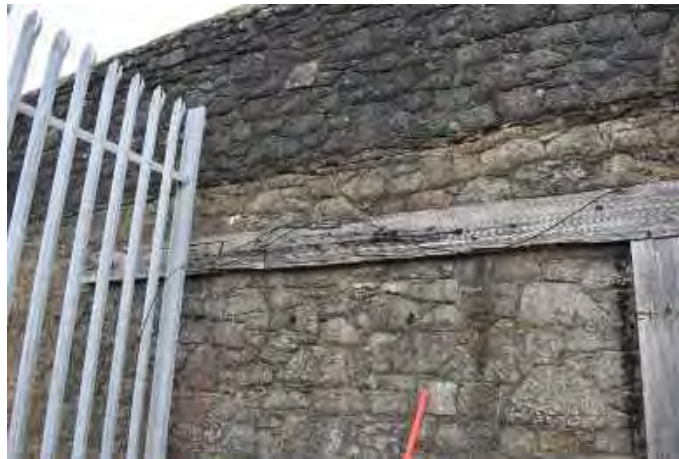
Timber board fixed to wall. (240 x 35mm).

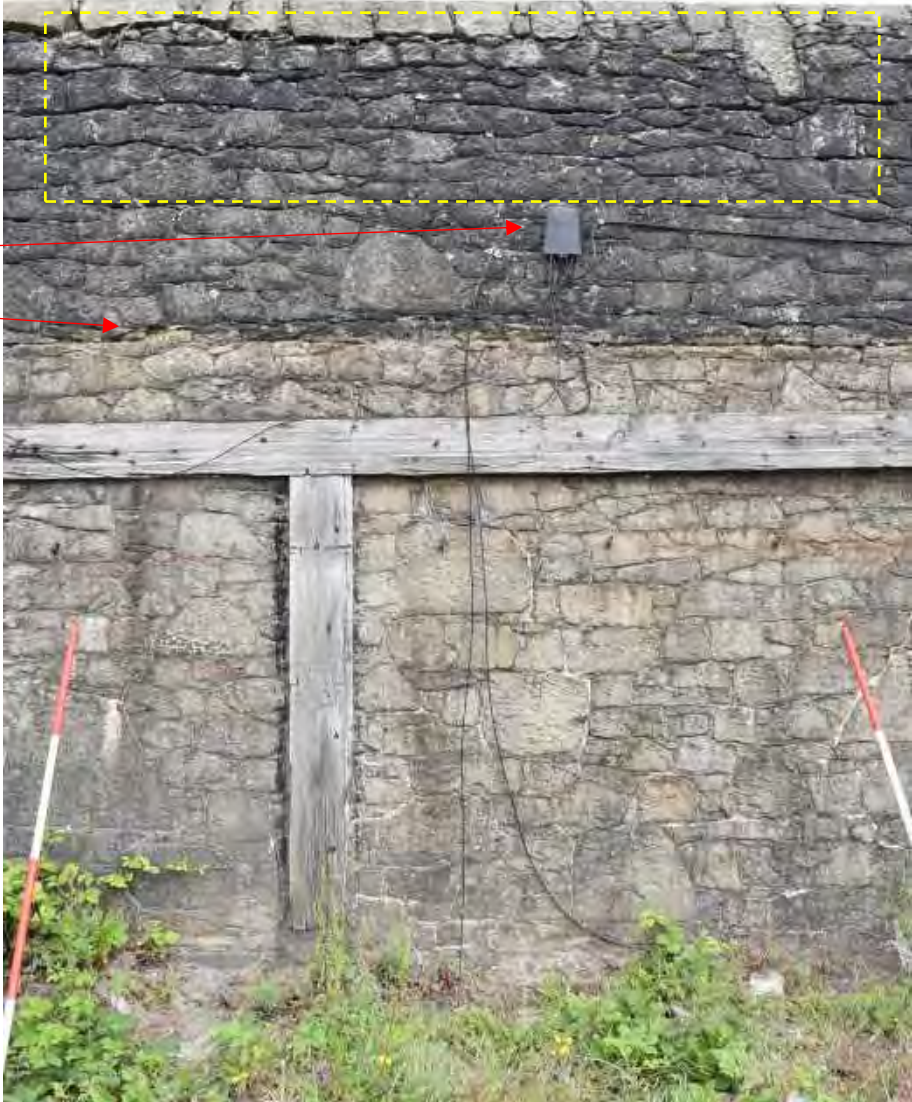
| Location Ref: | BMD Elevation – Section 48 |

| Location Ref: | BMD Elevation – Section 48 |
|---|--|
| <p>Wall section width approx. 3.0m</p> <p>Mortar loss and cracking to upper wall areas.</p> <p>Services fixed to wall.</p> <p>Rebate cut in wall.</p> <p>Timber boarding fixed to wall.</p> <p>Minor cracking to mortar at lower levels</p> | |
| <p>Condition:</p> | <p>Wall is generally stable but with some cracking and mortar loss around stones especially at higher levels which requires repair. Mechanical fixings applied to wall and rebate cut into wall. Timber boarding fixed to wall.</p> <p>Proposed treatment:</p> <p>Re-point areas of cracked and missing mortar - additional grouting of the upper core areas may be required.</p> <p>Remove timber / fixings and make good.</p> <p>Mortar repair to rebate.</p> <p>Remove services and make good.</p> |

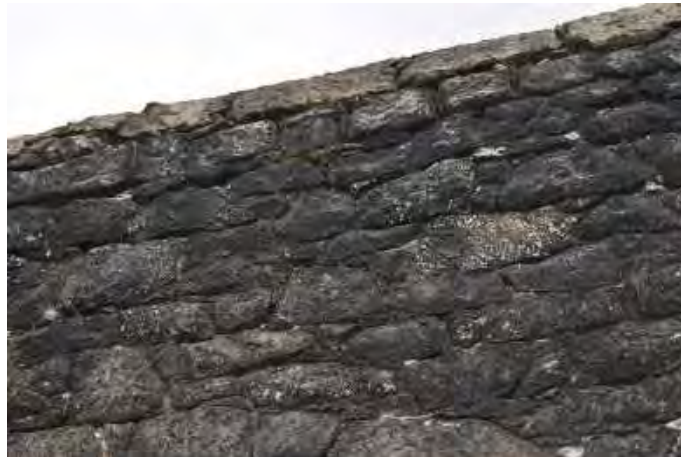
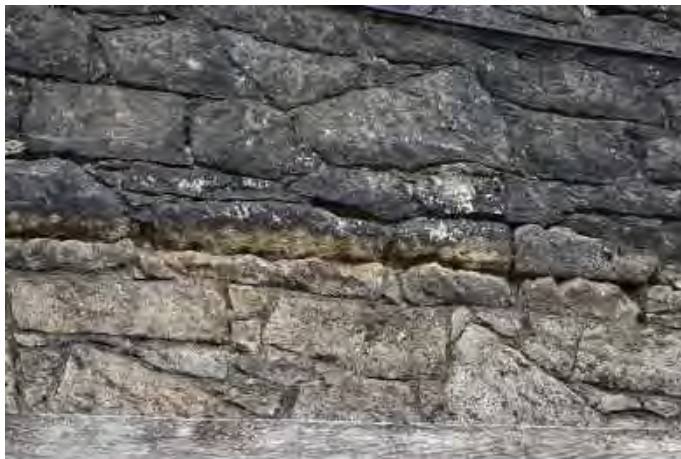
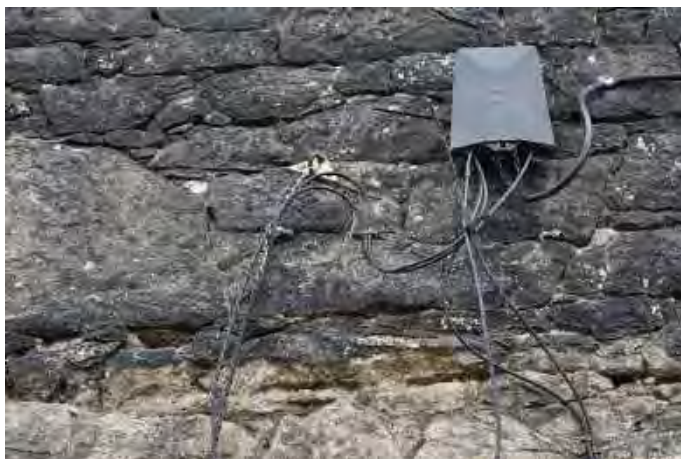
Dark pollution staining to face of wall.

Cracking and mortar loss to upper wall areas.

Rebate cut into wall.

Services on face of wall.

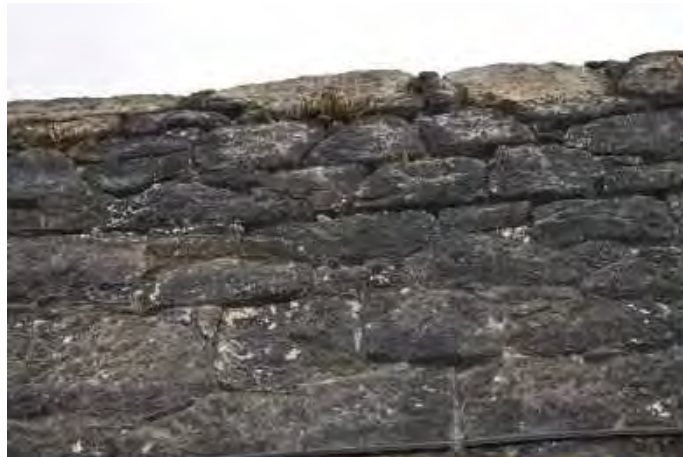
Mortar loss to upper
wall.

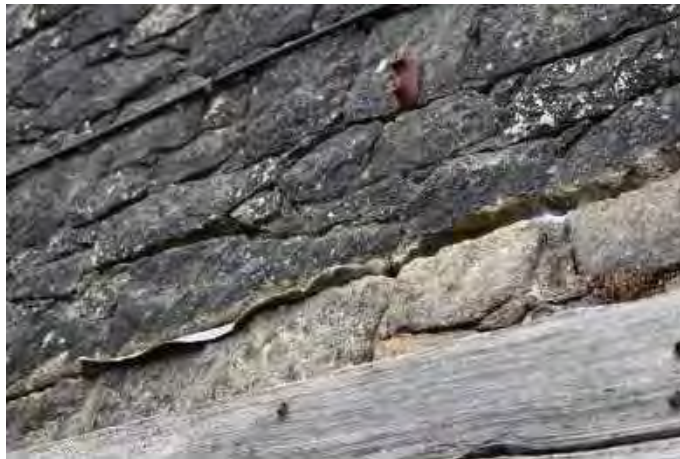
Services fixed to face
of stonework. Rebate
cut into wall.

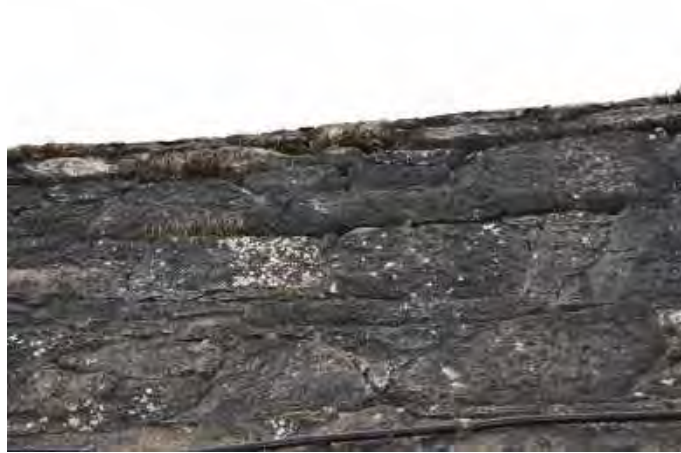
Plant growth to upper
wall area.

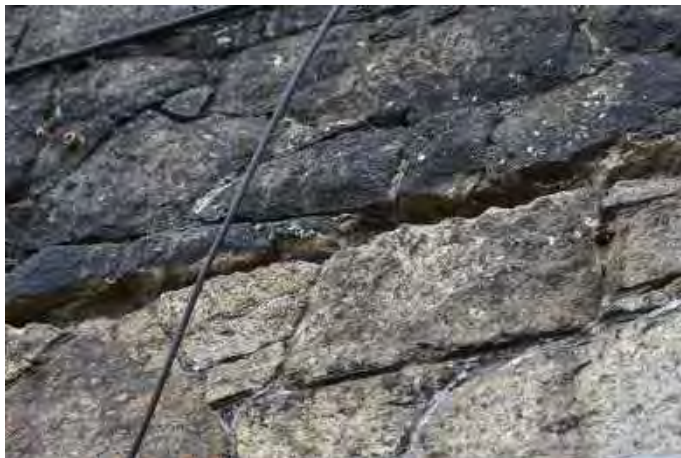
Rebate cut into wall.

Services on face of
wall.

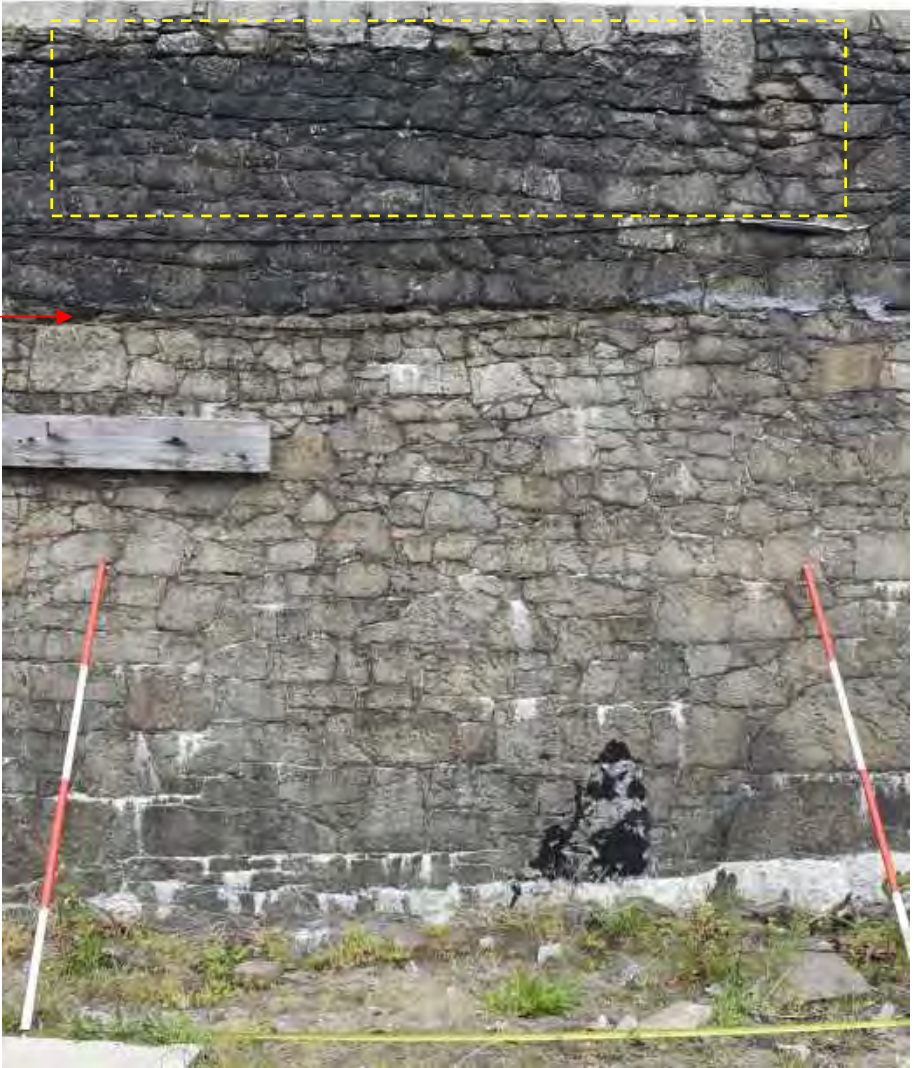
| Location Ref: | BMD Elevation – Section 51 |

| Location Ref: | BMD Elevation – Section 51 |
|--|--|
| <p>Wall section width approx. 3.0m</p> <p>Mortar loss and cracking to upper wall areas.</p> <p>Rebate in wall. </p> <p>Timber fixed to wall.</p> <p>Minor cracking to mortar at lower levels</p> <p>Paint on wall.</p> <p>Calcium deposits.</p> | |
| <p>Condition:</p> | <p>Wall is generally stable but with some cracking and mortar loss around stones especially at higher levels which requires repair. Mechanical fixings applied to wall and rebate cut into wall Some paint and calcium deposits at low level.</p> <p>Proposed treatment: Re-point areas of cracked and missing mortar - additional grouting of the upper core areas may be required. Remove fixings and make good. Mortar repair to rebate. Remove paint from face of wall.</p> |

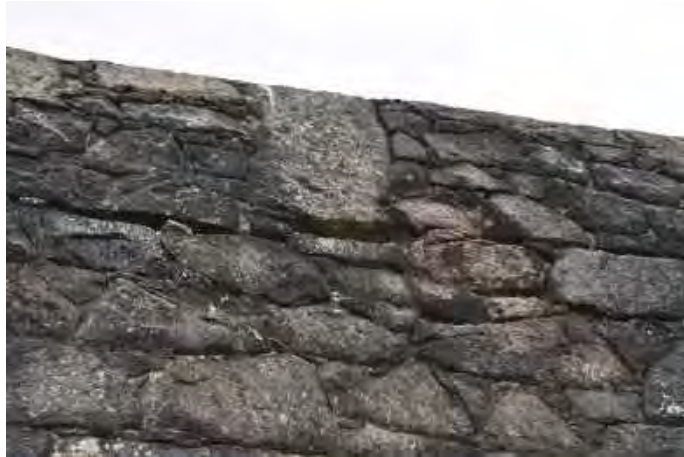
Mortar loss and cracking at upper wall level.

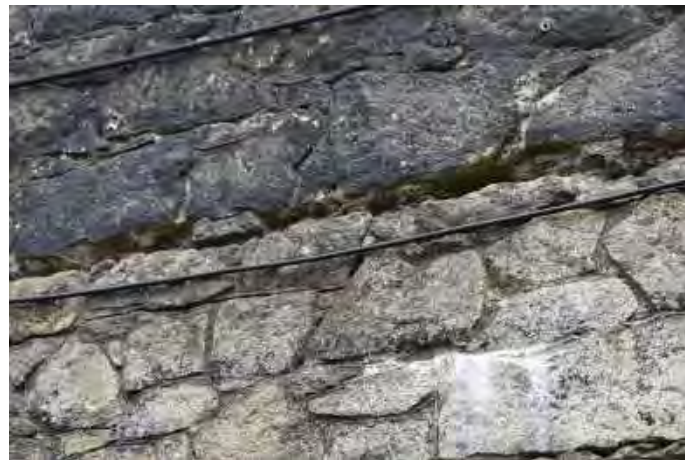
Rebate cut in wall.

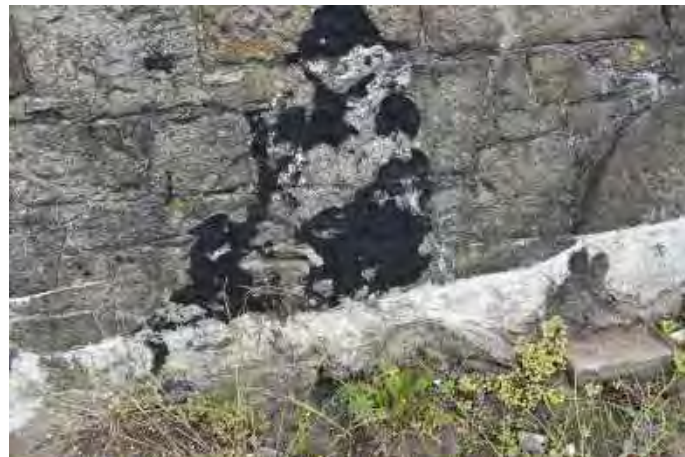
Paint on lower wall areas.

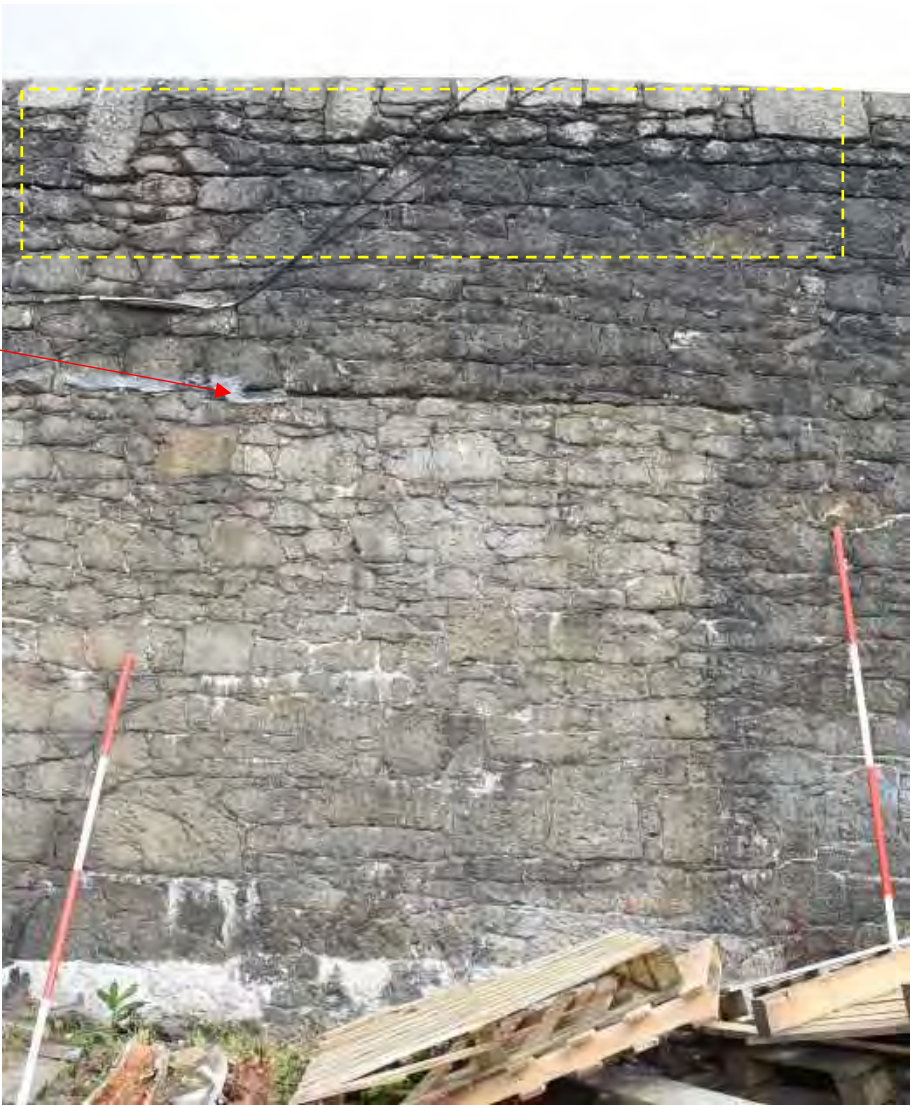
| Location Ref: | BMD Elevation – Section 52 |

| Location Ref: | BMD Elevation – Section 52 |
|---|---|
| <p>Wall section width approx. 3.0m</p> <p>Mortar loss and cracking to upper wall areas.</p> <p>Rebate cut in wall.</p> <p>Services on wall.</p> <p>Minor cracking to mortar at lower levels</p> <p>Calcium deposits</p> | |
| <p>Condition:</p> | <p>Wall is generally stable but with some cracking and mortar loss around stones especially at higher levels which requires repair. Mechanical fixings applied to wall and rebate cut into wall</p> <p>Proposed treatment: Re-point areas of cracked and missing mortar - additional grouting of the upper core areas may be required. Remove fixings and make good. Mortar repair to rebate.</p> |

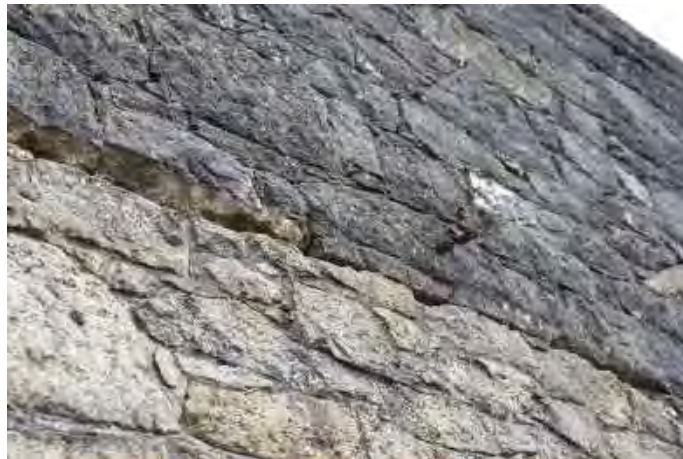
Rebate cut into wall.

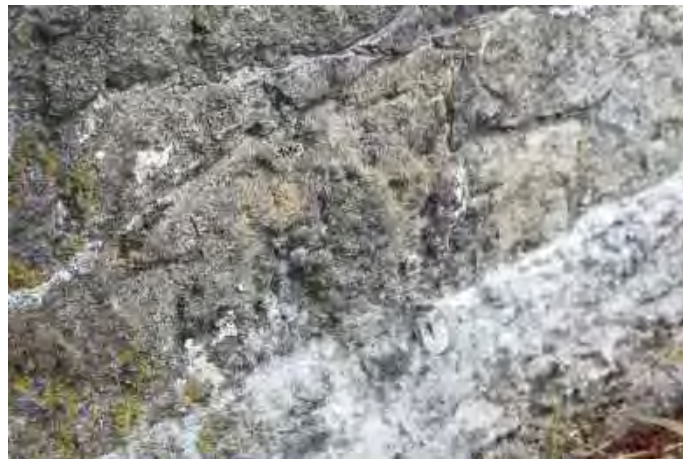
Calcium deposits on
lower wall.

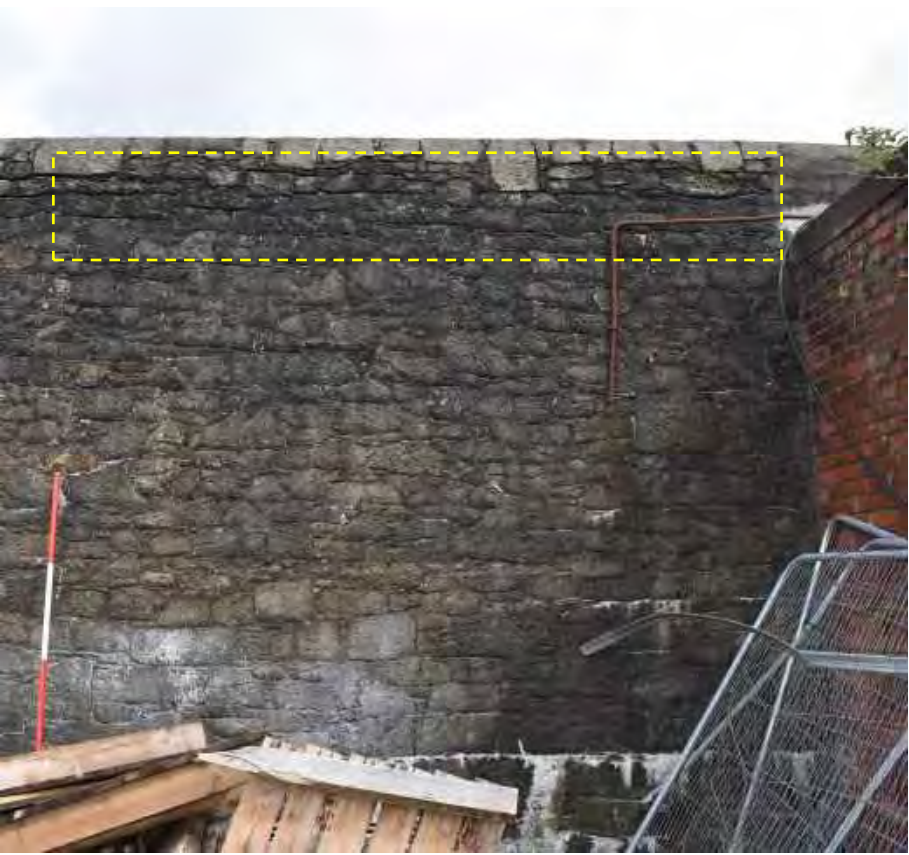
| Location Ref: | BMD Elevation – Section 53 and part 54 |

| Location Ref: | BMD Elevation – Section 53 and part 54 |
|--|---|
| <p>Wall section width approx. 3.0m</p> <p>Mortar loss and cracking to upper wall areas.</p> <p>Services on wall.</p> <p>Minor cracking to mortar at lower levels</p> <p>Traces of white paint.</p> | |
| <p>Condition:</p> | <p>Wall is generally stable but with some cracking and mortar loss around stones especially at higher levels which requires repair. Mechanical fixings applied to wall. Some traces of paint on wall.</p> <p>Proposed treatment:</p> <p>Re-point areas of cracked and missing mortar - additional grouting of the upper core areas may be required.</p> <p>Remove fixings and make good.</p> <p>Mortar repair to rebate.</p> <p>Remove paint from stonework.</p> |

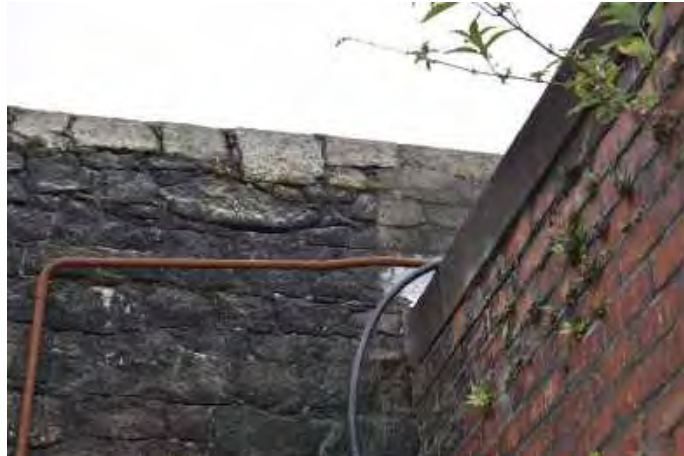
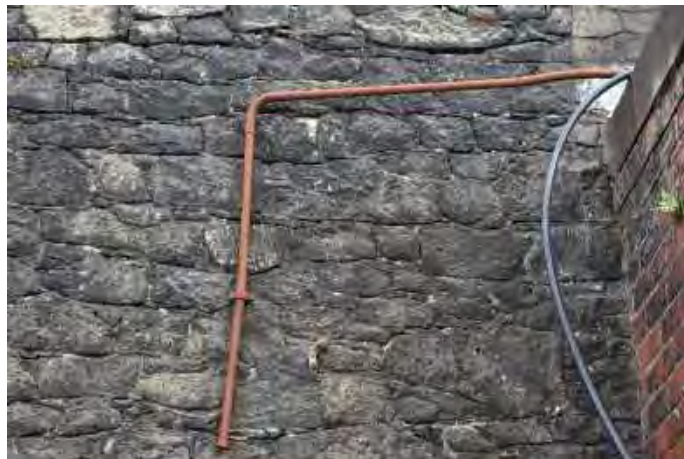
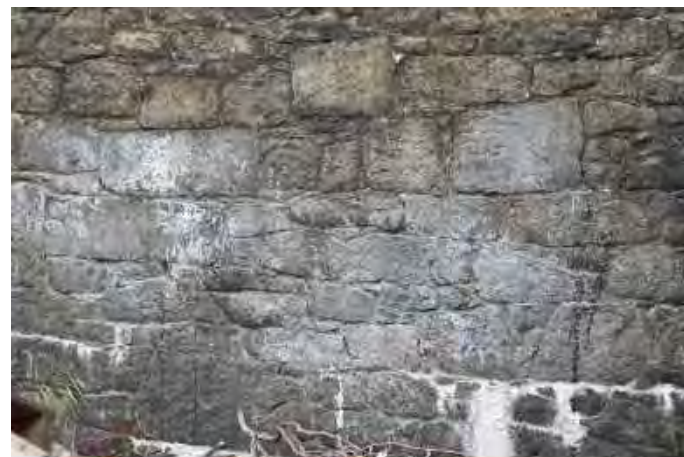
Mortar loss and cracking to upper wall areas.

Conduit on face of wall.

Traces of white paint finishes.

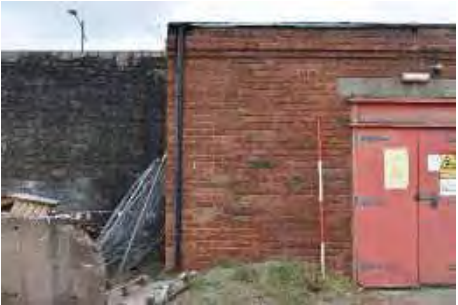
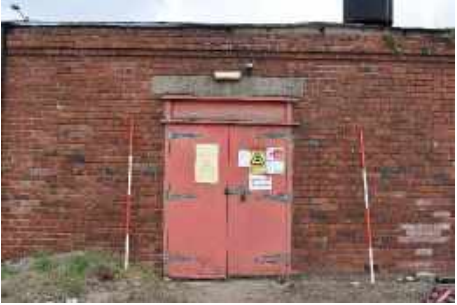
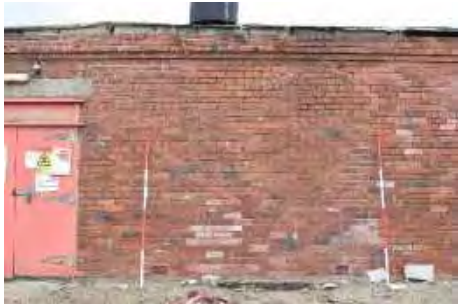
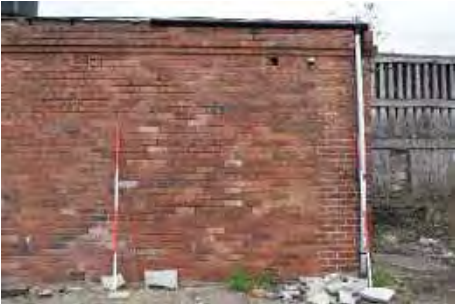
| Location Ref: | BMD Elevation – Section part 54, 55, 56 and 57 |

| Location Ref: | BMD Elevation – Section part 54, 55, 56 and 57 |
|---|--|
| <p>Wall section width approx. 3.0m</p> <p>Mortar loss and cracking to upper wall areas.</p> | <div data-bbox="507 241 967 544"></div> <div data-bbox="978 241 1437 544"></div> <div data-bbox="507 562 967 864"></div> <div data-bbox="978 562 1437 864"></div> <p>Electrical sub-station obscures wall.</p> |
| <p>Condition:</p> | <p>Not possible to review wall condition in these areas.</p> <p>Proposed treatment:</p> <p>Assume similar treatment to adjacent wall areas together with repairs to rebated brickwork and possible removal of finishes from wall.</p> |

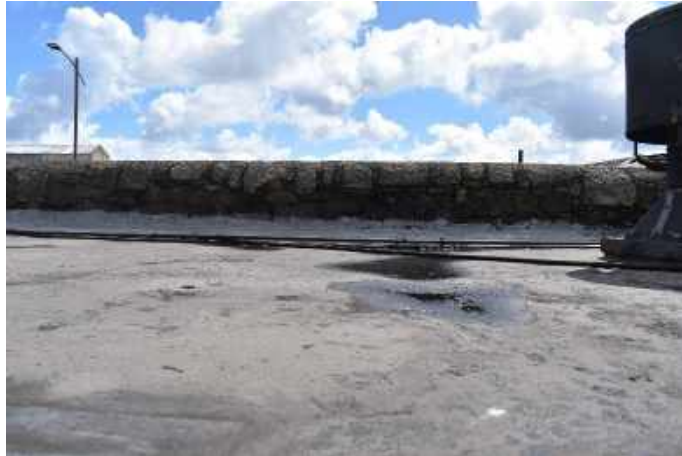
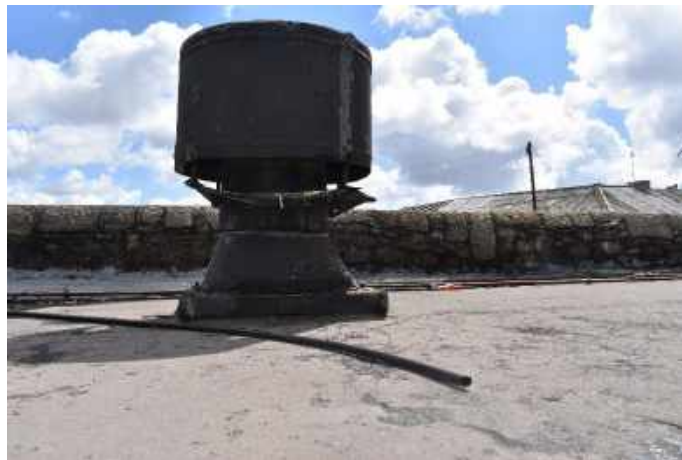
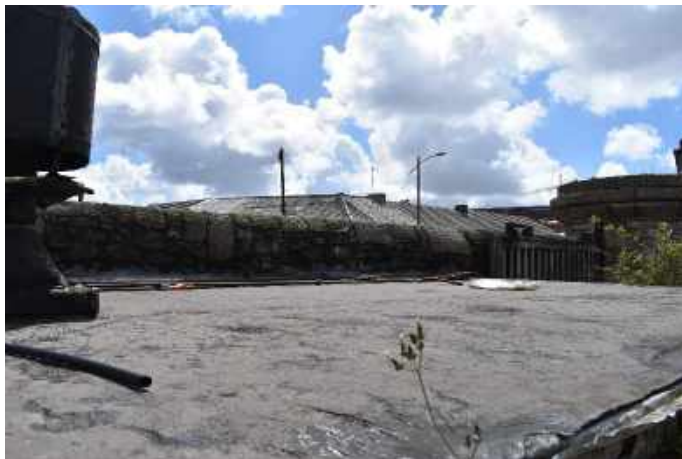
Top of wall above
substation.

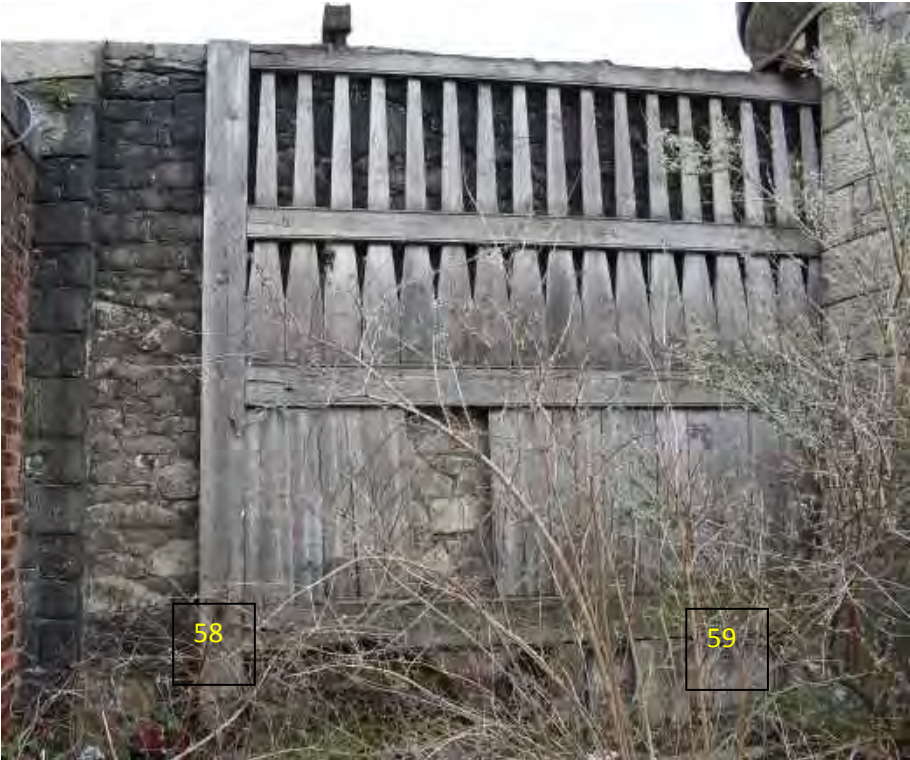
| Location Ref: | BMD Elevation – Section 58 and 59 |

| Location Ref: | BMD Elevation – Section 58 and 59 |
|--|--|
| <p>Wall section width approx. 3.0m</p> <p>Mortar loss and cracking to upper wall areas.</p> <p>Step in wall for gate rebate.</p> <p>Sliding gate and plant growth obscures wall.</p> | |
| <p>Condition:</p> | <p>Wall appears to be generally stable but with some cracking and mortar loss around stones especially at higher levels which requires repair. Gate position obscures wall survey.</p> <p>Proposed treatment: Re-point areas of cracked and missing mortar - additional grouting of the upper core areas may be required.</p> |

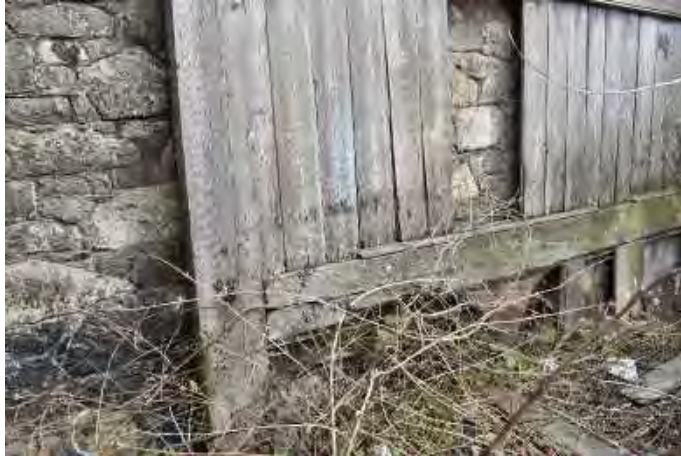
Timber sliding gate.

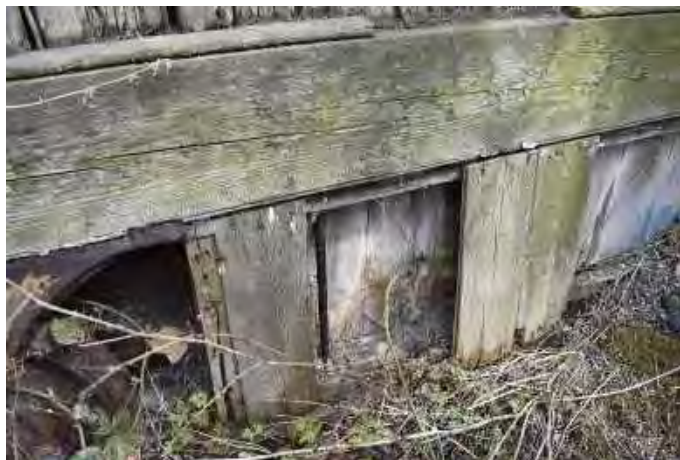
Iron wheel of gate.

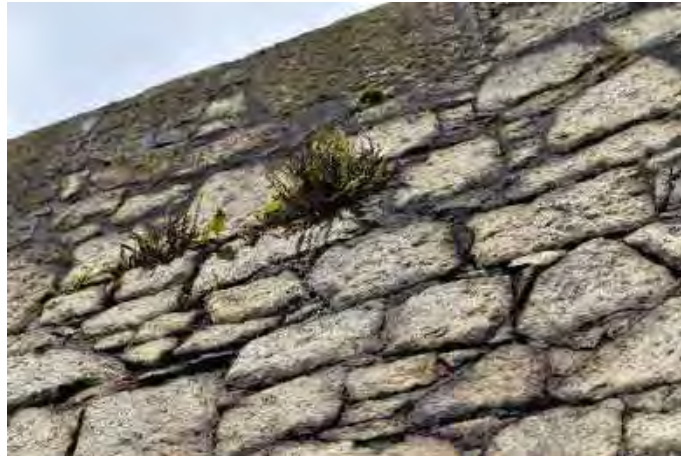
Coping stones have been re-pointed.
Mortar loss and cracking to upper wall.

Plant growth in mortar joints.

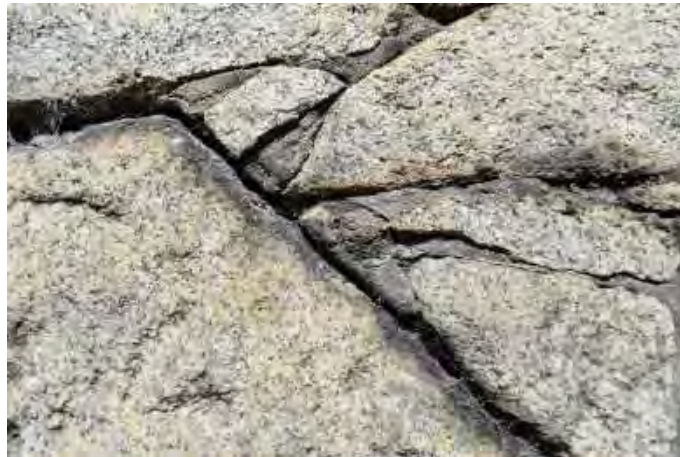
Cracking of mortar showing displacement of stonework.

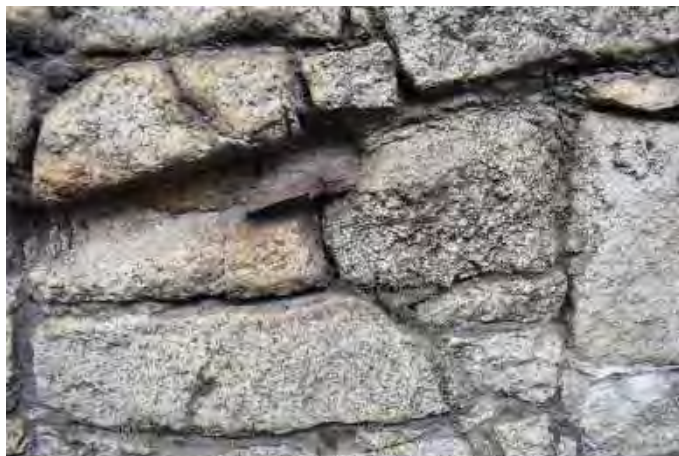
Embedded ironwork (possibly handrail to gate pier).

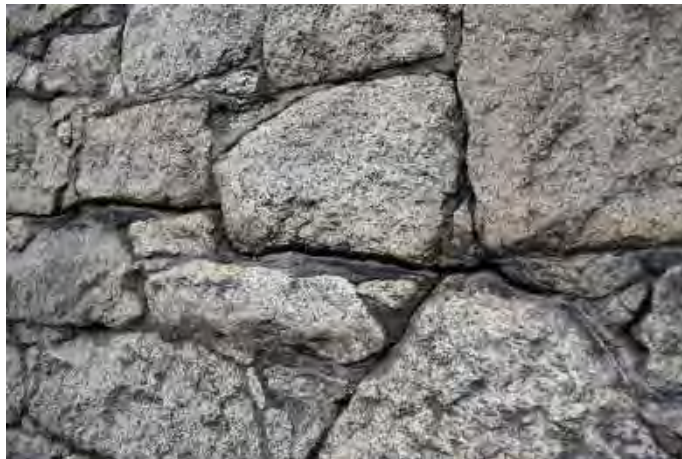
Cracking of mortar
around stones.

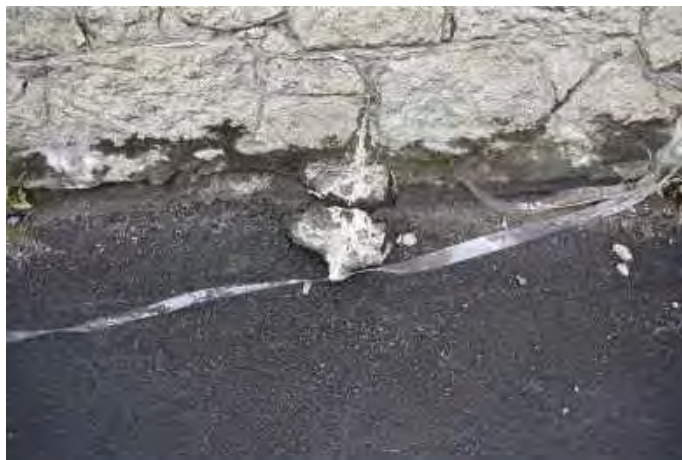
Calcium deposits.

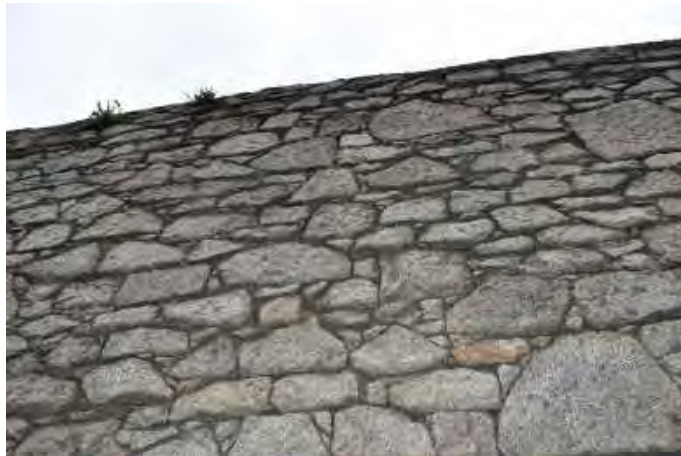
Coping stones have been re-pointed.
Mortar loss and cracking to upper wall.

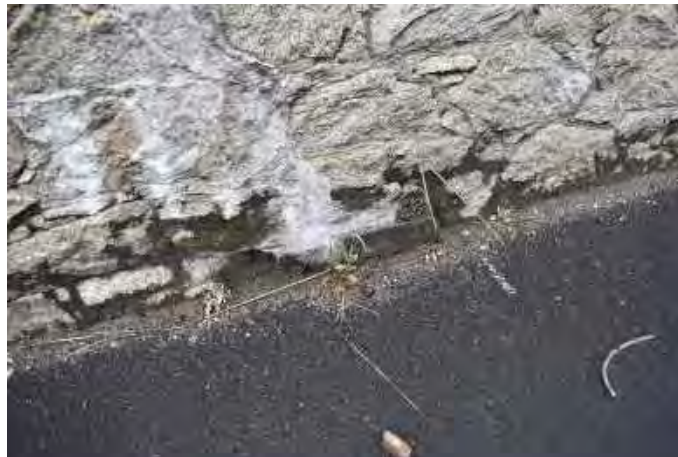
Calcium deposits.

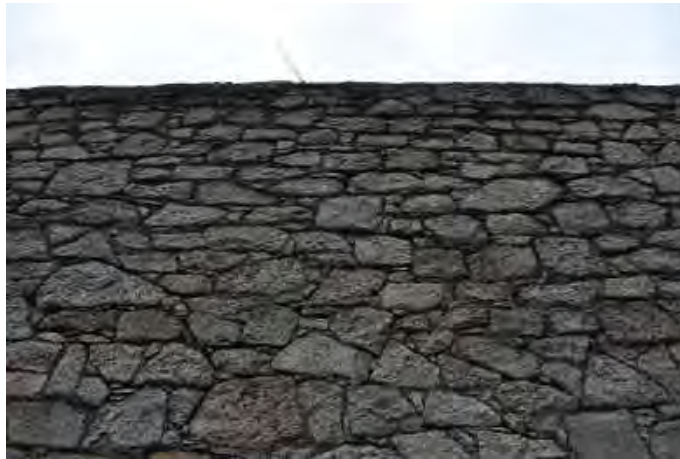
Coping stones have
been re-pointed.
Mortar loss and
cracking to upper wall.

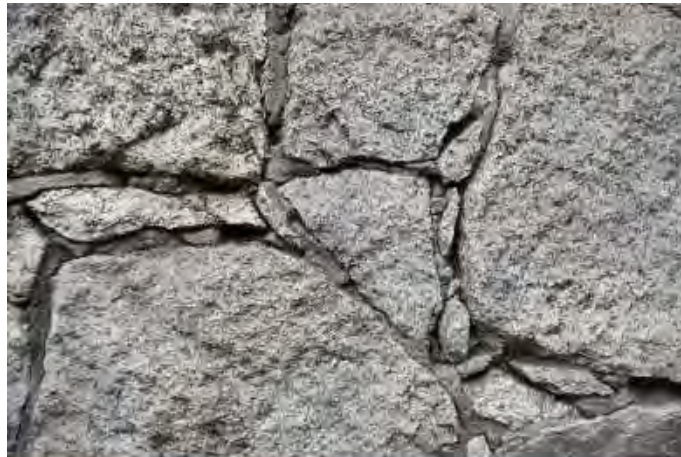
Mortar loss around
stones.
