| Location Ref: | BMD Elevation – Section 44 |

| Location Ref: | RR Elevation – Section 01 |

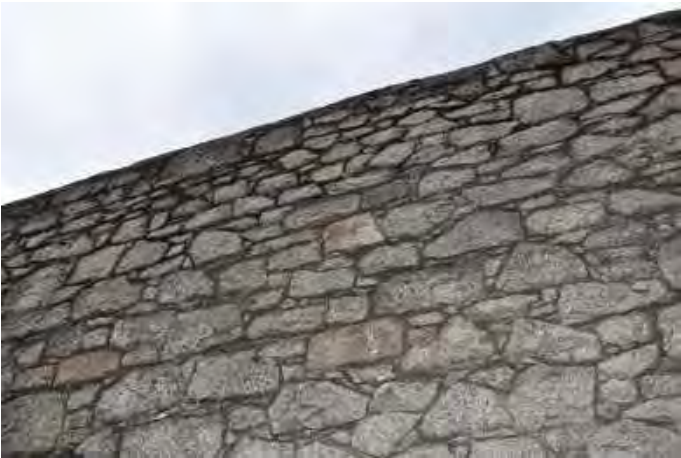
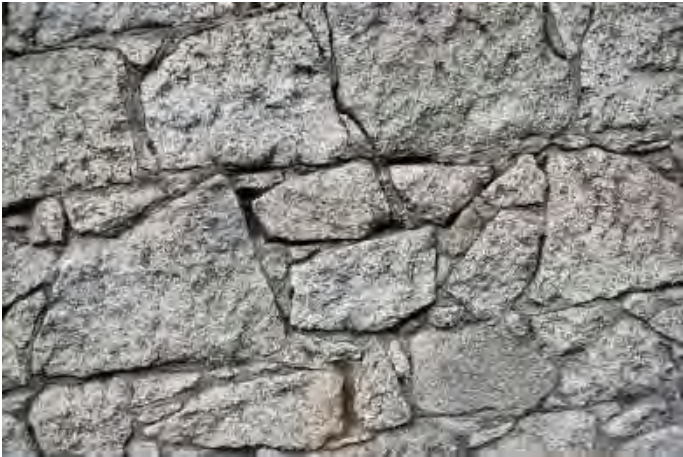
| <p data-bbox="204 235 459 302">Additional notes and photographs:</p> <p data-bbox="204 342 480 481">Coping stones have been re-pointed. Mortar loss and cracking to upper wall.</p> <p data-bbox="204 880 400 981">Mortar loss and cracking around stones.</p> | <div data-bbox="635 286 1319 741">A photograph showing the upper portion of a stone wall, specifically the coping stones. The stones are laid in a regular pattern, and the mortar joints between them have been re-pointed, appearing lighter and more uniform than the surrounding older mortar.</div> <div data-bbox="630 779 1316 1234">A close-up photograph of the stone masonry. It highlights areas of mortar loss and cracking around the stones. The stones themselves are irregular in shape and size, with a rough, weathered texture. The mortar is a light grey color, and the cracks are visible in several places, particularly around the edges of the stones.</div> |

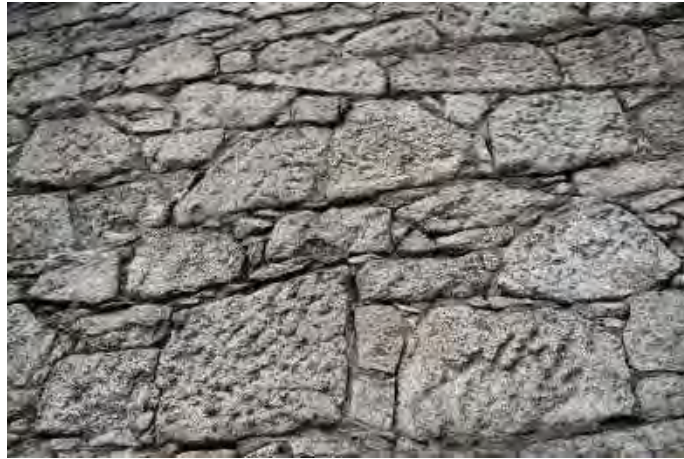
Mortar loss and
cracking to upper wall.

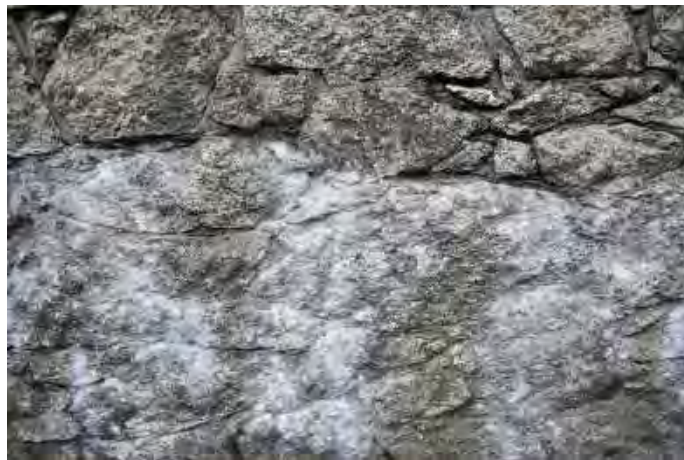
Calcium deposits.

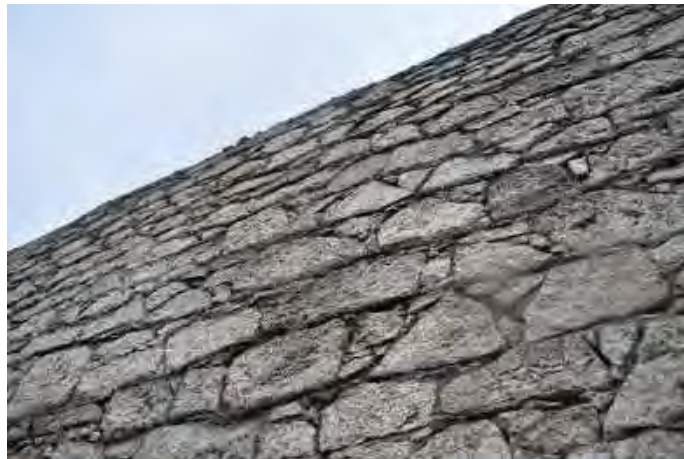
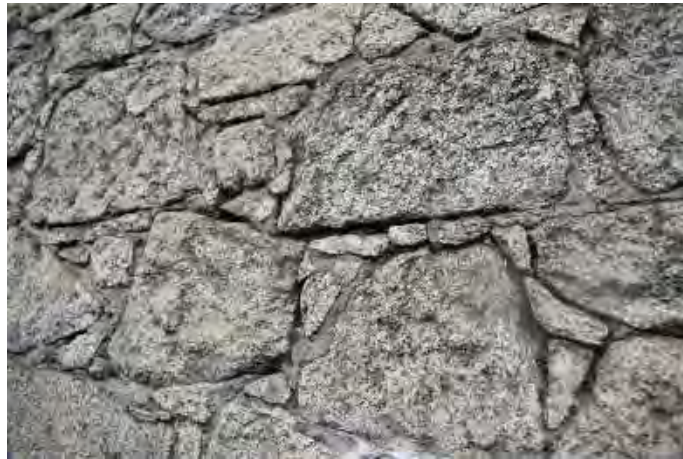
Coping stones have
been re-pointed.
Mortar loss and
cracking to upper wall.

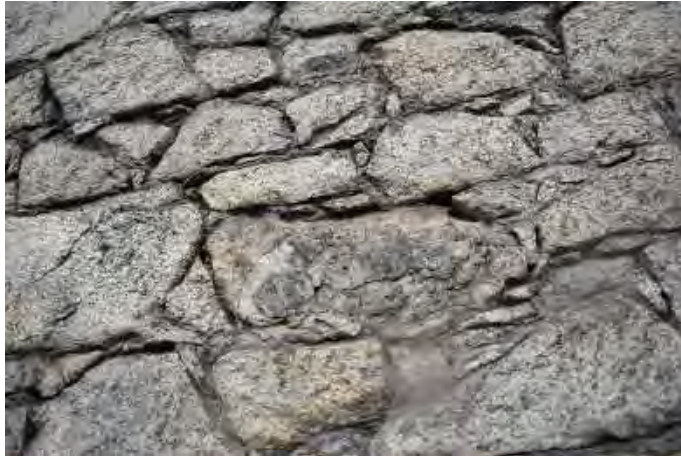
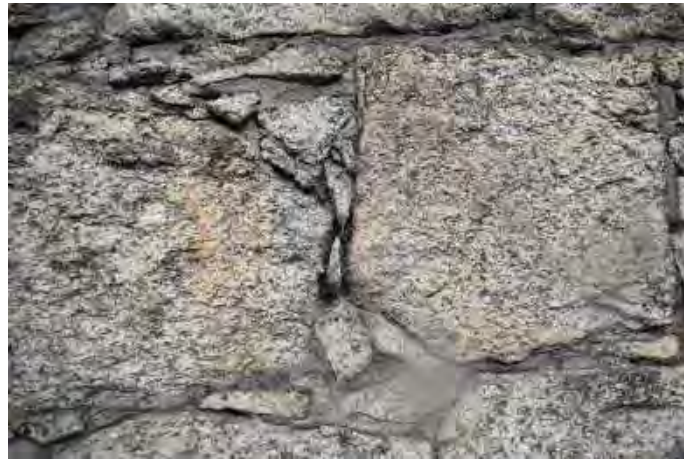
Coping stones have
been re-pointed.
Mortar loss and
cracking to upper wall.

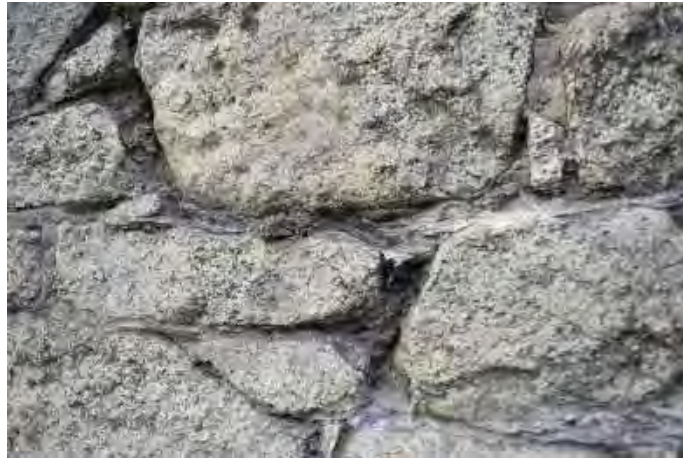
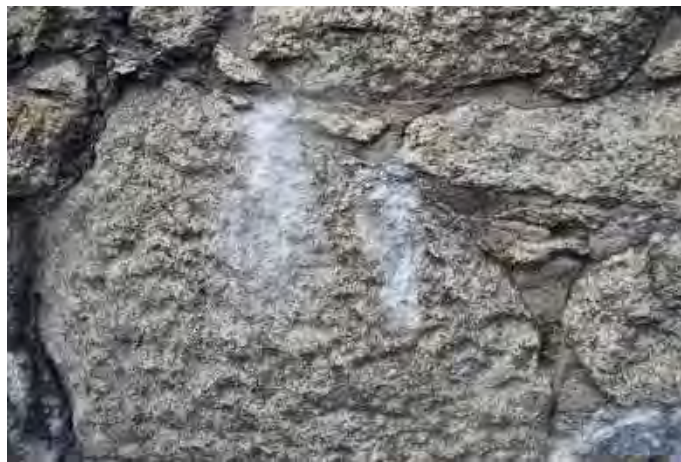
Mortar loss and
cracking to upper wall.

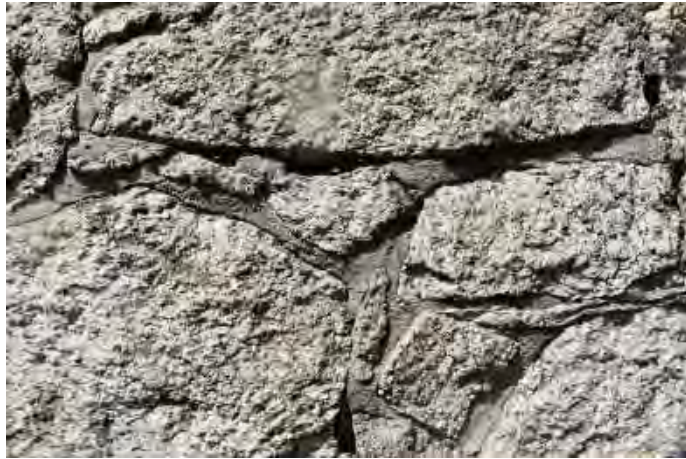
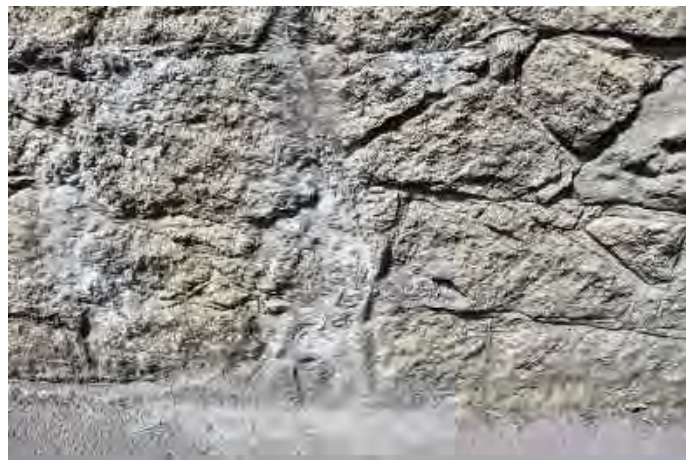
Mortar loss and
cracking to upper wall.

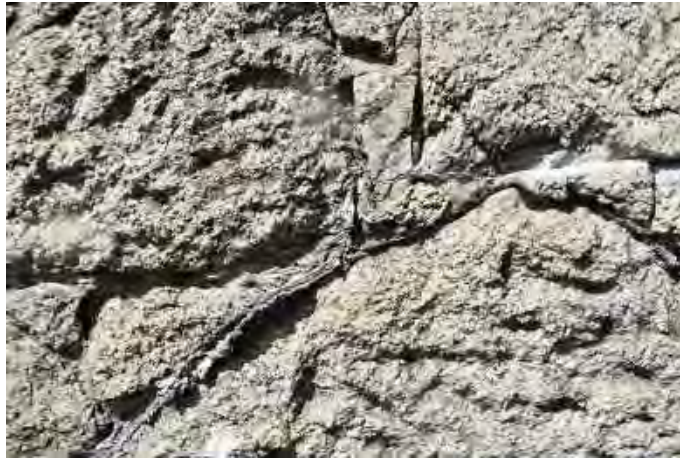
Mortar loss and
cracking to upper wall.

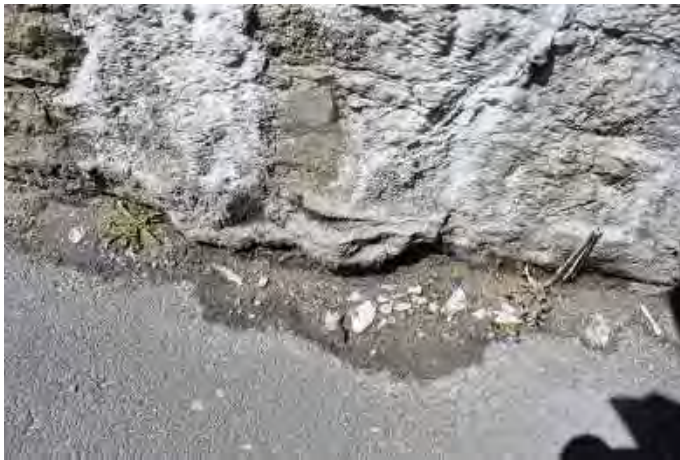
Calcium deposits.

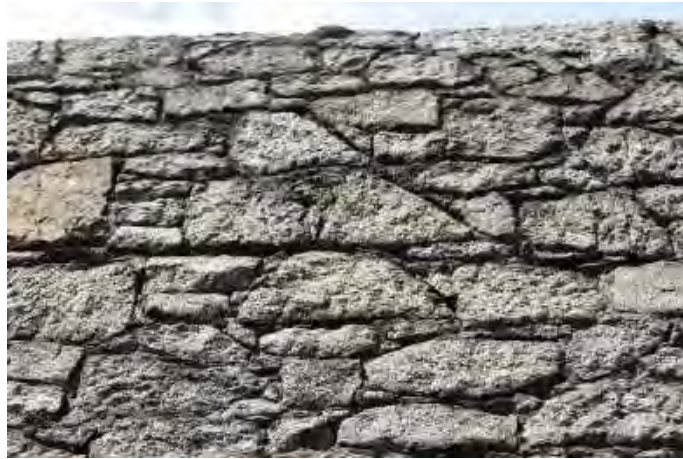
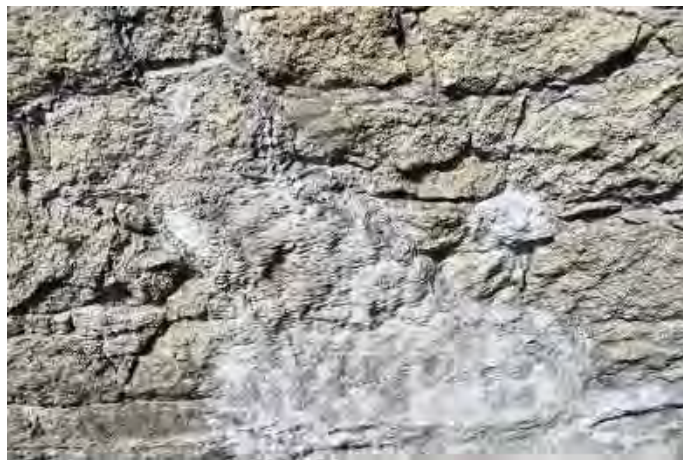
Coping stones have been re-pointed.
Mortar loss and cracking to upper wall.

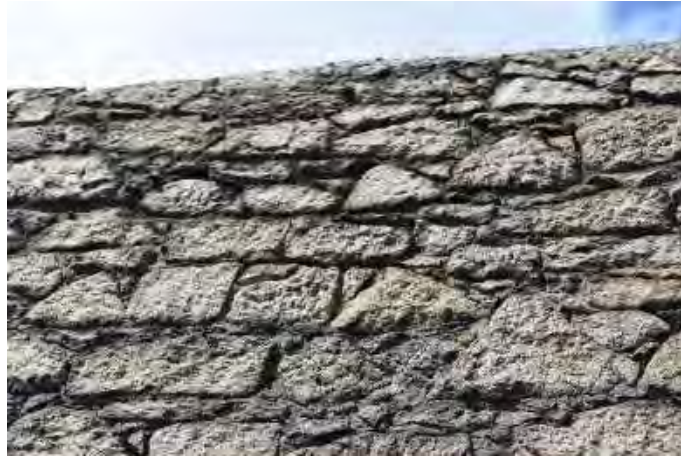
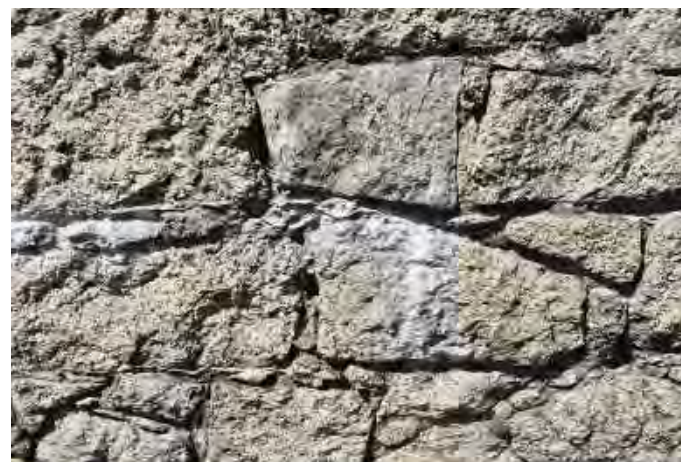
| Location Ref: | RR Elevation – Section 14 |

Coping stones have been re-pointed.
Mortar loss and cracking to upper wall.

| Location Ref: | RR Elevation – Section 14 |
|---|--|
| <p>Condition:</p> | <p>Coping stones to top of wall have been repointed (RR side only). Wall is generally stable but with some cracking and mortar loss around stones especially at higher levels which requires repair.</p> <p>Proposed treatment: Re-point areas of cracked and missing mortar - additional grouting of the upper core areas may be required.</p> |

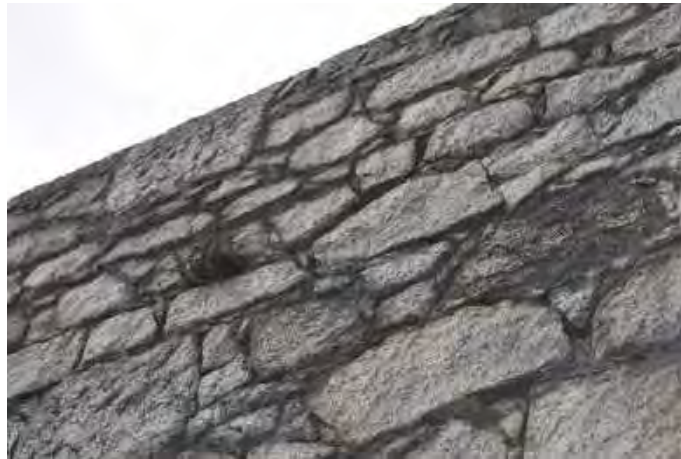
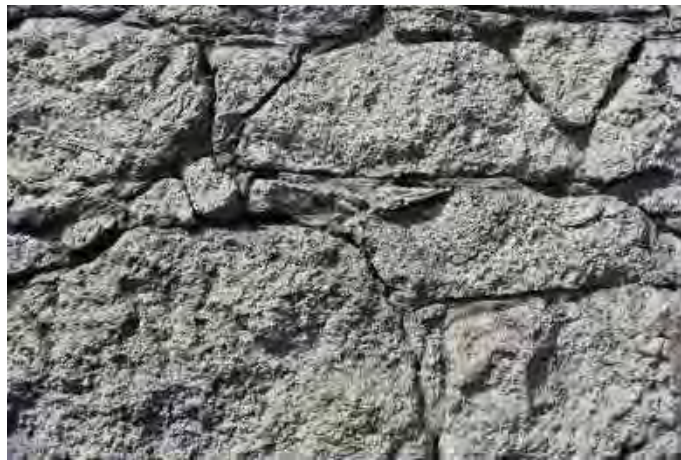
| Location Ref: | RR Elevation – Section 15 |

Coping stones have
been re-pointed.
Mortar loss and
cracking to upper wall.

| Location Ref: | RR Elevation – Section 15 |
|---|--|
| <p>Condition:</p> | <p>Coping stones to top of wall have been repointed (RR side only). Wall is generally stable but with some cracking and mortar loss around stones especially at higher levels which requires repair.</p> <p>Proposed treatment: Re-point areas of cracked and missing mortar - additional grouting of the upper core areas may be required.</p> |

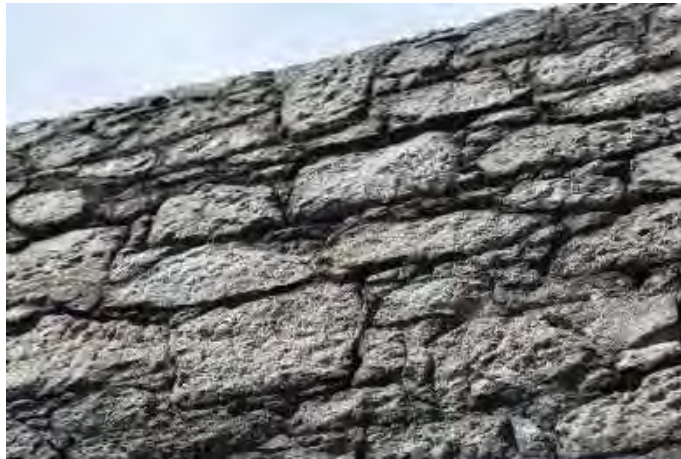
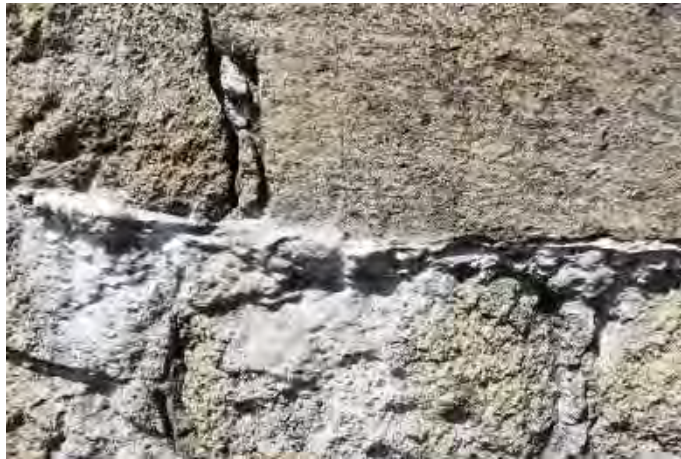
| Location Ref: | RR Elevation – Section 16 |

Coping stones have
been re-pointed.
Mortar loss and
cracking to upper wall.

| Location Ref: | RR Elevation – Section 16 |
|--|--|
| <p>Condition:</p> | <p>Coping stones to top of wall have been repointed (RR side only). Wall is generally stable but with some cracking and mortar loss around stones especially at higher levels which requires repair.</p> <p>Proposed treatment: Re-point areas of cracked and missing mortar - additional grouting of the upper core areas may be required.</p> |

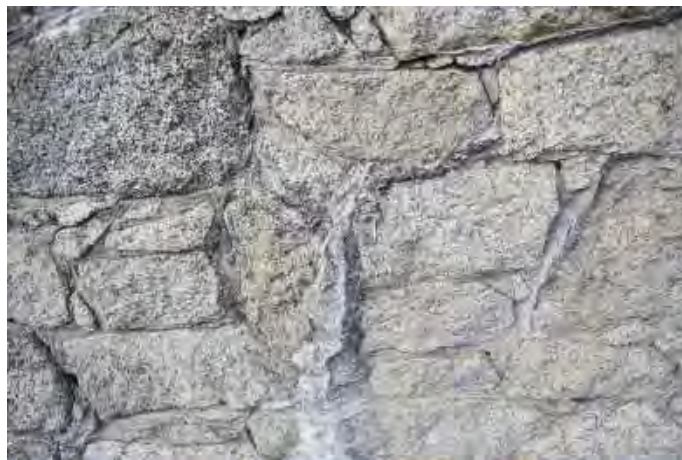
| Location Ref: | RR Elevation – Section 17 |

Coping stones have
been re-pointed.
Mortar loss and
cracking to upper wall.

Vertical crack in wall

| Location Ref: | RR Elevation – Section 17 |
|---|---|
| <p>Condition:</p> | <p>Coping stones to top of wall have been repointed (RR side only). Wall is generally stable but with some cracking and mortar loss around stones especially at higher levels which requires repair.</p> <p>Proposed treatment: Re-point areas of cracked and missing mortar - additional grouting of the upper core areas may be required.</p> |

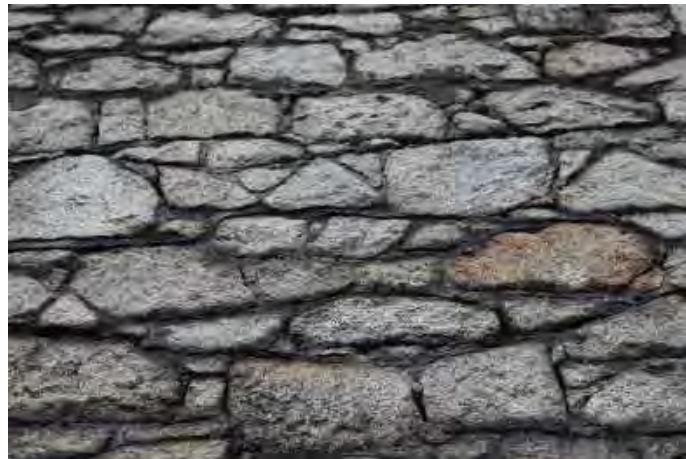
Mortar loss and
cracking to upper wall.

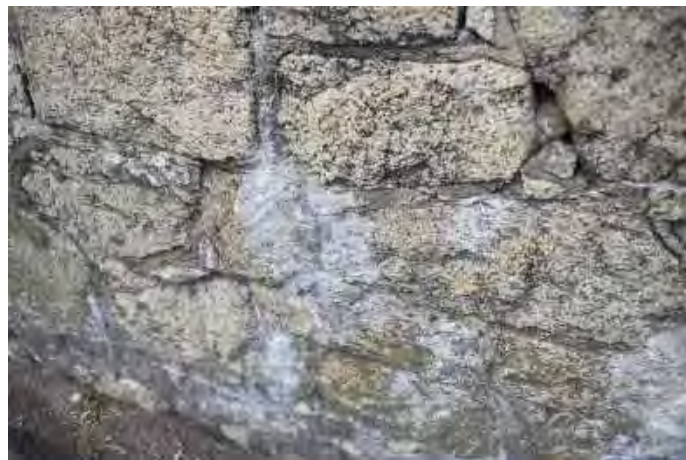
Calcium deposits to
lower wall.

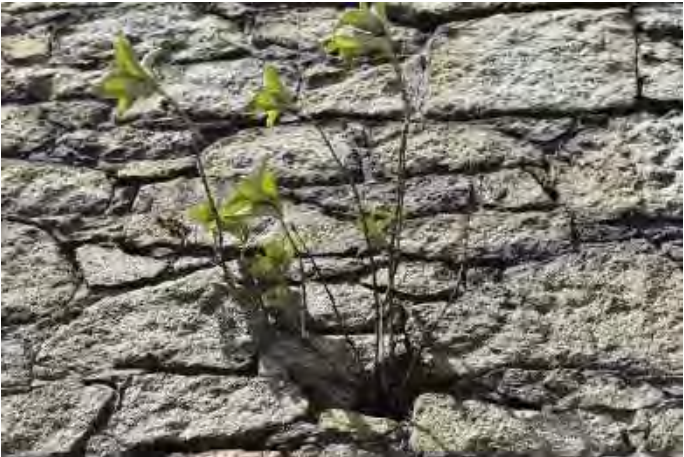
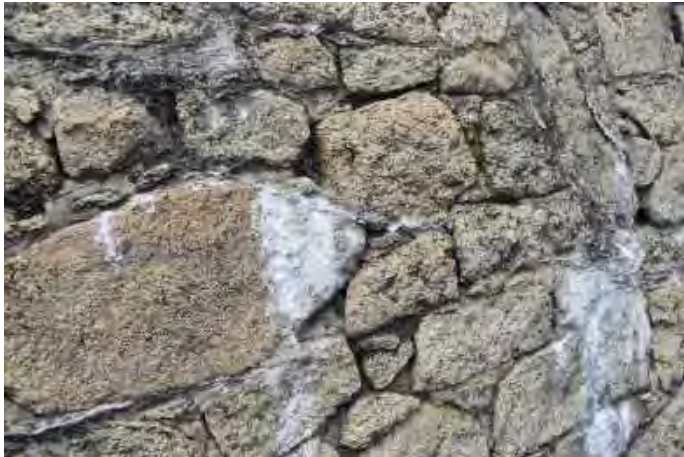
| Location Ref: | RR Elevation – Section 18 |
|---|--|
| <p>Condition:</p> | <p>Coping stones to top of wall have been repointed (RR side only). Wall is generally stable but with some cracking and mortar loss around stones especially at higher levels which requires repair.</p> <p>Proposed treatment: Re-point areas of cracked and missing mortar - additional grouting of the upper core areas may be required. Remove plant growth, treat and mortar repair.</p> |

| <p>Additional notes and photographs:</p> <p>Mortar loss and cracking to upper wall. Vegetation growth in void areas.</p> <p>Calcium deposits to lower wall areas.</p> | <p>9</p> <div data-bbox="644 219 1331 674">A close-up photograph of a stone wall. The stones are irregular and weathered. Several thin, dark stems with small green leaves are growing out of the gaps between the stones.</div> <div data-bbox="644 725 1331 1180">A close-up photograph of a stone wall. The stones are irregular and weathered. There are prominent white, crystalline deposits on the surface of the stones, particularly in the lower half of the image.</div> |

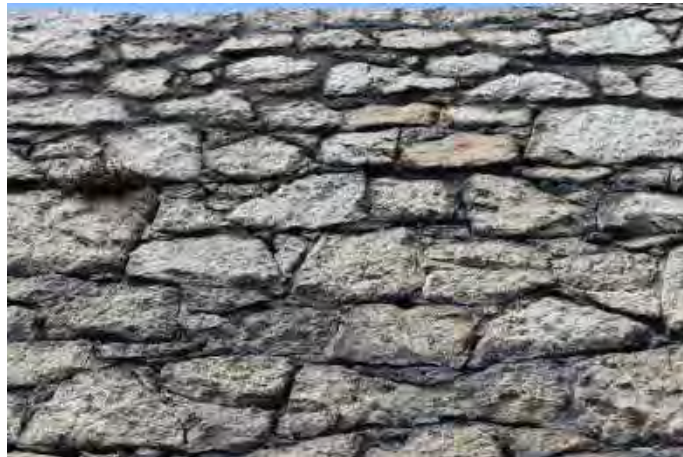
Coping stones have been re-pointed.
Mortar loss and cracking to upper wall.

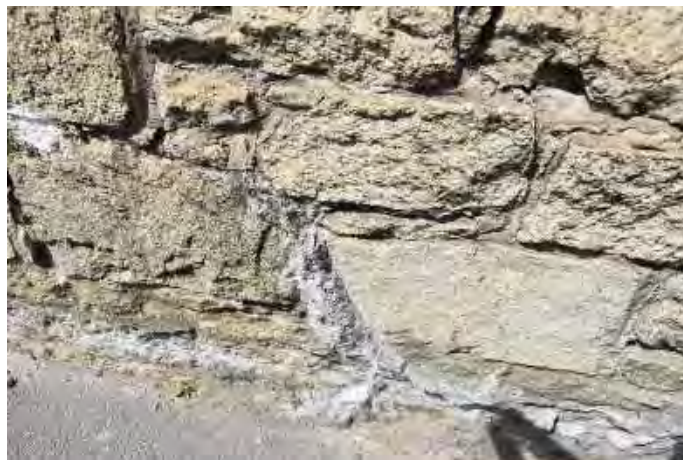
Calcium deposits to lower wall areas.

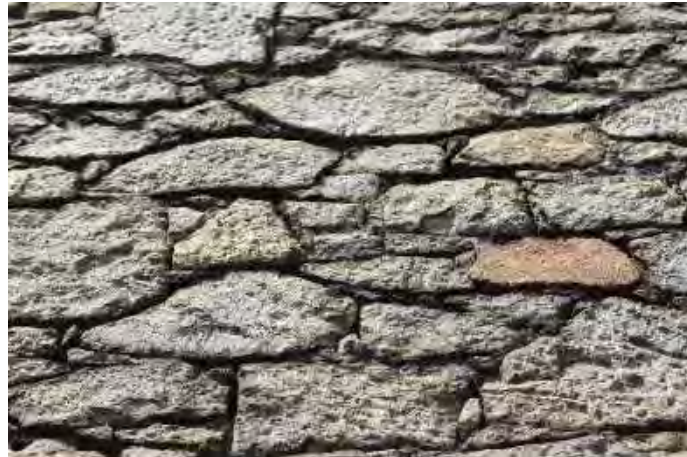
Coping stones have been re-pointed.
Mortar loss and cracking to upper wall.

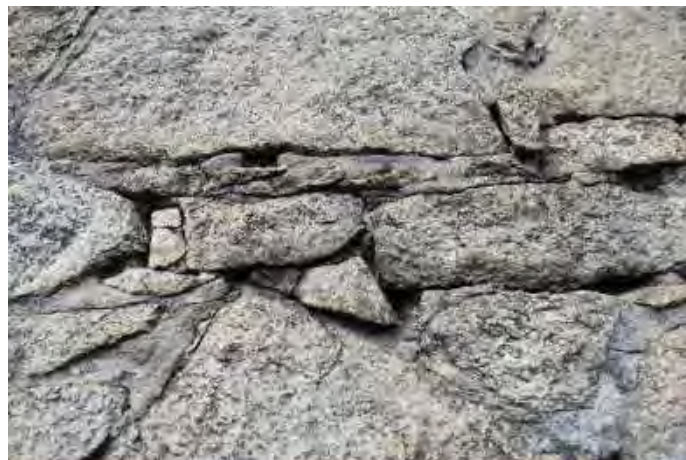
Mortar loss around small stone elements (loose).

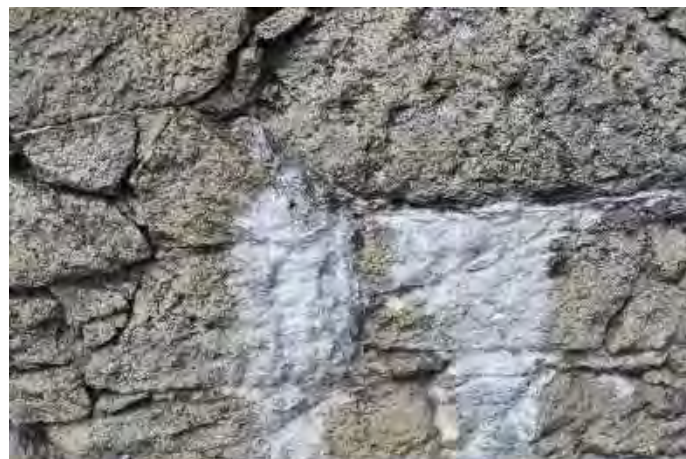
Calcium deposits at low level.

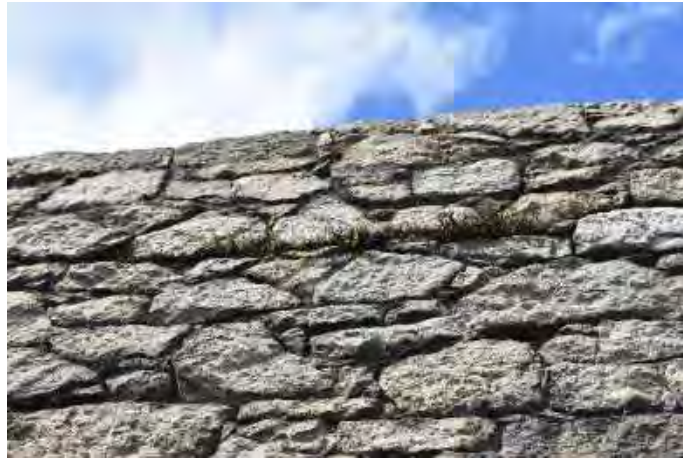
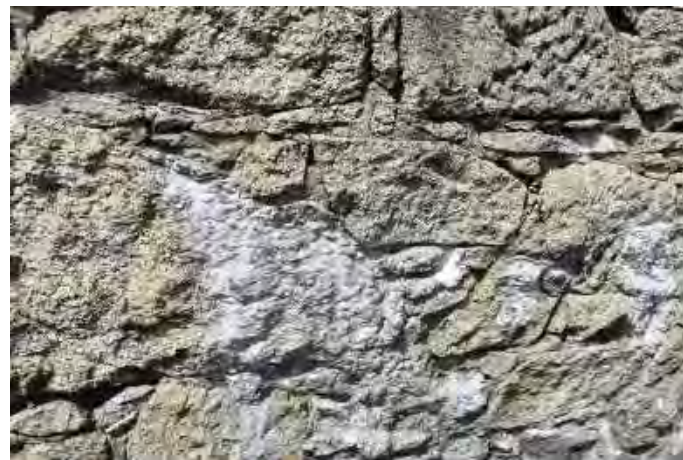
Coping stones have
been re-pointed.
Mortar loss and
cracking to upper wall.

Plant growth in crack.

Calcium deposits at
low level.

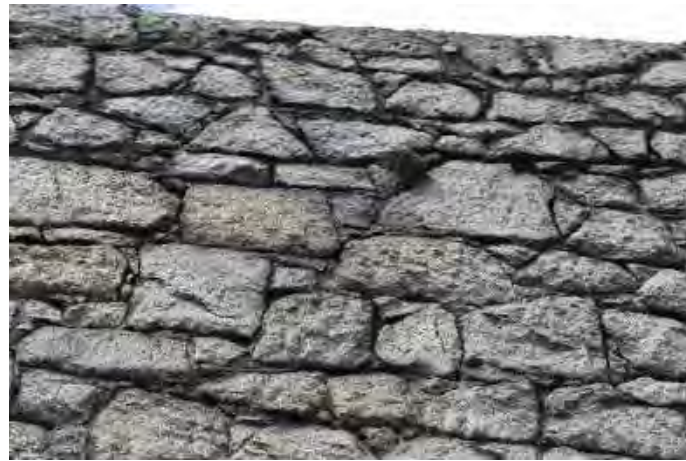
Coping stones have been re-pointed.
Mortar loss and cracking to upper wall.

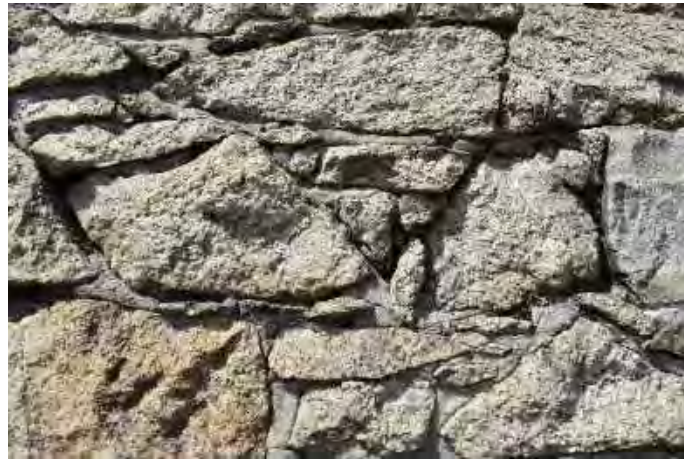
Weathered pointing mortar at mid height on wall.

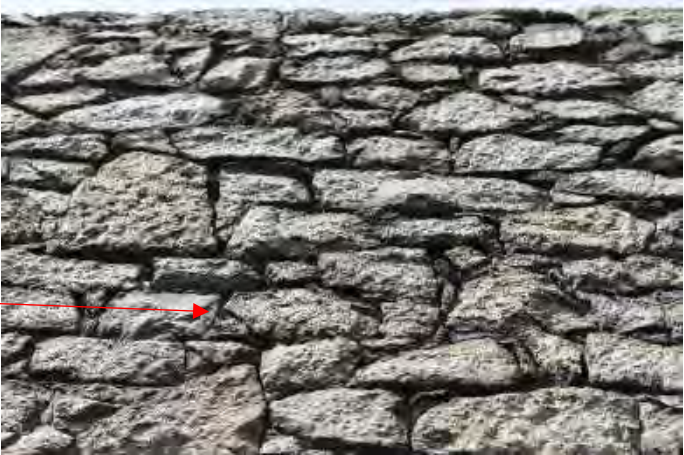
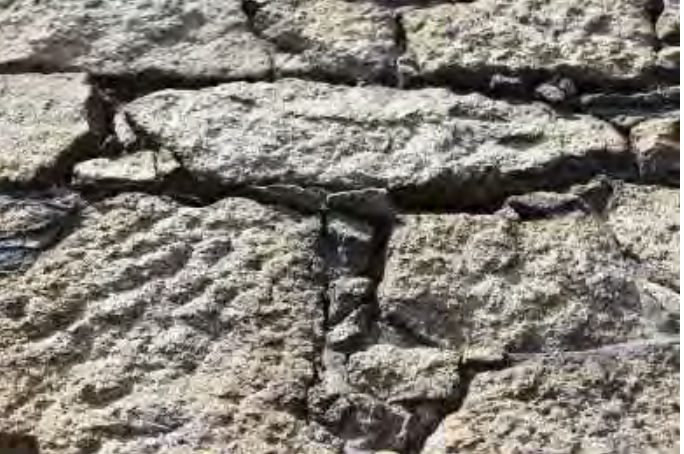
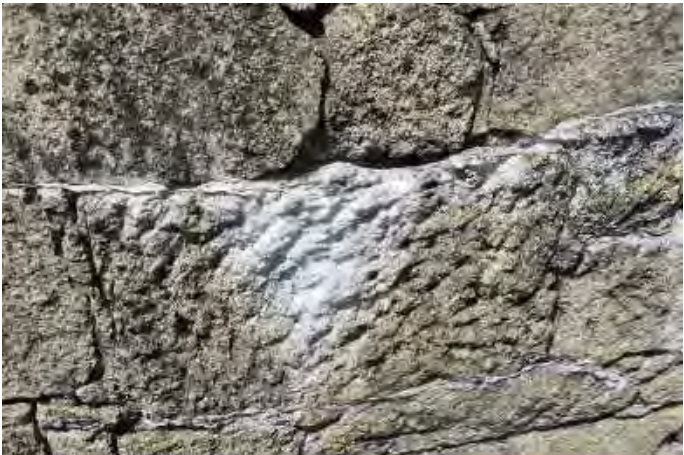
| Location Ref: | RR Elevation – Section 23 |
|---|--|
| <p>Condition:</p> | <p>Coping stones to top of wall have been repointed (RR side only). Wall is generally stable but with some cracking and mortar loss around stones especially at higher levels which requires repair.</p> <p>Proposed treatment: Re-point areas of cracked and missing mortar - additional grouting of the upper core areas may be required.</p> |

| <p>Additional notes and photographs:</p> <p>Coping stones have been re-pointed. Mortar loss and cracking to upper wall.</p> <p>Vertical crack line</p> <p>Loose small stone elements where mortar is missing.</p> <p>Calcium deposits at low level.</p> | |

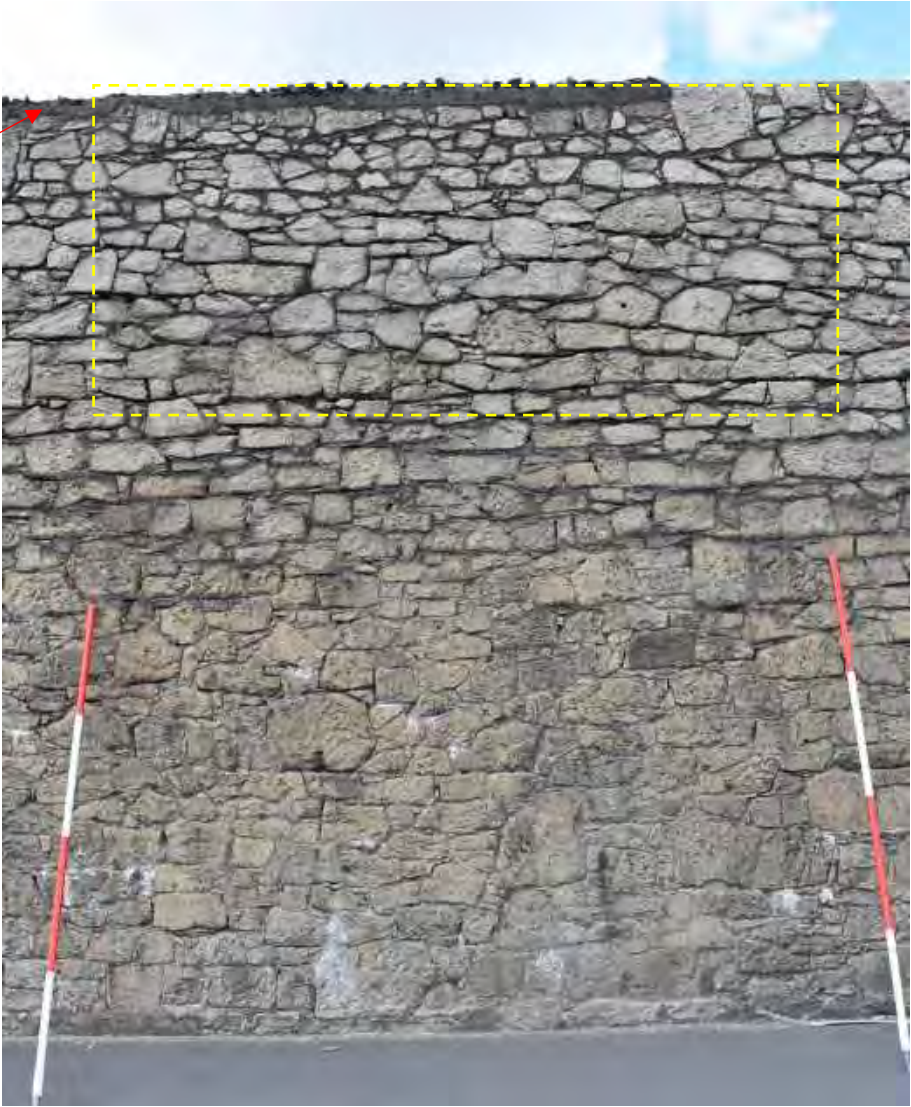
| Location Ref: | RR Elevation – Section 24 |

| Location Ref: | RR Elevation – Section 24 |
|---|--|
| <p>Wall section width approx. 3.0m</p> <p>Render and broken glass to coping. </p> <p>Coping stones have been re-pointed (RR side only).</p> <p>Mortar loss and cracking to upper wall areas.</p> <p>Minor cracking to mortar at lower levels</p> | |
| <p>Condition:</p> | <p>Coping stones to top of wall have been repointed (RR side only). Wall is generally stable but with some cracking and mortar loss around stones especially at higher levels which requires repair.</p> <p>Proposed treatment: Re-point areas of cracked and missing mortar - additional grouting of the upper core areas may be required. Consider removal of upper render and broken glass elements.</p> |

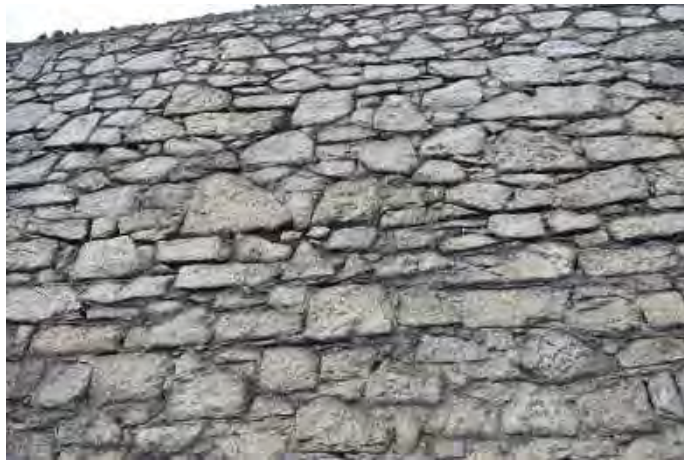
Coping stones have been re-pointed.
Mortar loss and cracking to upper wall.

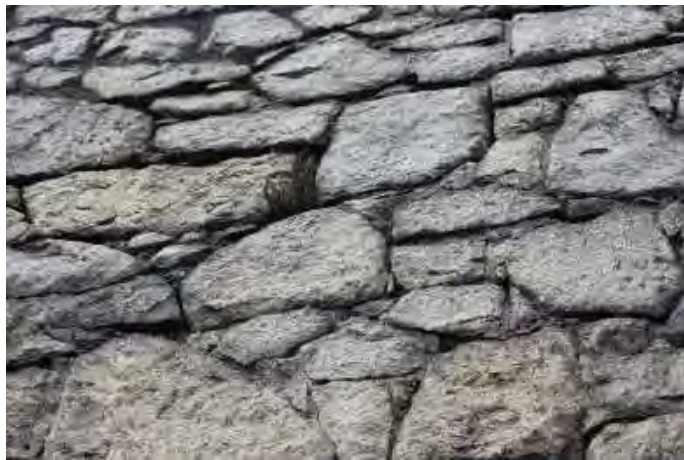
Loose small stones where mortar is missing.

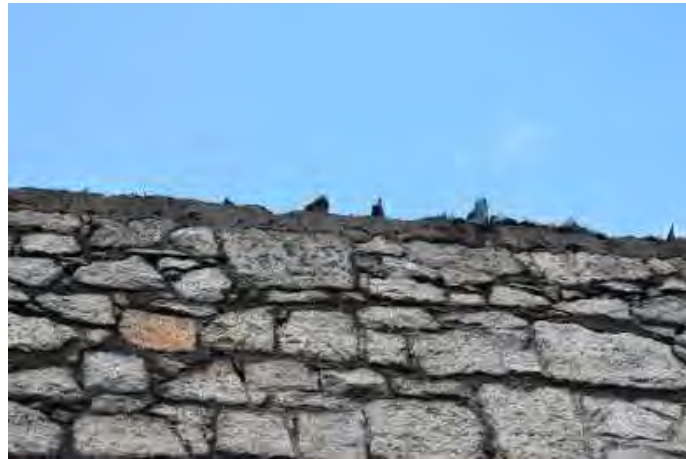
Coping stones have been re-pointed.
Mortar loss and cracking to upper wall.

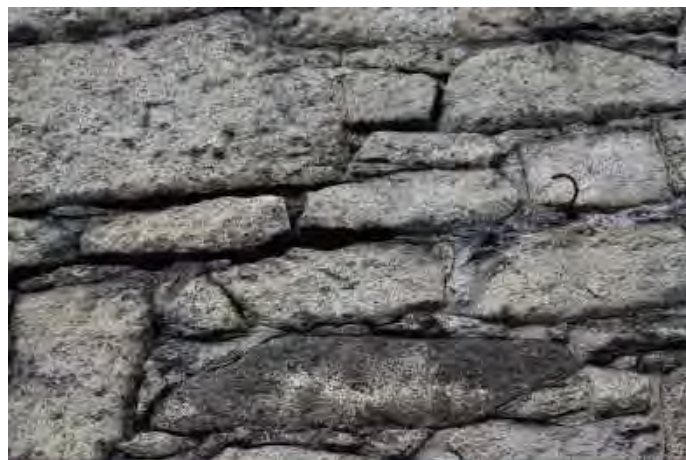
Mortar loss around stones .

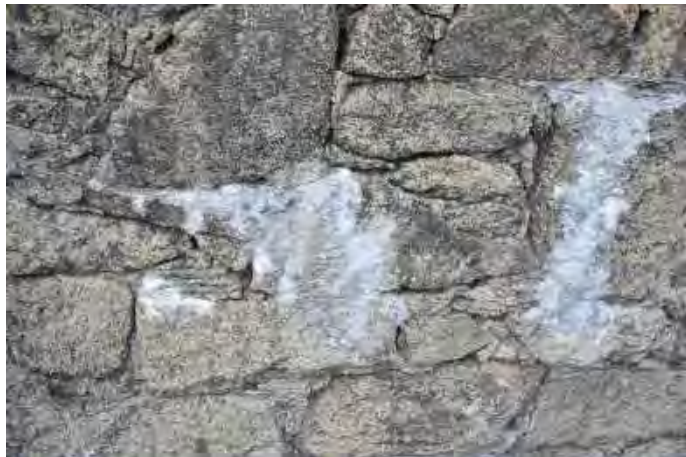
Calcium deposits at low level.

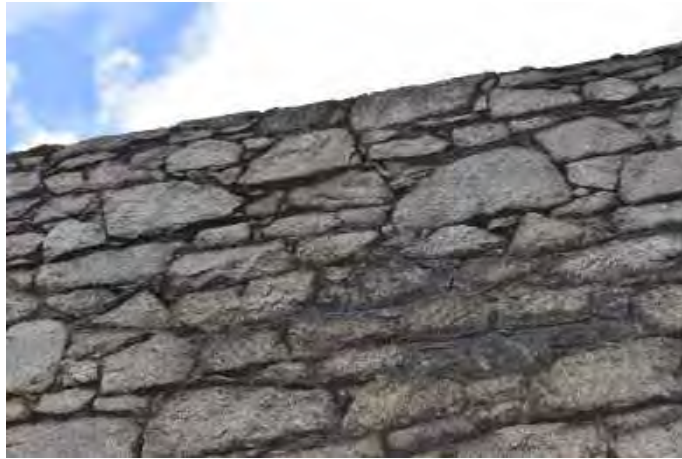
Coping stones have been re-pointed. Mortar loss and cracking to upper wall.

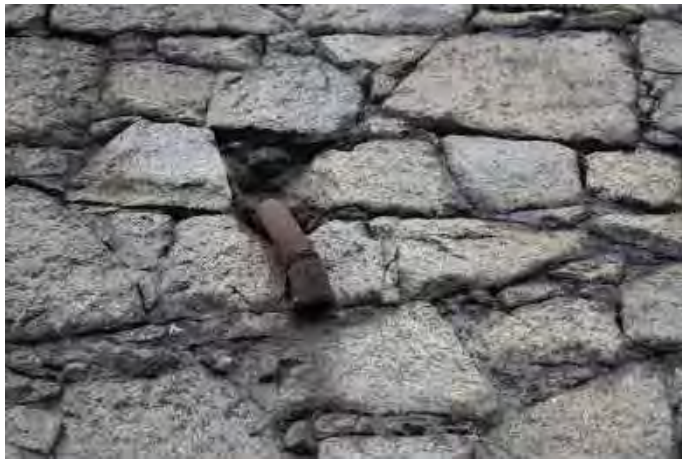
| Location Ref: | RR Elevation – Section 26 |
|--|--|
| <p>Condition:</p> | <p>Coping stones to top of wall have been repointed (RR side only). Wall is generally stable but with some cracking and mortar loss around stones especially at higher levels which requires repair.</p> <p>Proposed treatment: Re-point areas of cracked and missing mortar - additional grouting of the upper core areas may be required. Remove conduit and repair void.</p> |

Remains of conduit in wall.

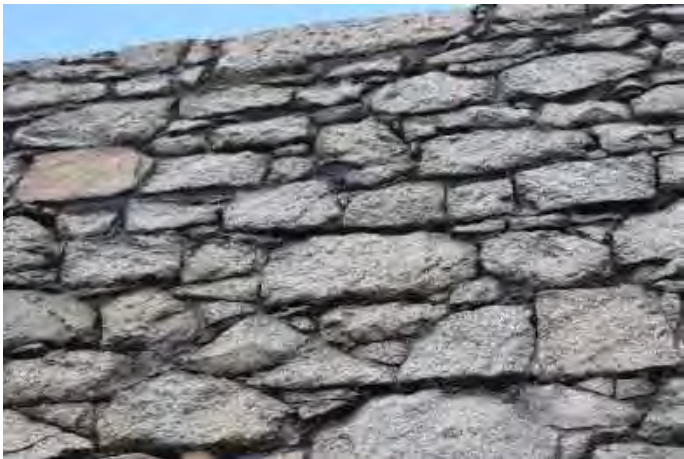
Coping stones have been re-pointed.
Mortar loss and cracking to upper wall.

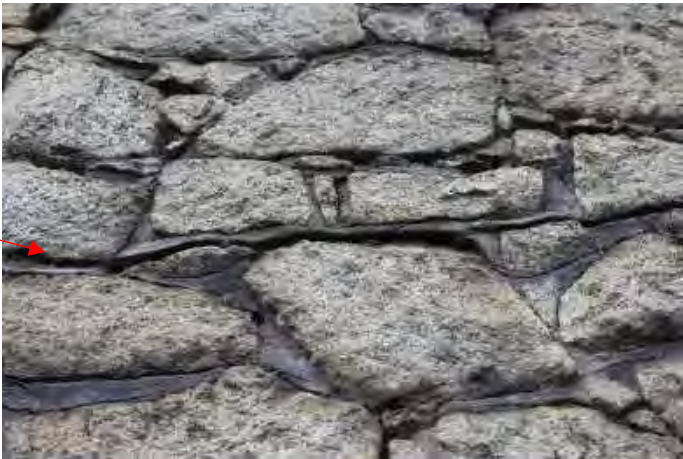
Crack line

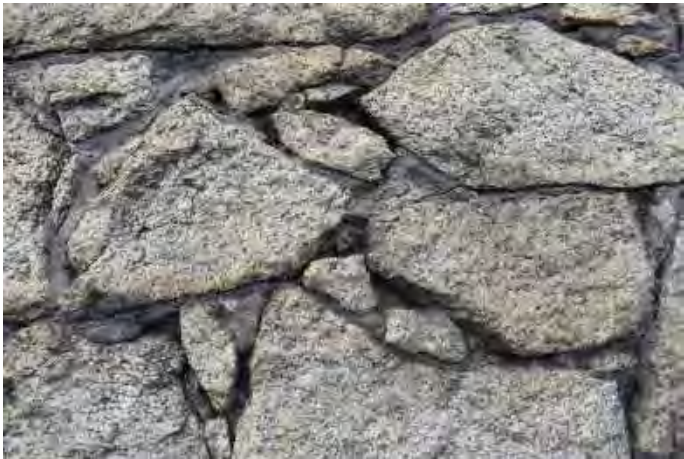
Mortar loss around stones.

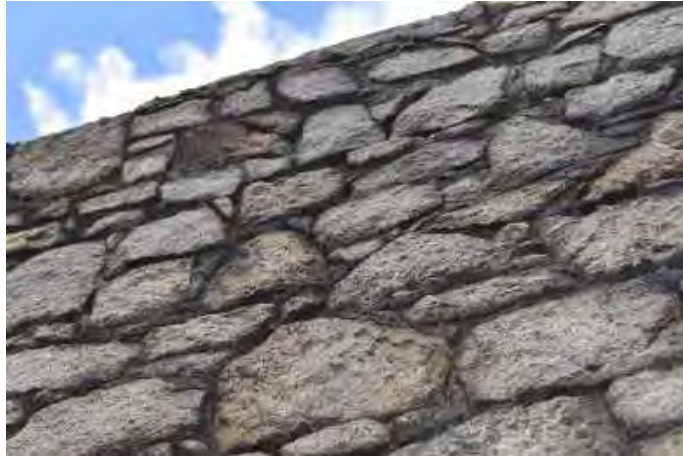
Coping stones have been re-pointed. Mortar loss and cracking to upper wall.

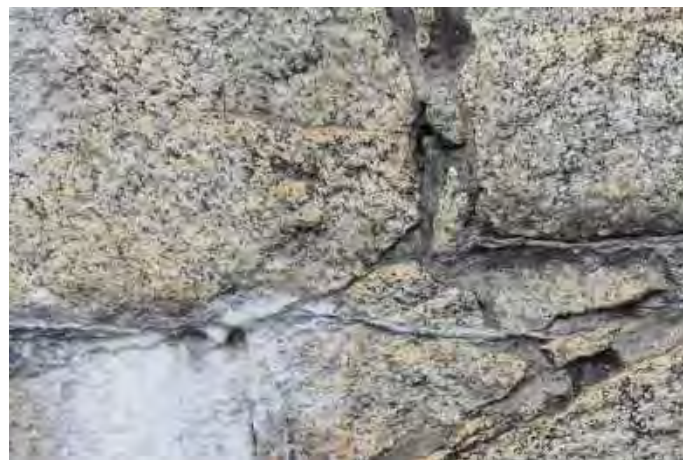
Calcium deposits at low level.

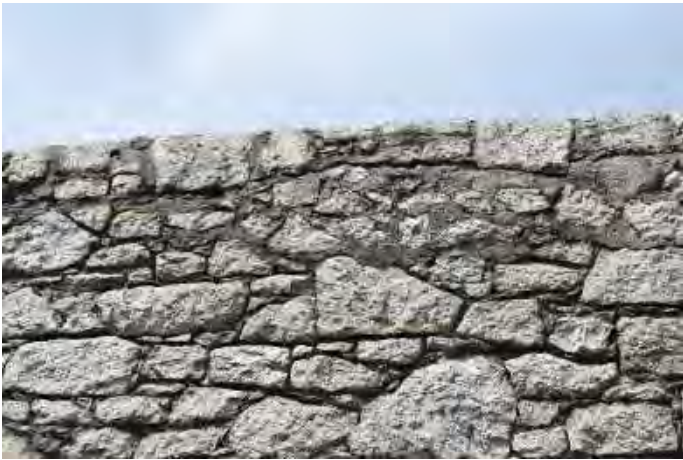
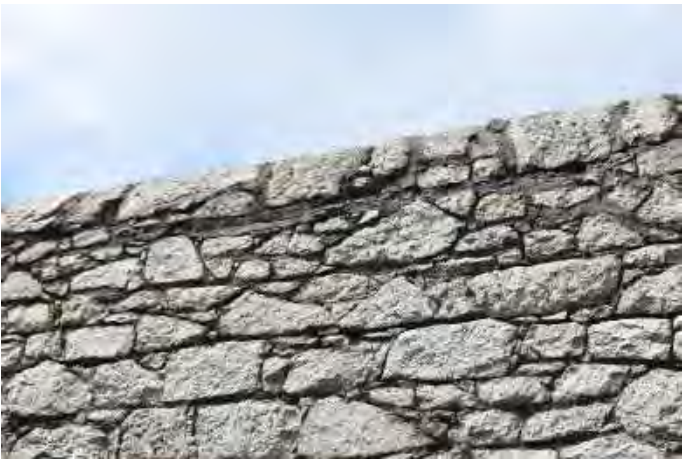
| Location Ref: | RR Elevation – Section 29 |
|--|---|
| <p>Wall section width approx. 3.0m</p> <p>Coping stones have been re-pointed (RR side only).</p> <p>Large crack to underside of the coping stones.</p> <p>Mortar loss and cracking to upper wall areas.</p> <p>Minor cracking to mortar at lower levels.</p> | |

| <p>Additional notes and photographs:</p> <p>Coping stones have been re-pointed. Mortar loss and cracking to upper wall.</p> <p>Crack to underside of the coping stones.</p> <p>Crack to underside of coping stones.</p> | |

| Location Ref: | RR Elevation – Section 29 |
|--|---|
| <p>Condition:</p> | <p>Coping stones to top of wall have been repointed (RR side only). Wall is generally stable but with some cracking and mortar loss around stones especially at higher levels which requires repair.</p> <p>Proposed treatment: Large crack under coping stones – mortar fill. Re-point areas of cracked and missing mortar - additional grouting of the upper core areas may be required.</p> |

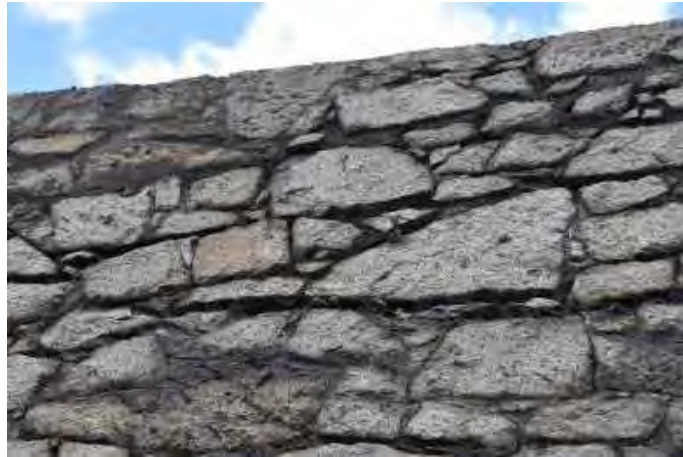
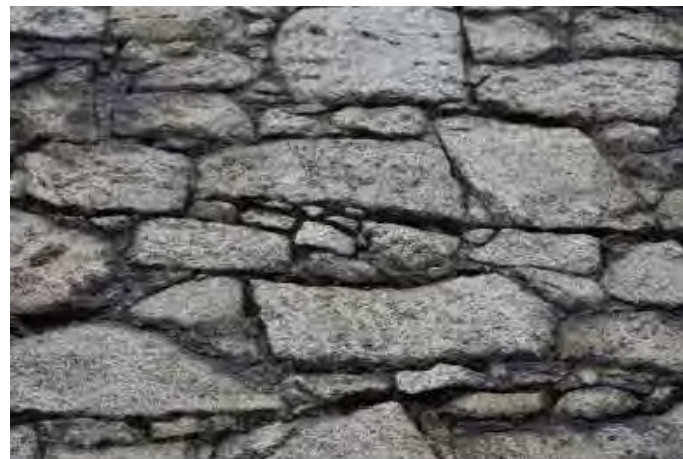
| Location Ref: | RR Elevation – Section 30 |
|---|--|
| <p>Wall section width approx. 3.0m</p> <p>Coping stones have been re-pointed (RR side only).</p> <p>Significant cracking to underside of the coping stones.</p> <p>Mortar loss and cracking to upper wall areas.</p> <p>Minor cracking to mortar at lower levels.</p> | |

Coping stones have been re-pointed.
Mortar loss and cracking to upper wall.

Significant cracking of upper stonework.

Mortar loss around small stones.

| Location Ref: | RR Elevation – Section 30 |
|---|--|
| <p>Condition:</p> | <p>Coping stones to top of wall have been repointed (RR side only). Wall is generally stable but with some cracking and mortar loss around stones especially at higher levels which requires repair.</p> <p>Proposed treatment: Re-point areas of cracked and missing mortar - additional grouting of the upper core areas may be required.</p> |

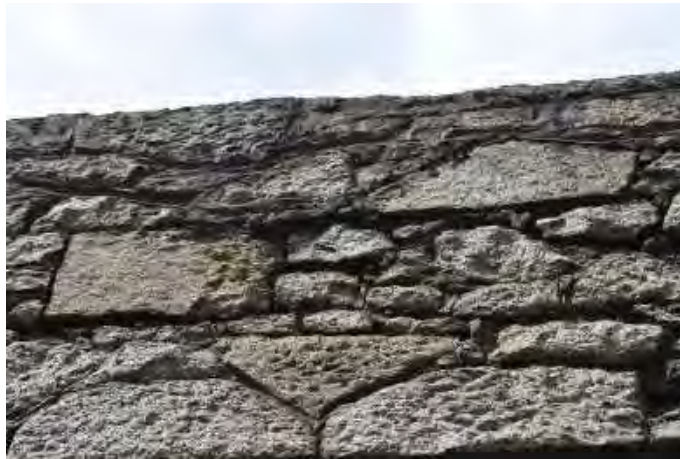
Coping stones have been re-pointed. Mortar loss and cracking to upper wall.

| Location Ref: | RR Elevation – Section 31 |
|--|--|
| <p>Condition:</p> | <p>Coping stones to top of wall have been repointed (RR side only). Wall is generally stable but with some cracking and mortar loss around stones especially at higher levels which requires repair.</p> <p>Proposed treatment: Re-point areas of cracked and missing mortar - additional grouting of the upper core areas may be required.</p> |

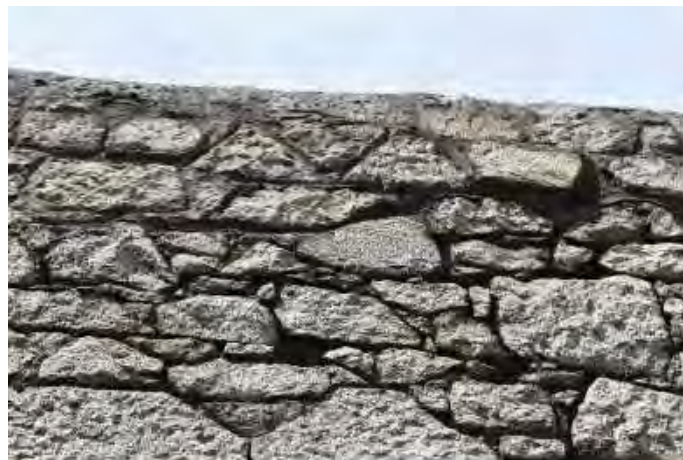
Area of repointed coping. Mortar loss and cracking of stonework below.

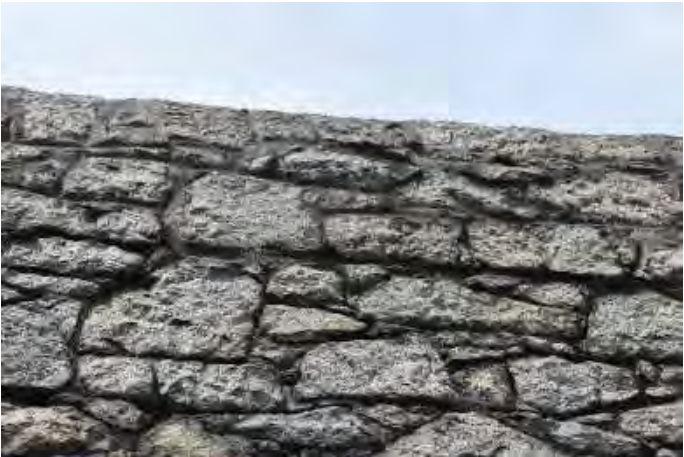
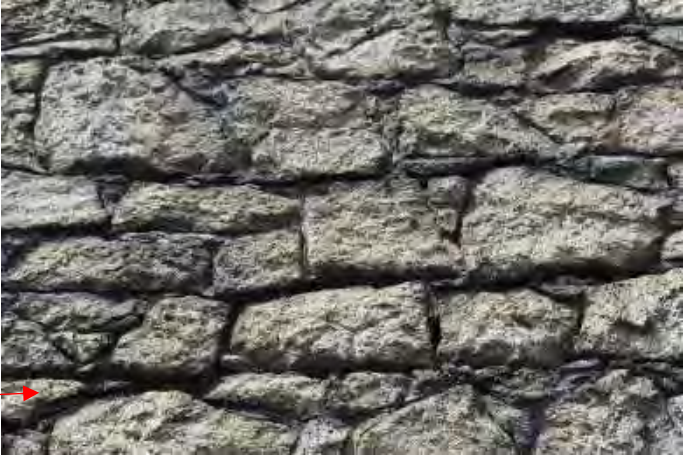
| Location Ref: | RR Elevation – Section 32 |
|---|---|
| <p>Wall section width approx. 3.0m</p> <p>Coping stones have been re-pointed (RR side only).</p> <p>Crack</p> <p>Mortar loss and cracking to upper wall areas.</p> <p>Minor cracking to mortar at lower levels.</p> | <p>The photograph shows a close-up of a stone wall. A yellow dashed rectangular box is drawn around the upper portion of the wall, from the top coping stones down to about two-thirds of the way up. A red arrow points from the text 'Crack' to a vertical crack in the mortar between stones in the upper part of the wall. The wall is made of irregular, greyish-brown stones. To the right, a stone plaque with the letters 'BRAMI' is visible. Two surveying poles with red and white stripes are positioned at the base of the wall for scale. The ground in front of the wall is a light grey concrete or asphalt surface.</p> |

| <p>Additional notes and photographs:</p> <p>Coping stones have been re-pointed. Mortar loss and cracking to upper wall.</p> <p>Crack</p> | |

| Location Ref: | RR Elevation – Section 32 |
|---|---|
| <p>Condition:</p> | <p>Coping stones to top of wall have been repointed (RR side only). Wall is generally stable but with some cracking and mortar loss around stones especially at higher levels which requires repair.</p> <p>Proposed treatment:</p> <p>Re-point areas of cracked and missing mortar - additional grouting of the upper core areas may be required.</p> |
