| Location Ref: | BMD Elevation – Section 44 |

| Location Ref: | RR Elevation – Section 01 |

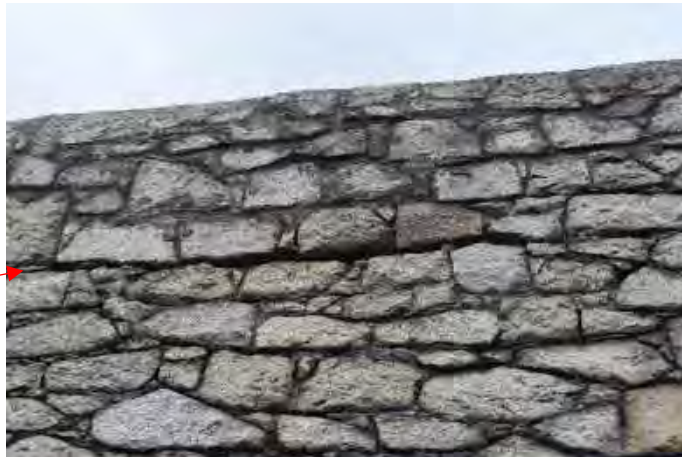
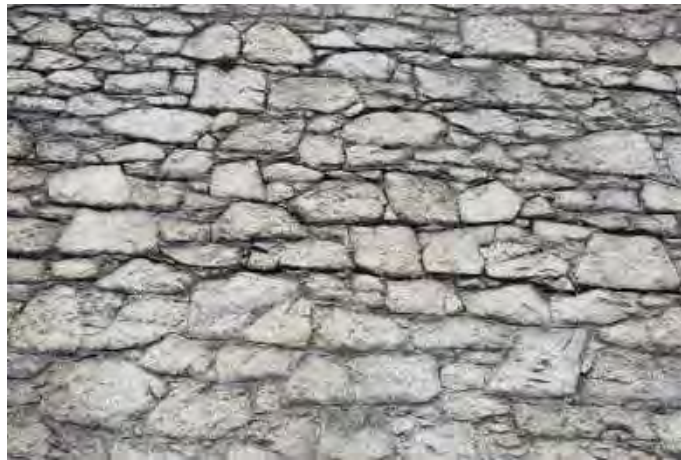
| Location Ref: | RR Elevation – Section 33 |
|--|---|
| <p>Wall section width approx. 3.0m</p> <p>Coping stones have been re-pointed (RR side only).</p> <p>Cracks</p> <p>Mortar loss and cracking to upper wall areas.</p> <p>Minor cracking to mortar at lower levels.</p> | |

Coping stones have
been re-pointed.
Mortar loss and
cracking to upper wall.

Large crack / mortar
loss.

| Location Ref: | RR Elevation – Section 33 |
|--|---|
| <p>Condition:</p> | <p>Coping stones to top of wall have been repointed (RR side only). Wall is generally stable but with some cracking and mortar loss around stones especially at higher levels which requires repair.</p> <p>Proposed treatment:</p> <p>Re-point areas of cracked and missing mortar - additional grouting of the upper core areas may be required.</p> |

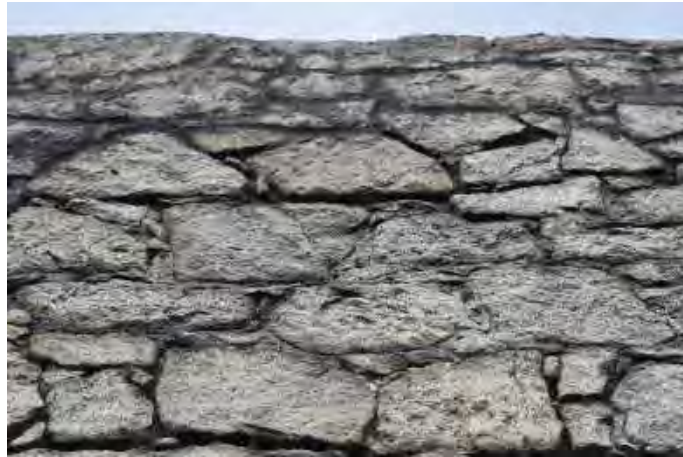
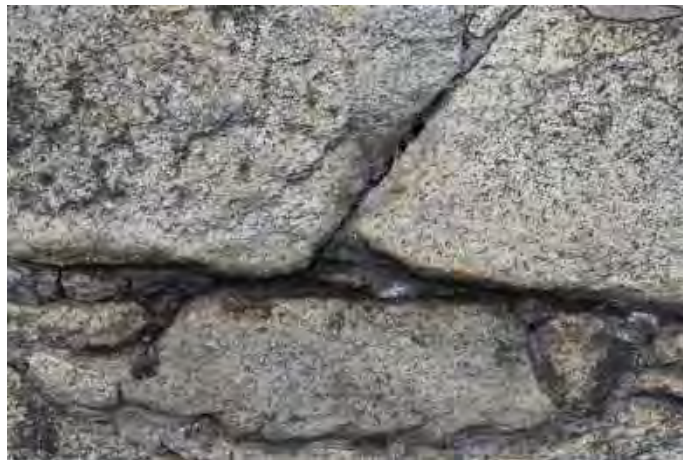
Coping stones have
been re-pointed.
Mortar loss and
cracking to upper wall.

| Location Ref: | RR Elevation – Section 34 |
|--|--|
| <p>Condition:</p> | <p>Coping stones to top of wall have been repointed (RR side only). Wall is generally stable but with some cracking and mortar loss around stones especially at higher levels which requires repair.</p> <p>Proposed treatment: Re-point areas of cracked and missing mortar - additional grouting of the upper core areas may be required.</p> |

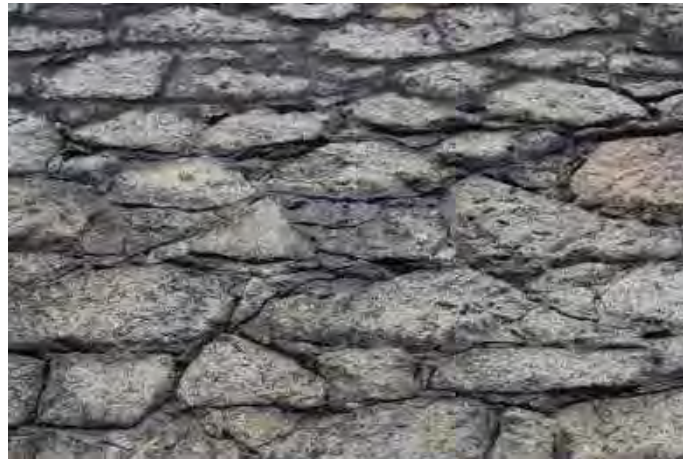
Coping stones have been re-pointed.
Mortar loss and cracking to upper wall.

| Location Ref: | RR Elevation – Section 35 |
|---|---|
| <p>Condition:</p> | <p>Coping stones to top of wall have been repointed (RR side only). Wall is generally stable but with some cracking and mortar loss around stones especially at higher levels which requires repair.</p> <p>Proposed treatment: Re-point areas of cracked and missing mortar - additional grouting of the upper core areas may be required. Remove sign and fixings – make good.</p> |

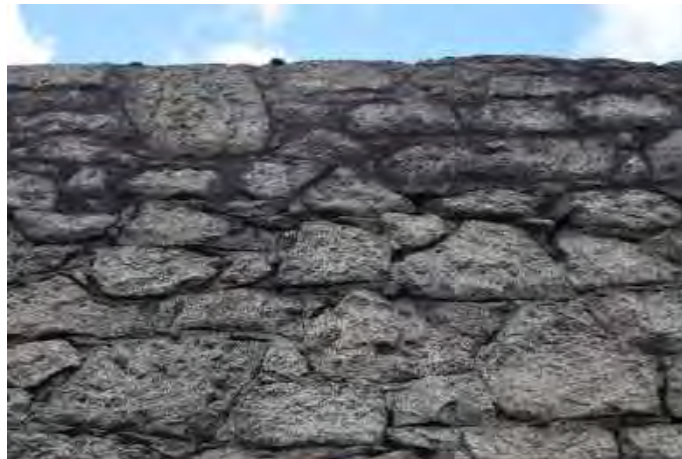
Coping stones have
been re-pointed.
Mortar loss and
cracking to upper wall.

| Location Ref: | RR Elevation – Section 36 |
|---|--|
| <p>Condition:</p> | <p>Coping stones to top of wall have been repointed (RR side only). Wall is generally stable but with some cracking and mortar loss around stones especially at higher levels which requires repair.</p> <p>Proposed treatment: Re-point areas of cracked and missing mortar - additional grouting of the upper core areas may be required.</p> |

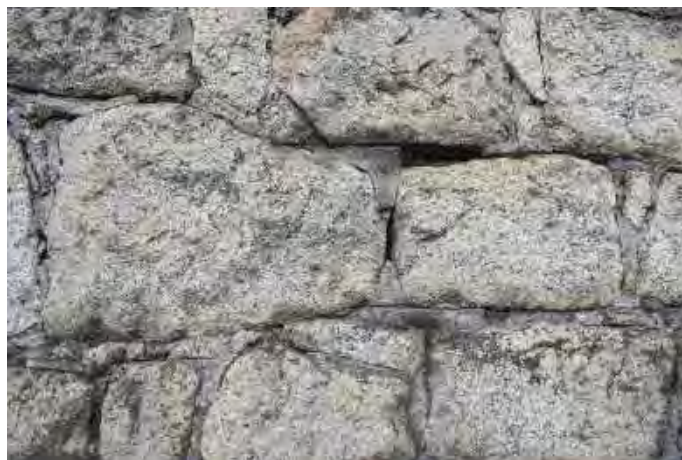
Mortar loss at mid
height.

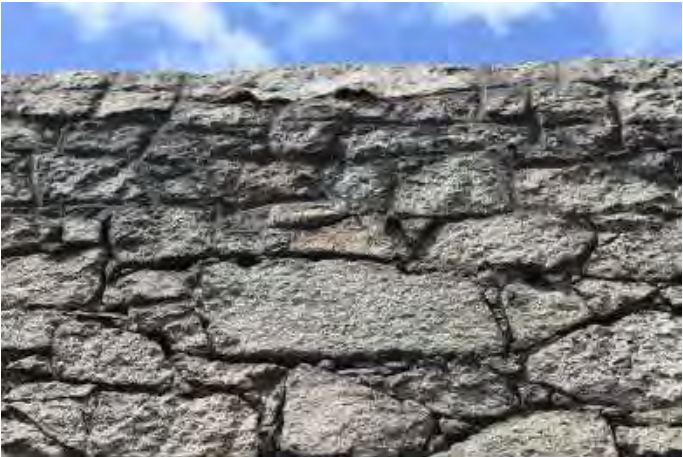
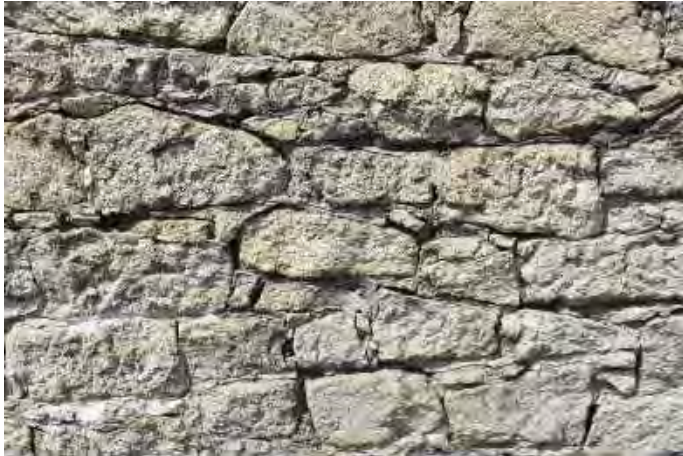
| <p>Additional notes and photographs:</p> <p>Coping stones have been re-pointed. Mortar loss and cracking to upper wall.</p> <p>Cracking at low level.</p> | |

| Location Ref: | RR Elevation – Section 37 |
|---|--|
| <p>Condition:</p> | <p>Coping stones to top of wall have been repointed (RR side only). Wall is generally stable but with some cracking and mortar loss around stones especially at higher levels which requires repair.</p> <p>Proposed treatment: Re-point areas of cracked and missing mortar - additional grouting of the upper core areas may be required.</p> |

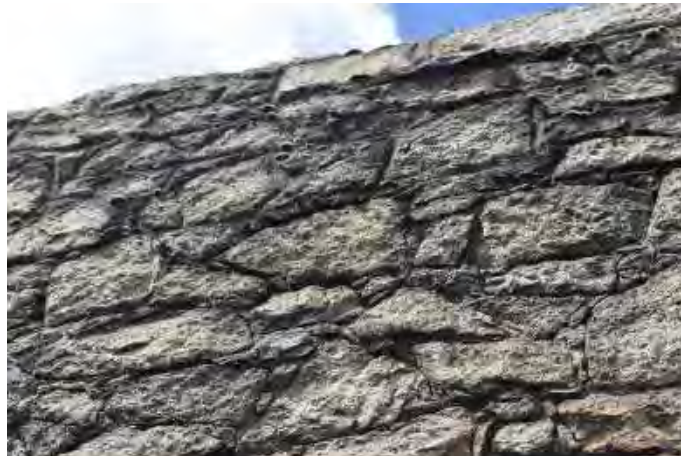
Coping stones have
been re-pointed.
Mortar loss and
cracking to upper wall.

| Location Ref: | RR Elevation – Section 38 |
|---|--|
| <p>Condition:</p> | <p>Coping stones to top of wall have been repointed (RR side only). Wall is generally stable but with some cracking and mortar loss around stones especially at higher levels which requires repair.</p> <p>Proposed treatment: Re-point areas of cracked and missing mortar - additional grouting of the upper core areas may be required.</p> |

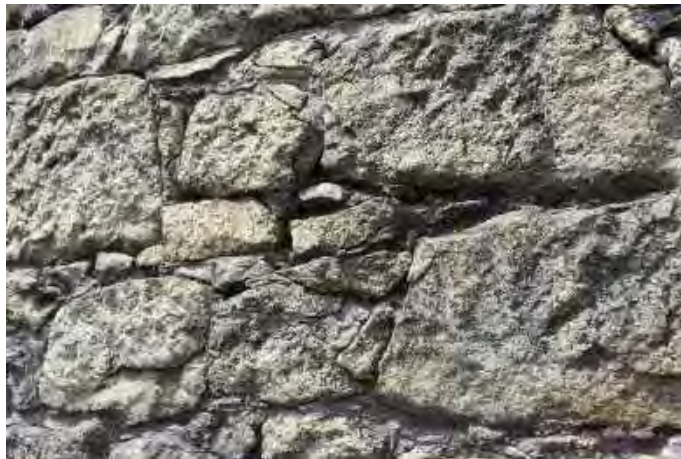
Loose small stone
elements.

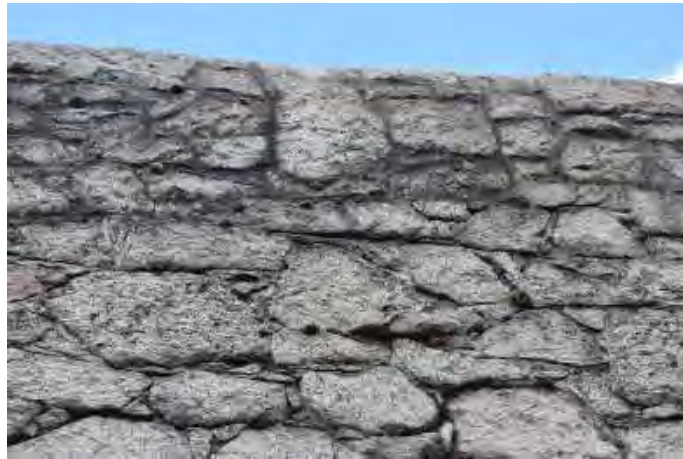
Coping stones have
been re-pointed.
Mortar loss and
cracking to upper wall.

| Location Ref: | RR Elevation – Section 39 |
|---|--|
| <p>Condition:</p> | <p>Coping stones to top of wall have been repointed (RR side only). Wall is generally stable but with some cracking and mortar loss around stones especially at higher levels which requires repair.</p> <p>Proposed treatment: Re-point areas of cracked and missing mortar - additional grouting of the upper core areas may be required.</p> |

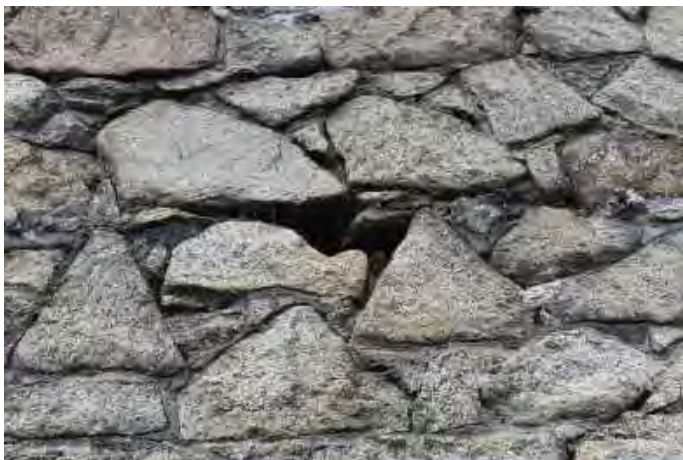
Missing stone from
upper wall.

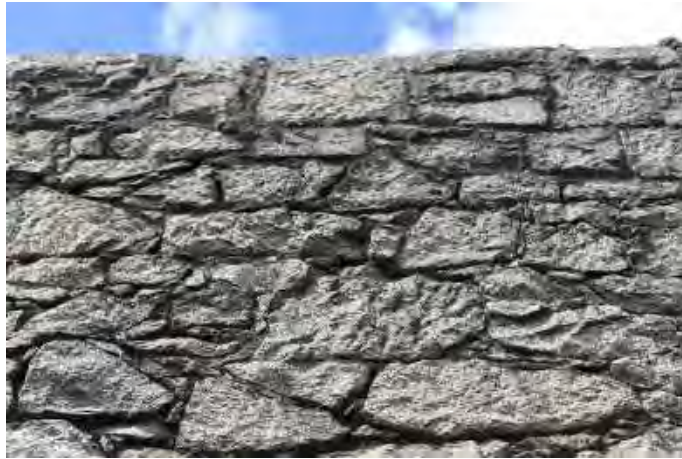
Coping stones have been re-pointed.
Mortar loss and cracking to upper wall.

| Location Ref: | RR Elevation – Section 40 |
|---|--|
| <p>Condition:</p> | <p>Coping stones to top of wall have been repointed (RR side only). Wall is generally stable but with some cracking and mortar loss around stones especially at higher levels which requires repair.</p> <p>Proposed treatment: Re-point areas of cracked and missing mortar - additional grouting of the upper core areas may be required.</p> |

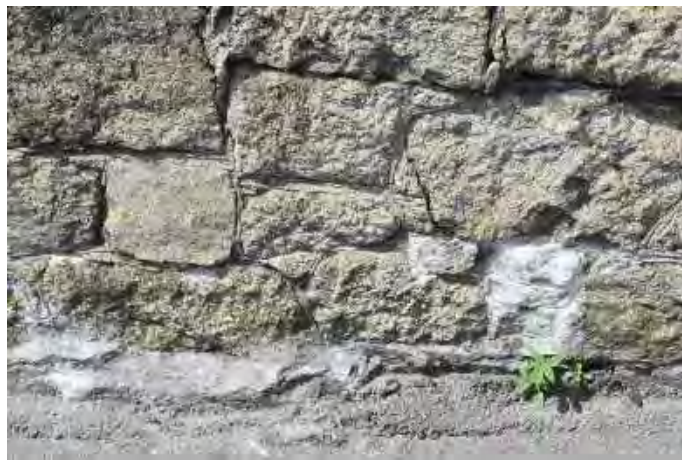
Calcium deposits at low level.

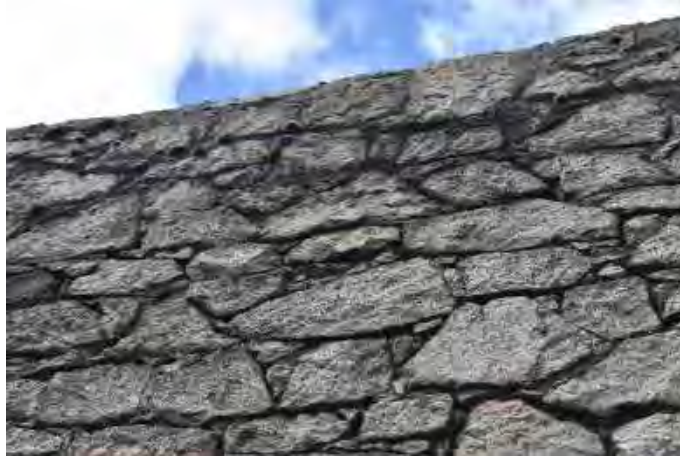
Coping stones have been re-pointed. Mortar loss and cracking to upper wall.

| Location Ref: | RR Elevation – Section 41 |
|---|--|
| <p>Condition:</p> | <p>Coping stones to top of wall have been repointed (RR side only). Wall is generally stable but with some cracking and mortar loss around stones especially at higher levels which requires repair.</p> <p>Proposed treatment: Re-point areas of cracked and missing mortar - additional grouting of the upper core areas may be required.</p> <p>Consider removal of stains as part of agreed cleaning strategy.</p> |

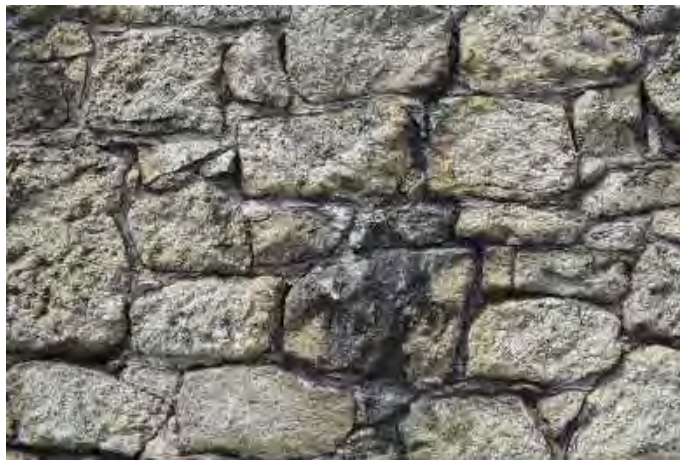
Calcium and staining to face of stonework.

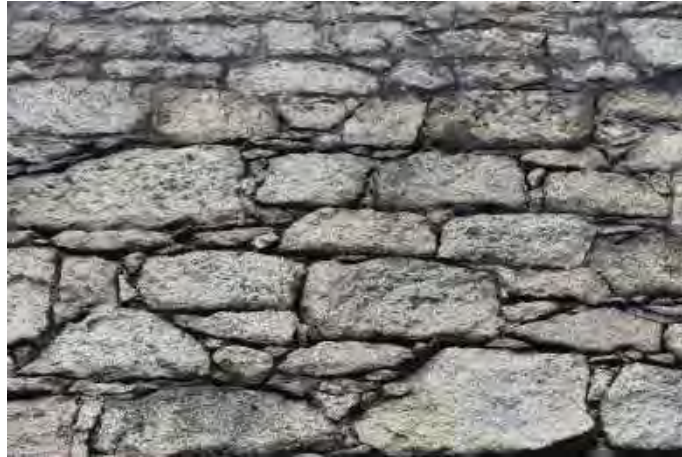
Coping stones have been re-pointed.
Mortar loss and cracking to upper wall.

| Location Ref: | RR Elevation – Section 42 |
|---|--|
| <p>Condition:</p> | <p>Coping stones to top of wall have been repointed (RR side only). Wall is generally stable but with some cracking and mortar loss around stones especially at higher levels which requires repair.</p> <p>Proposed treatment: Re-point areas of cracked and missing mortar - additional grouting of the upper core areas may be required.</p> |

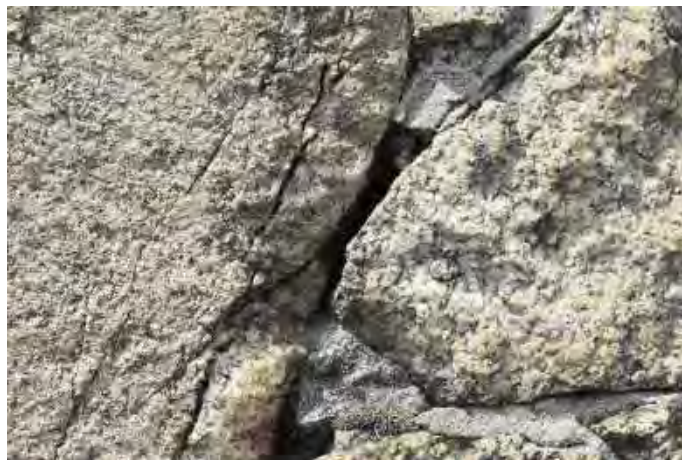
Cracking and mortar loss.

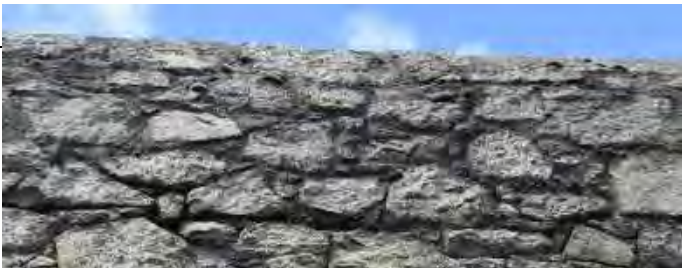
Coping stones have been re-pointed.
Mortar loss and cracking to upper wall.

| Location Ref: | RR Elevation – Section 43 |
|---|--|
| <p>Condition:</p> | <p>Coping stones to top of wall have been repointed (RR side only). Wall is generally stable but with some cracking and mortar loss around stones especially at higher levels which requires repair.</p> <p>Proposed treatment: Re-point areas of cracked and missing mortar - additional grouting of the upper core areas may be required. Repair hole through wall.</p> |

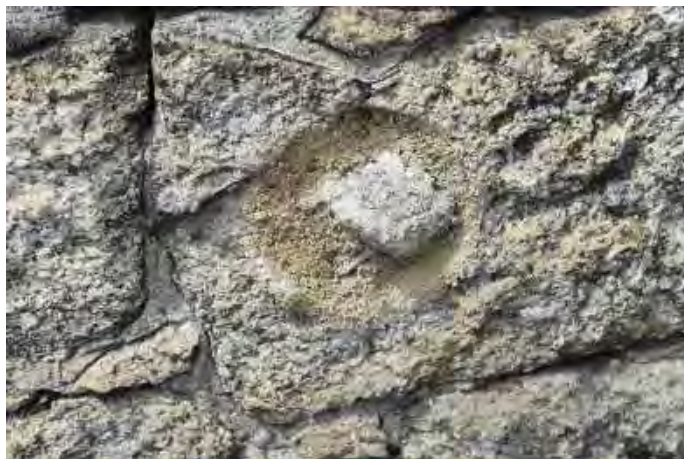
Previous core hole through wall.

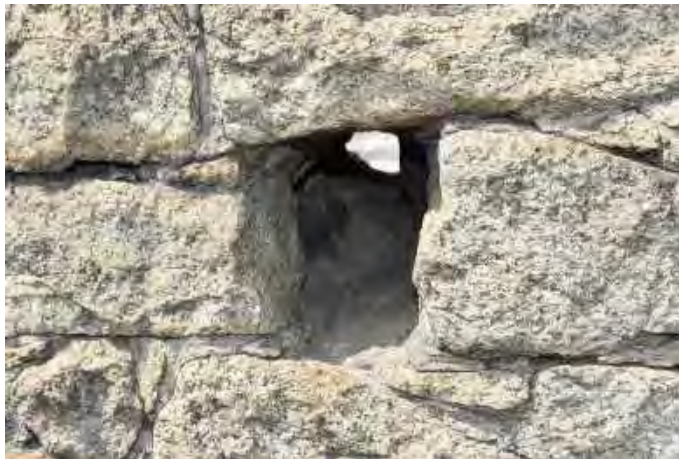
Hole through wall.

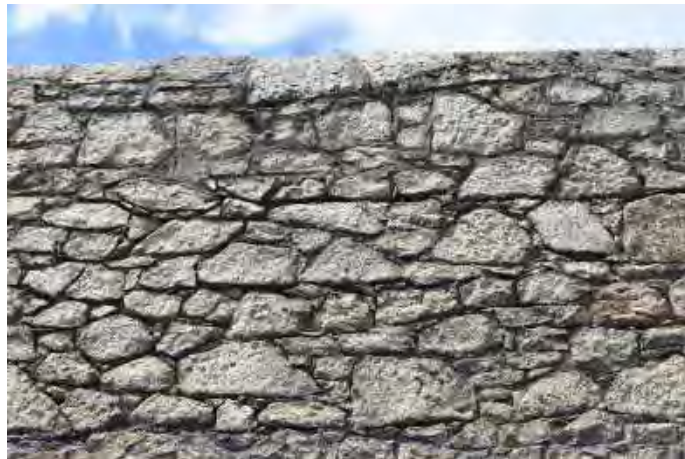
Coping stones have been re-pointed.
Mortar loss and cracking to upper wall.

| Location Ref: | RR Elevation – Section 44 |
|---|---|
| <p>Condition:</p> | <p>Coping stones to top of wall have been repointed (RR side only). Wall is generally stable but with some cracking and mortar loss around stones especially at higher levels which requires repair.</p> <p>Proposed treatment:</p> <p>Re-point areas of cracked and missing mortar - additional grouting of the upper core areas may be required.</p> |

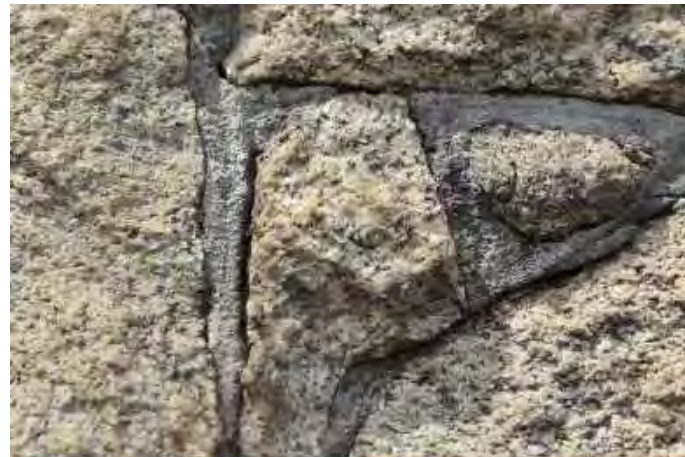
Cracking around stones – mid level.

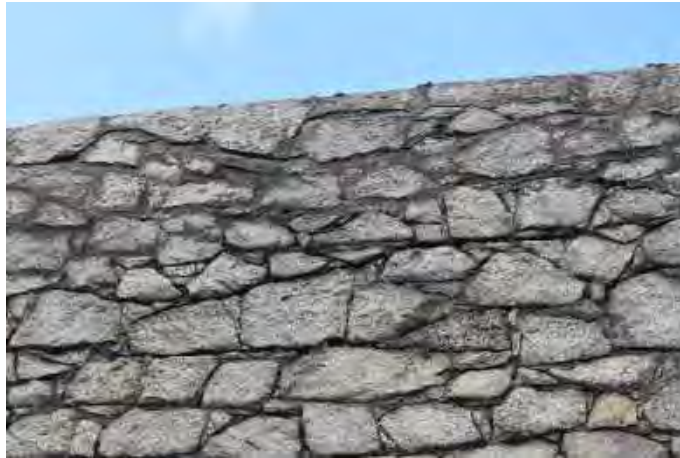
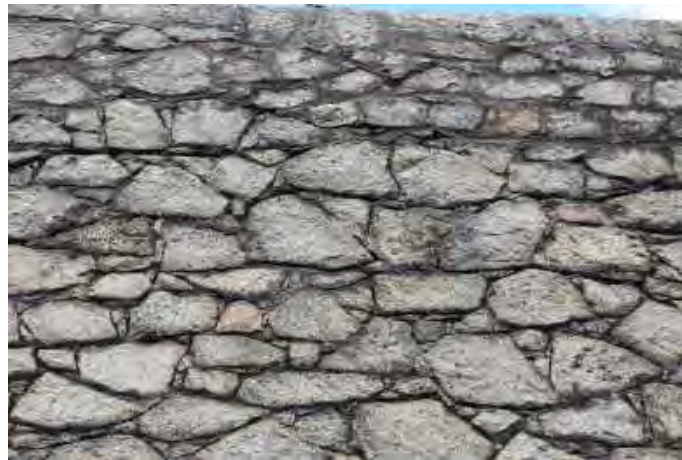
Coping stones have been re-pointed. Mortar loss and cracking to upper wall.

Cracking below coping stones.

| Location Ref: | RR Elevation – Section 45 |
|---|--|
| <p>Condition:</p> | <p>Coping stones to top of wall have been repointed (RR side only). Wall is generally stable but with some cracking and mortar loss around stones especially at higher levels which requires repair.</p> <p>Proposed treatment: Re-point areas of cracked and missing mortar - additional grouting of the upper core areas may be required.</p> |

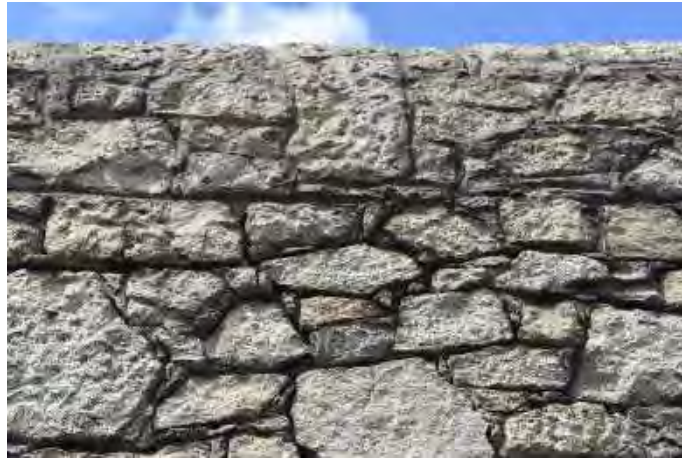
Coping stones have been re-pointed.
Mortar loss and cracking to upper wall.

| Location Ref: | RR Elevation – Section 46 |
|---|--|
| <p>Condition:</p> | <p>Coping stones to top of wall have been repointed (RR side only). Wall is generally stable but with some cracking and mortar loss around stones especially at higher levels which requires repair.</p> <p>Proposed treatment: Re-point areas of cracked and missing mortar - additional grouting of the upper core areas may be required.</p> |

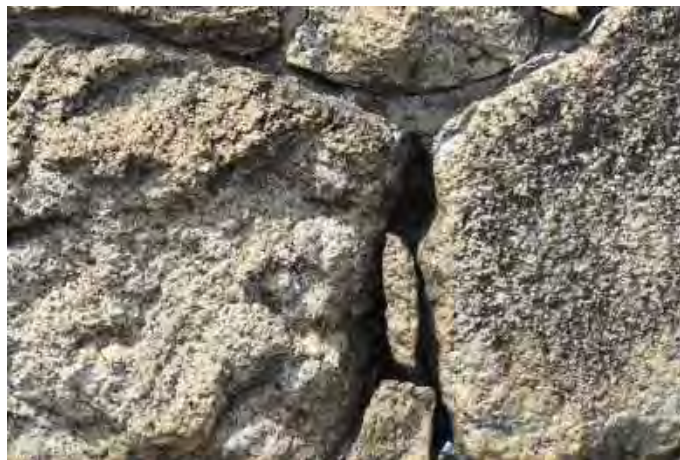
Loose small stone elements.

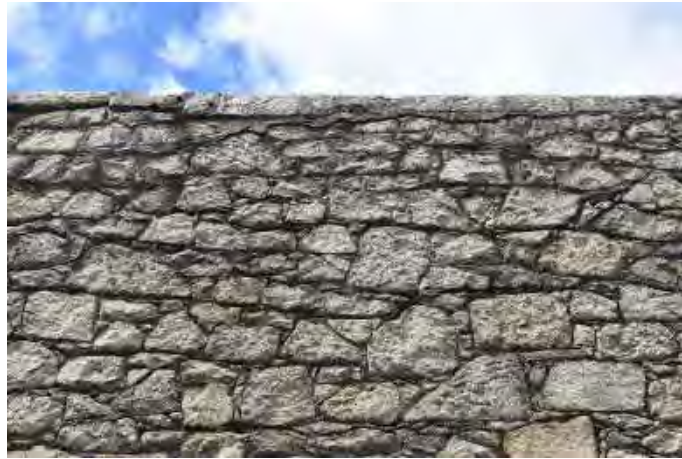
Coping stones have been re-pointed. Mortar loss and cracking to upper wall.

| Location Ref: | RR Elevation – Section 47 |
|---|--|
| <p>Condition:</p> | <p>Coping stones to top of wall have been repointed (RR side only). Wall is generally stable but with some cracking and mortar loss around stones especially at higher levels which requires repair.</p> <p>Proposed treatment: Re-point areas of cracked and missing mortar - additional grouting of the upper core areas may be required.</p> |

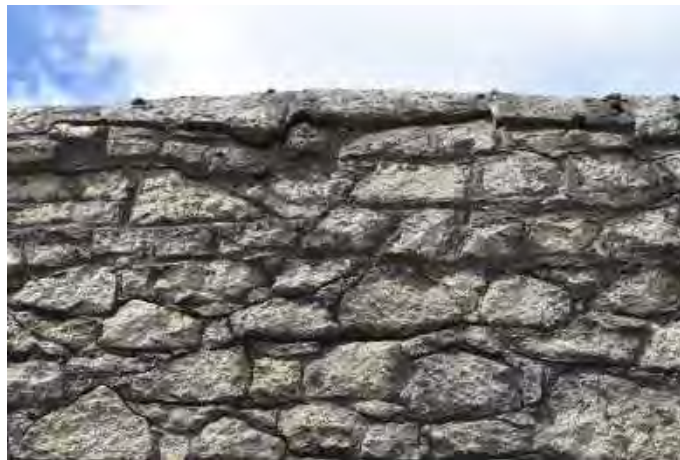
| Location Ref: | RR Elevation – Section 47 |
|---|--|
| <p>Wall section width approx. 3.0m</p> <p>Coping stones have been re-pointed (RR side only).</p> <p>Cracks and displacement under coping stones.</p> <p>Mortar loss and cracking to upper wall areas.</p> <p>More minor mortar loss and cracking to lower levels.</p> | |

Cracking and displacement under coping stones.

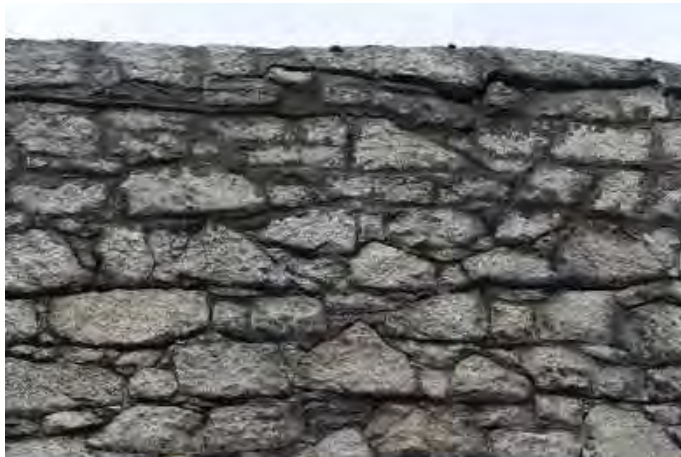
Coping stones have
been re-pointed.
Mortar loss and
cracking to upper wall.

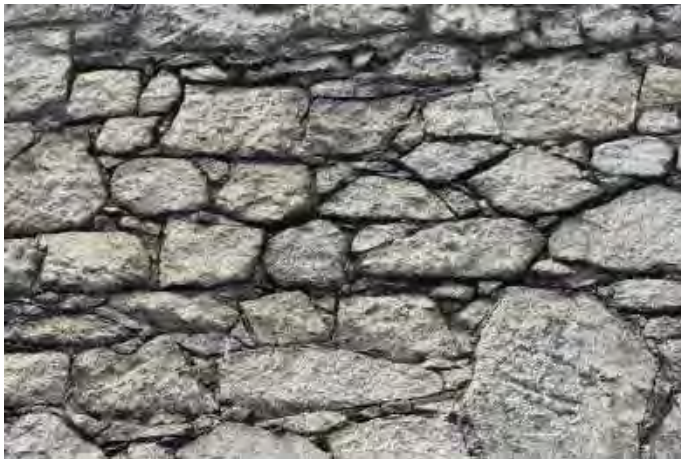
Coping displaced.

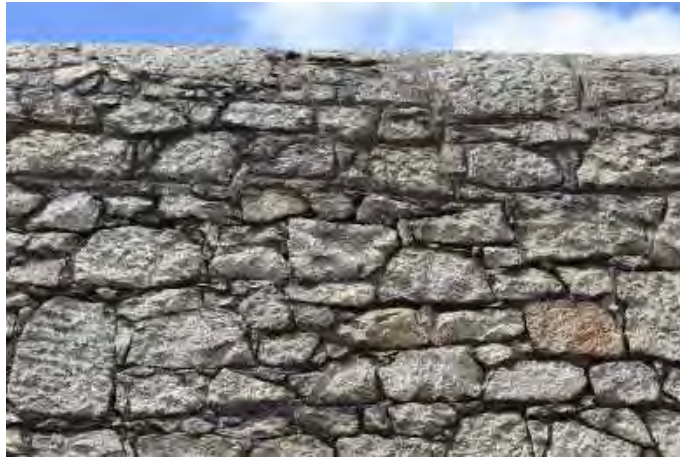
Coping stones have been re-pointed.
Mortar loss and cracking to upper wall.

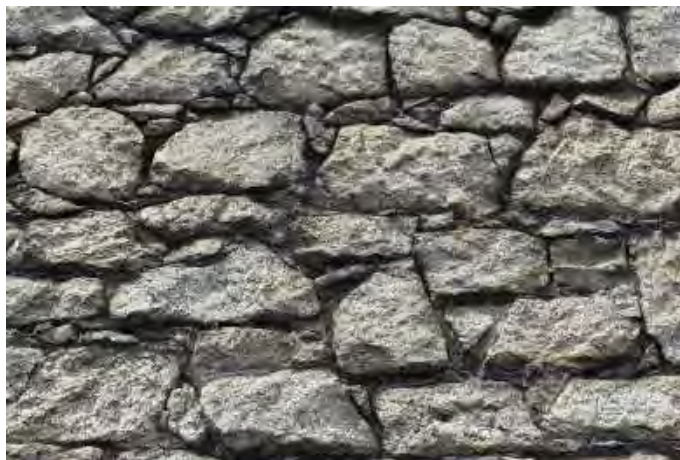
Mortar loss and loose small stone elements.

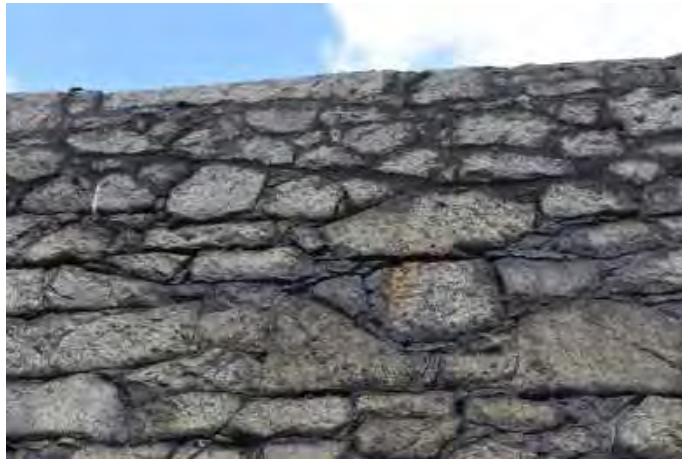
Coping stones have been re-pointed.
Mortar loss and cracking to upper wall.

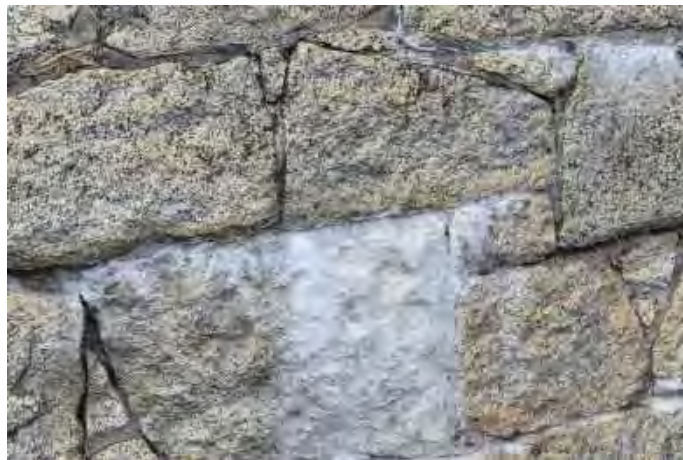
Calcium deposits at low level.

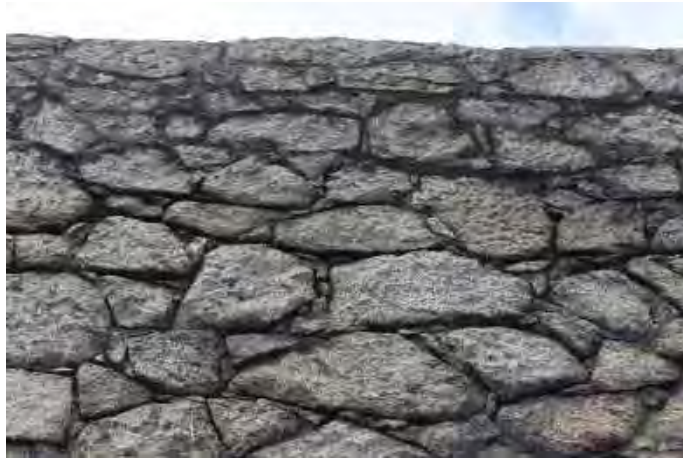
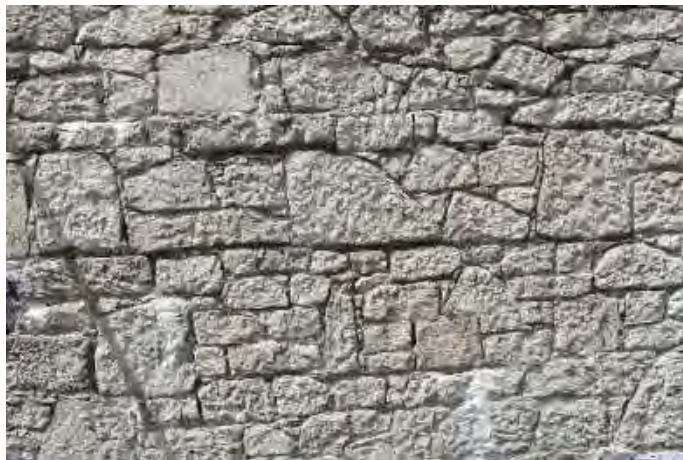
Coping stones have
been re-pointed.
Mortar loss and
cracking to upper wall.

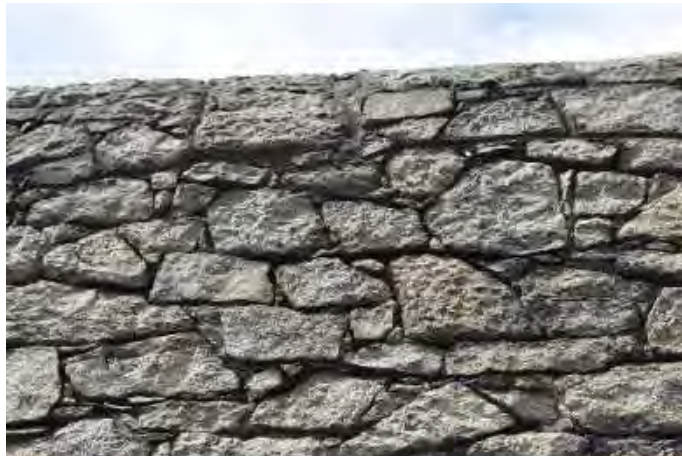
Coping stones have been re-pointed.
Mortar loss and cracking to upper wall.

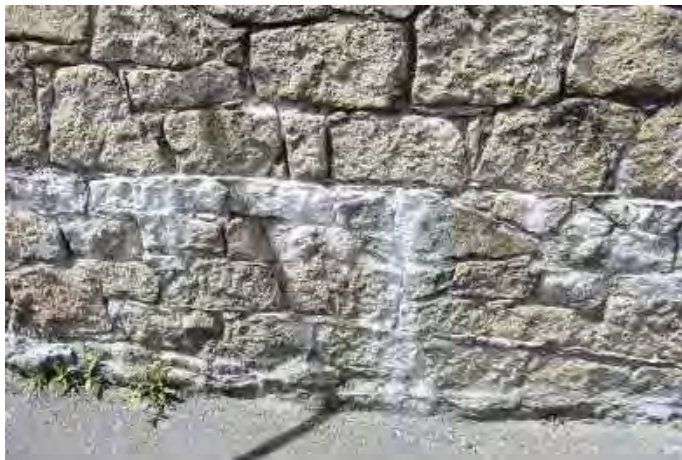
Calcium deposits at low level.

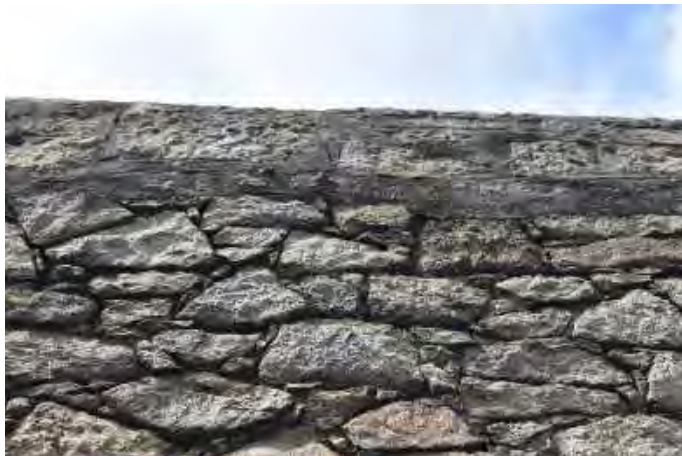
Coping stones have been re-pointed.
Mortar loss and cracking to upper wall.

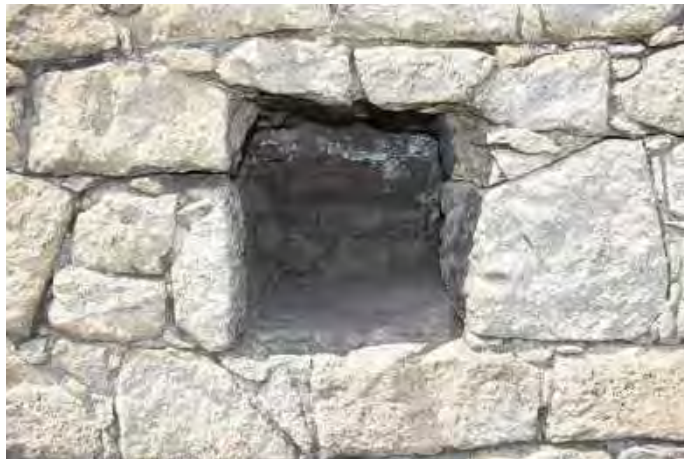
Purpose unknown –
retain where wall is
stable.

| Location Ref: | RR Elevation – Section 54 |
|---|---|
| <p>Condition:</p> | <p>Coping stones to top of wall have been repointed (RR side only). Wall is generally stable but with some cracking and mortar loss around stones especially at higher levels which requires repair.</p> <p>Proposed treatment: Re-point areas of cracked and missing mortar - additional grouting of the upper core areas may be required. Review condition of pocket – repoint areas of missing mortar and retain.</p> |

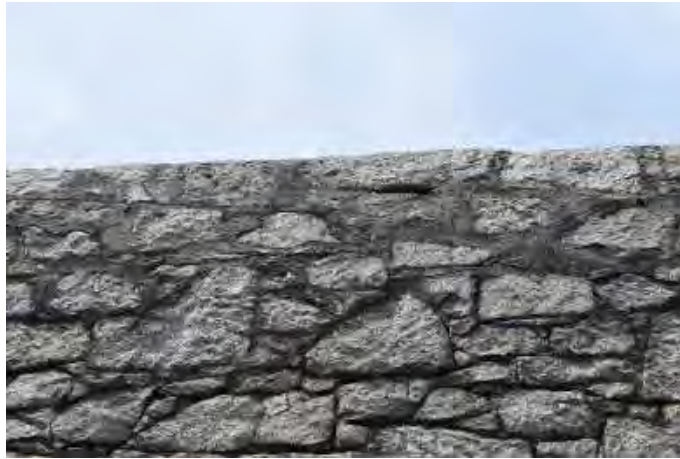
Coping stones have
been re-pointed.
Mortar loss and
cracking to upper wall.

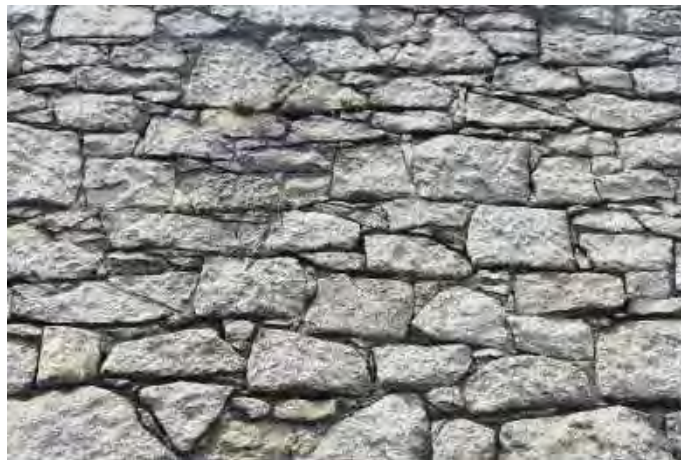
Mortar loss to face of
wall.

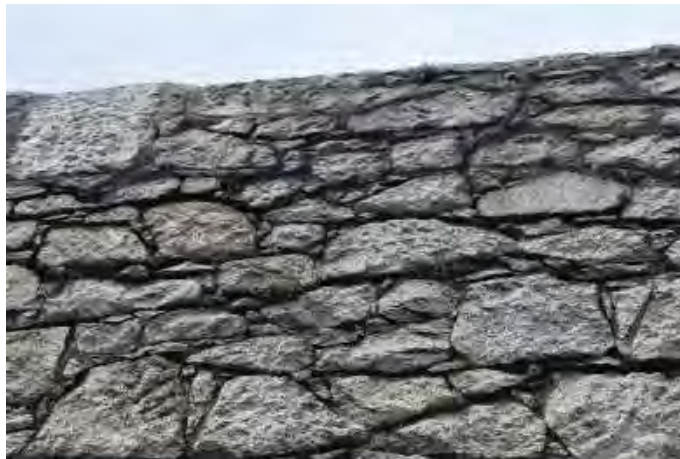
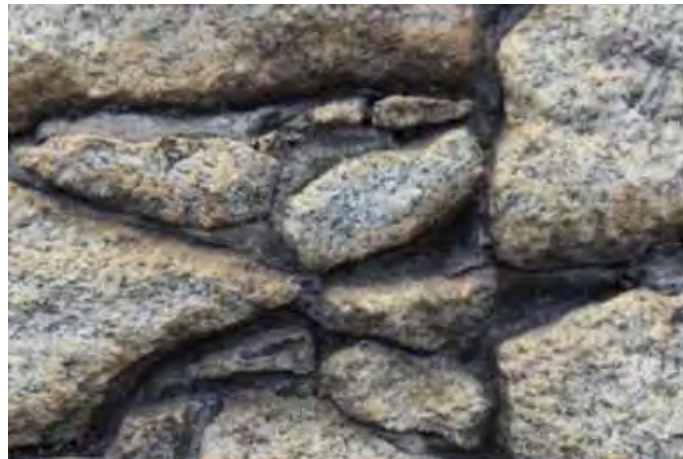
Coping stones have
been re-pointed.
Mortar loss and
cracking to upper wall.

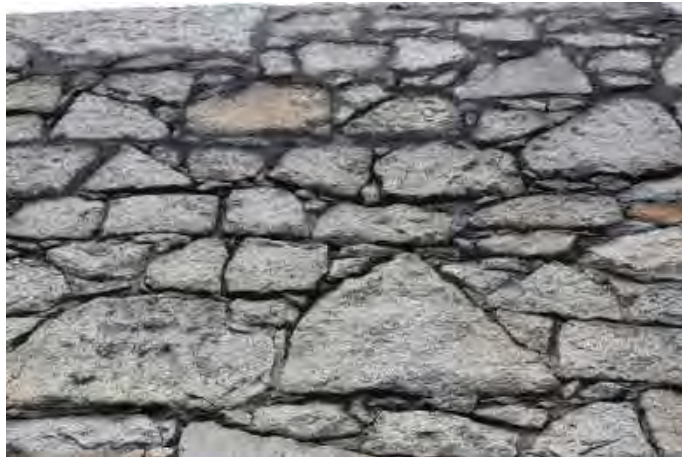
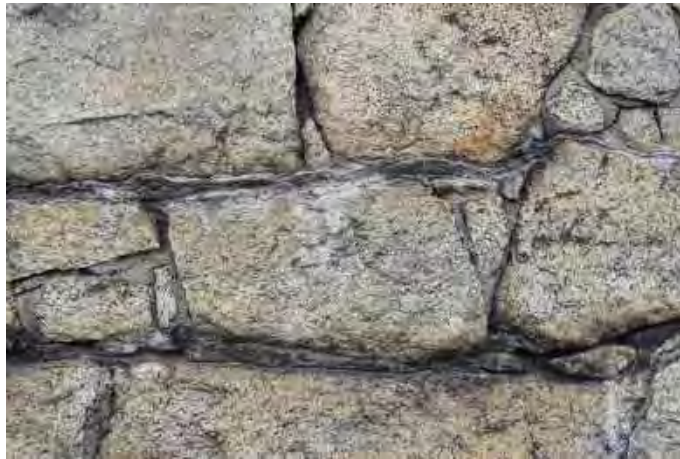
Coping stones have
been re-pointed.
Mortar loss and
cracking to upper wall.

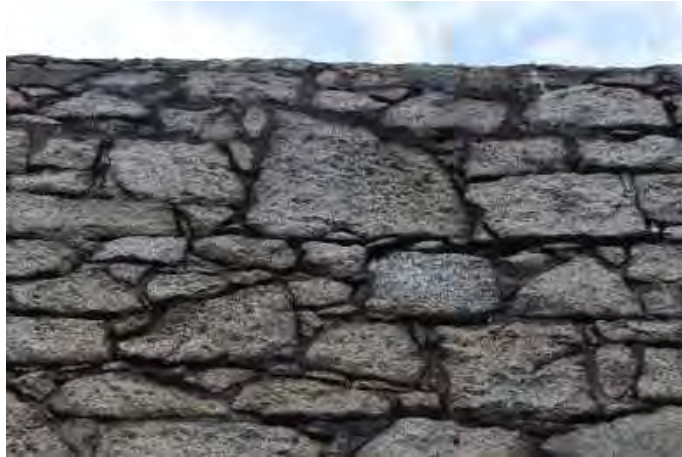
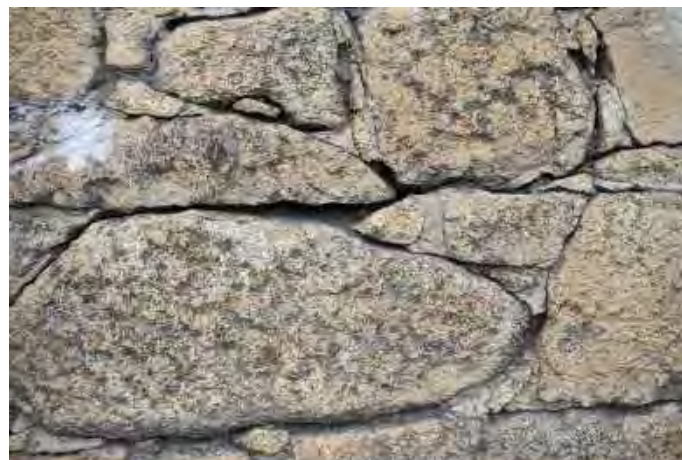
Coping stones have
been re-pointed.
Mortar loss and
cracking to upper wall.

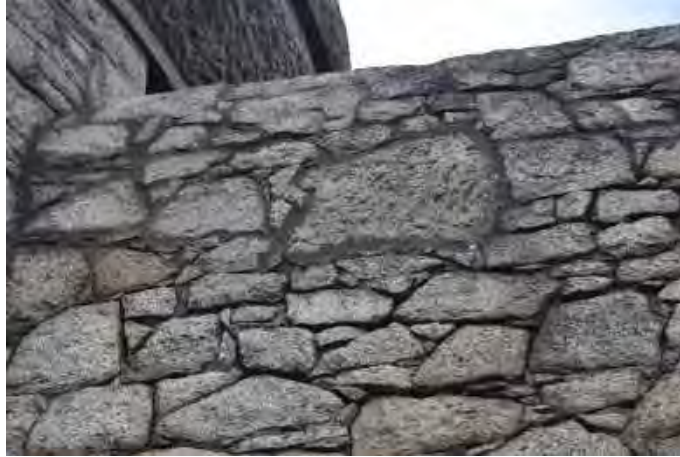
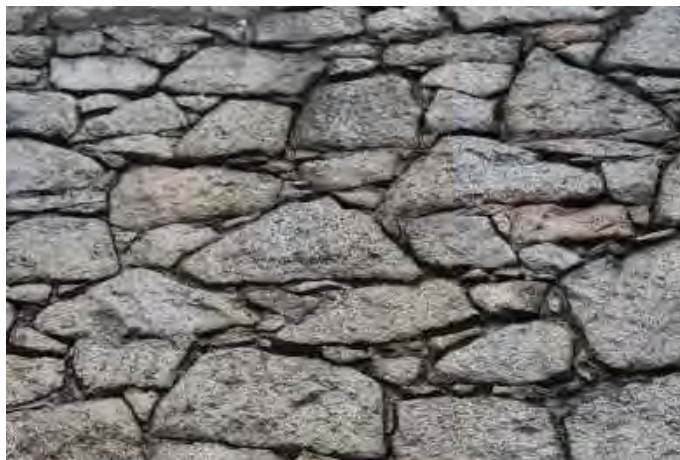
Coping stones have been re-pointed.
Mortar loss and cracking to upper wall.

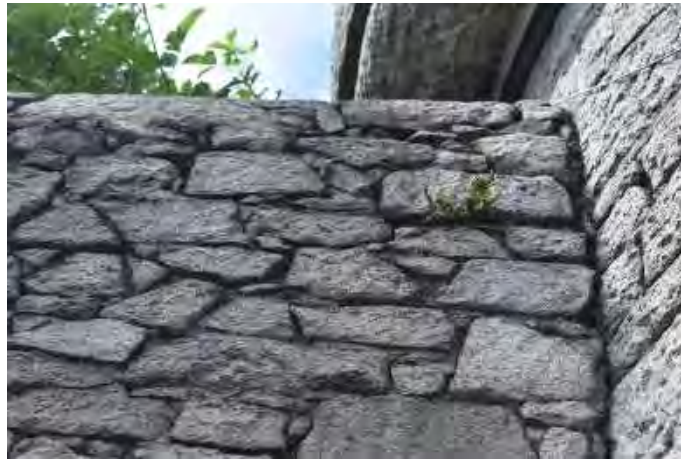
Coping stones have been re-pointed.
Mortar loss and cracking to upper wall.

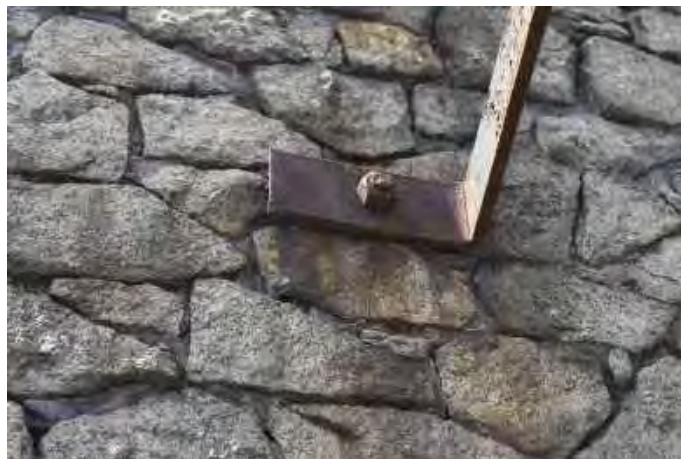
Signage fixed to wall – staining of stonework.

| Location Ref: | RR Elevation South – Section 01 |
|--|---|
| <p>Condition:</p> | <p>Coping stones to top of wall have been repointed (RR side only). Wall is generally stable but with some cracking and mortar loss around stones especially at higher levels which requires repair.</p> <p>Proposed treatment: Re-point areas of cracked and missing mortar - additional grouting of the upper core areas may be required. Remove sign, fixings and make good.</p> |

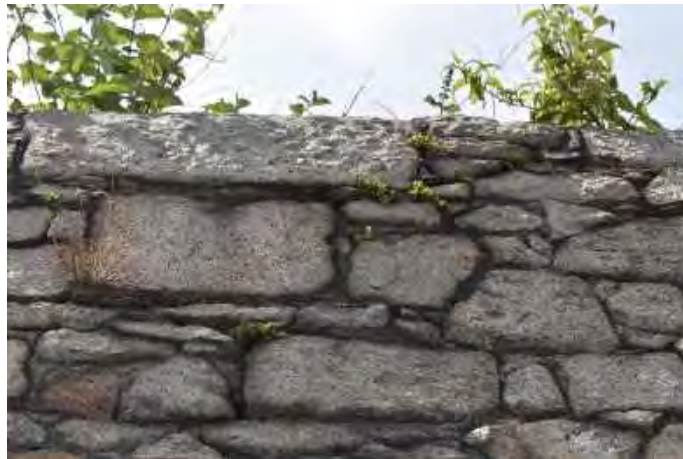
Plant growth to open mortar joints.

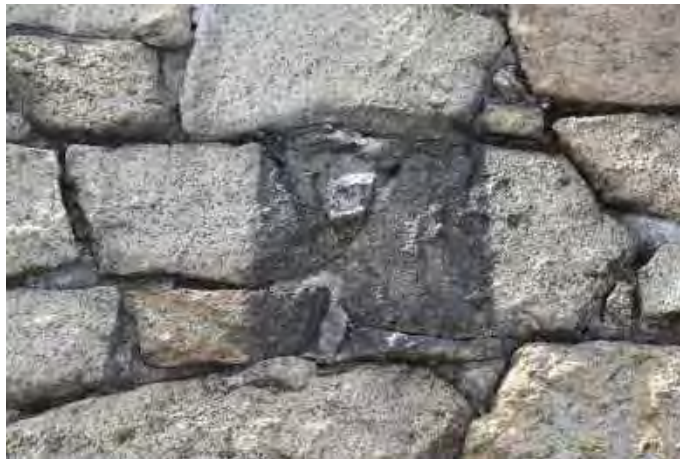
Former sign position –
wall cleaned around
sign.

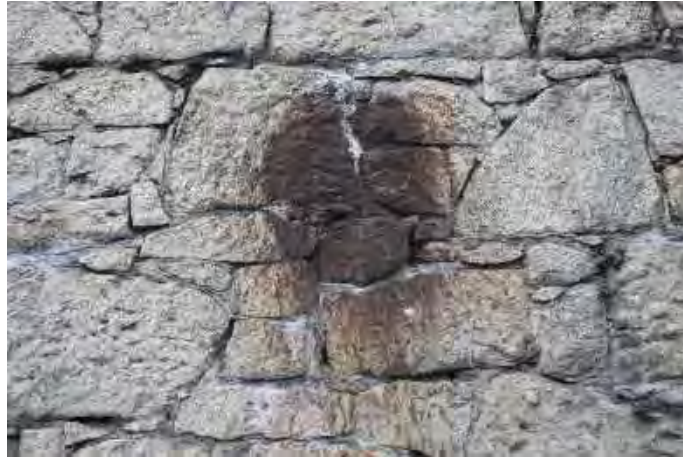
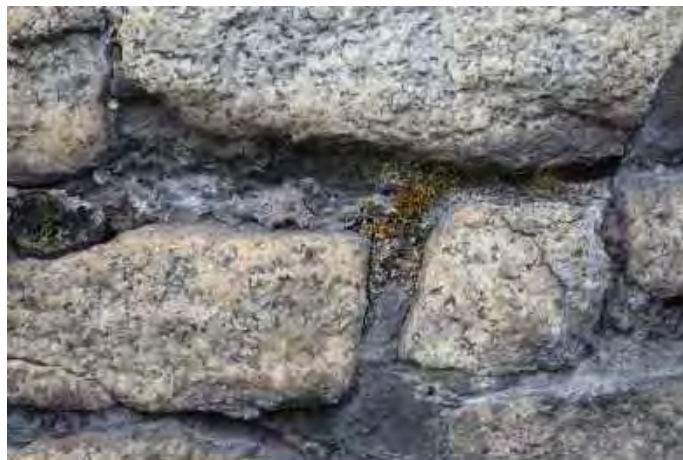
Rust staining to face of wall.

| Location Ref: | RR South Elevation – Section 03 |
|---|--|
| <p>Condition:</p> | <p>Coping stones to top of wall have been repointed (RR side only). Wall is generally stable but with some cracking and mortar loss around stones especially at higher levels which requires repair.</p> <p>Proposed treatment: Re-point areas of cracked and missing mortar - additional grouting of the upper core areas may be required. Undertake cleaning in line with agreed cleaning strategy with additional treatment to remove rust staining.</p> |

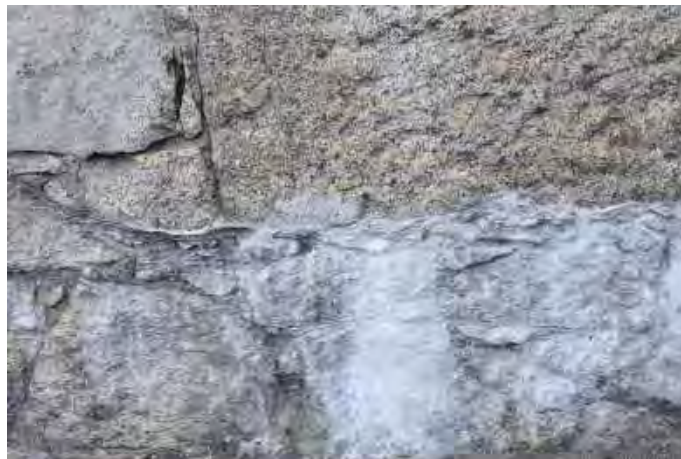
Calcium deposits to lower wall area.

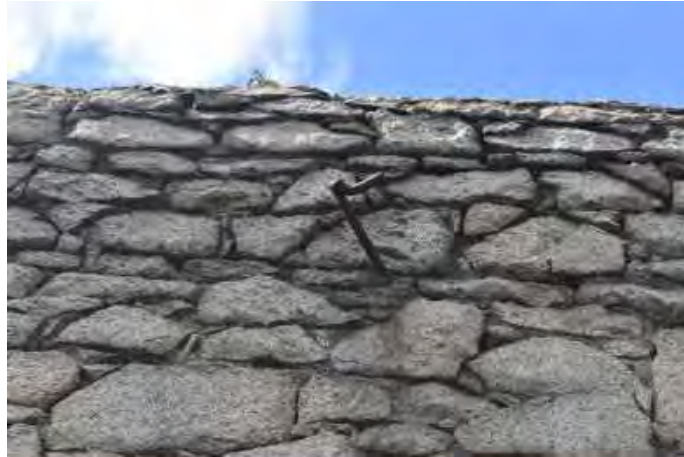
Coping stones have been re-pointed.
Mortar loss and cracking to upper wall.

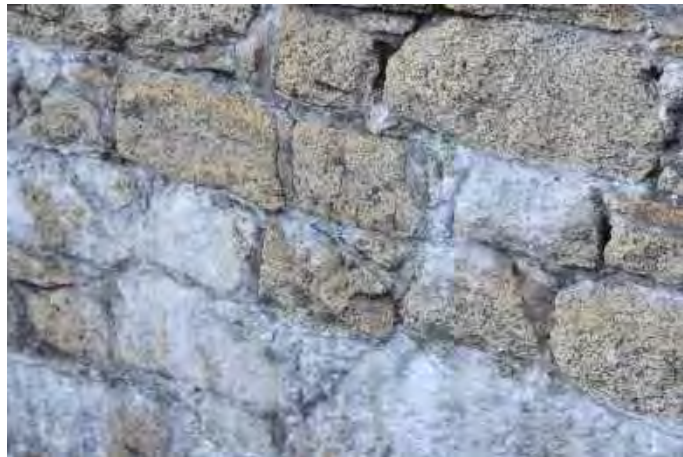
Calcium deposits at low level.

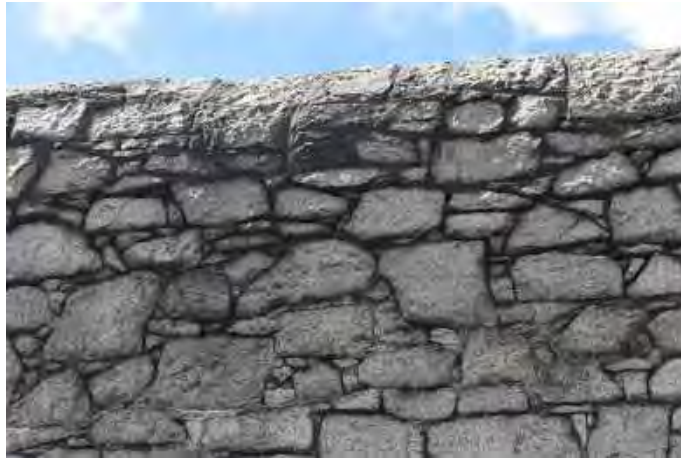
Coping stones have been re-pointed.
Mortar loss and cracking to upper wall.

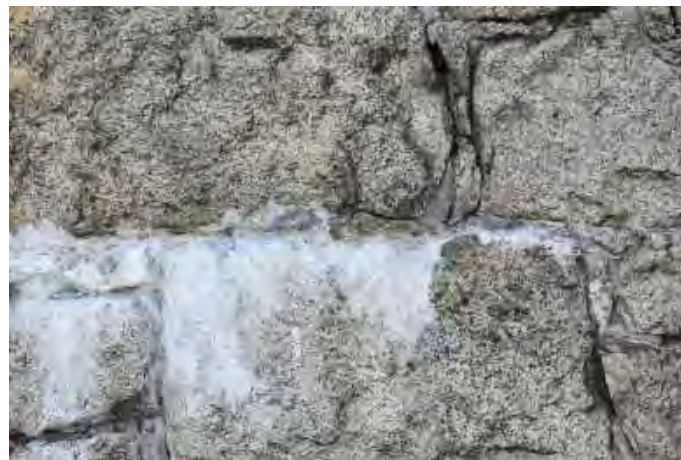
Calcium deposits at mid and low level.
