| Location Ref: | BMD Elevation – Section 44 |

| Location Ref: | RR Elevation – Section 01 |

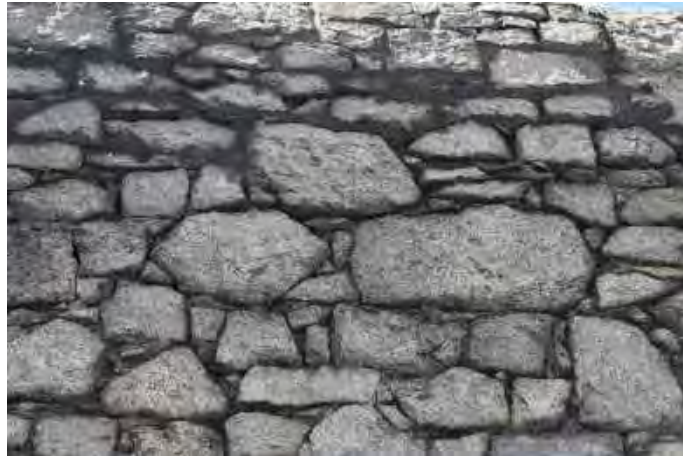
Coping stones have been re-pointed.
Mortar loss and cracking to upper wall.

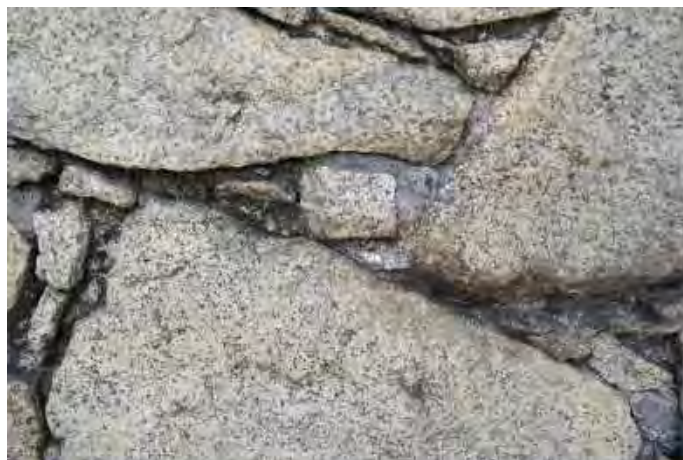
Mortar loss at mid height.

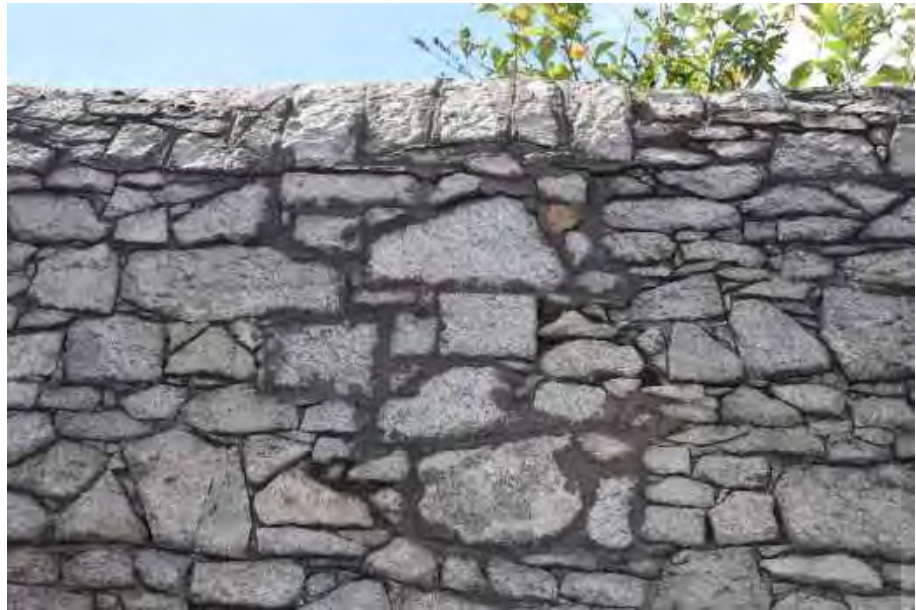
Area repointed – coping displaced.

| Location Ref: | RR South Elevation – Section 07 |
|---|---|
| <p>Condition:</p> | <p>Coping stones to top of wall have been repointed (RR side only). Wall is generally stable but with some cracking and mortar loss around stones especially at higher levels which requires repair.</p> <p>Proposed treatment: Re-point areas of cracked and missing mortar - additional grouting of the upper core areas may be required. Remove failing area of repointed mortar and make good. Stone repair void area.</p> |

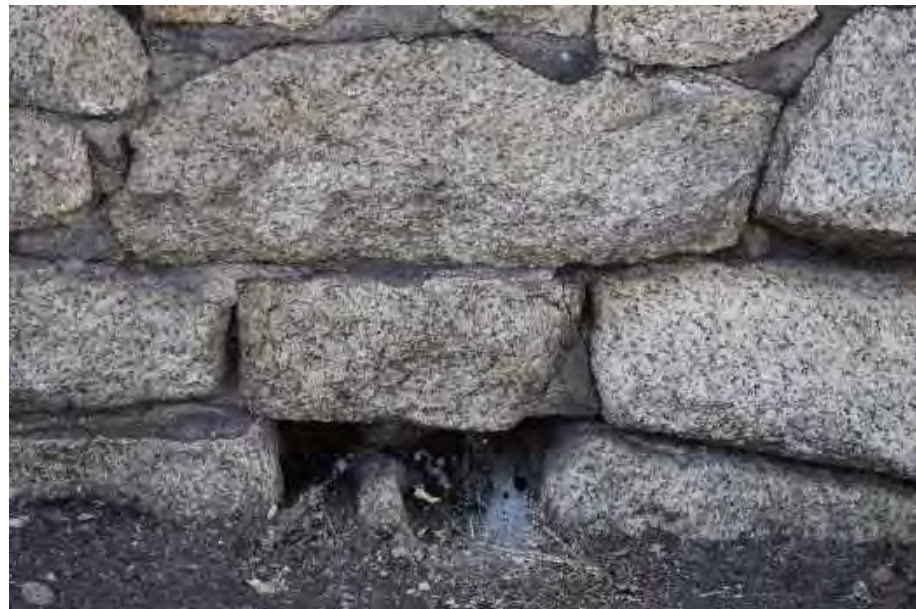
Void area at low level.

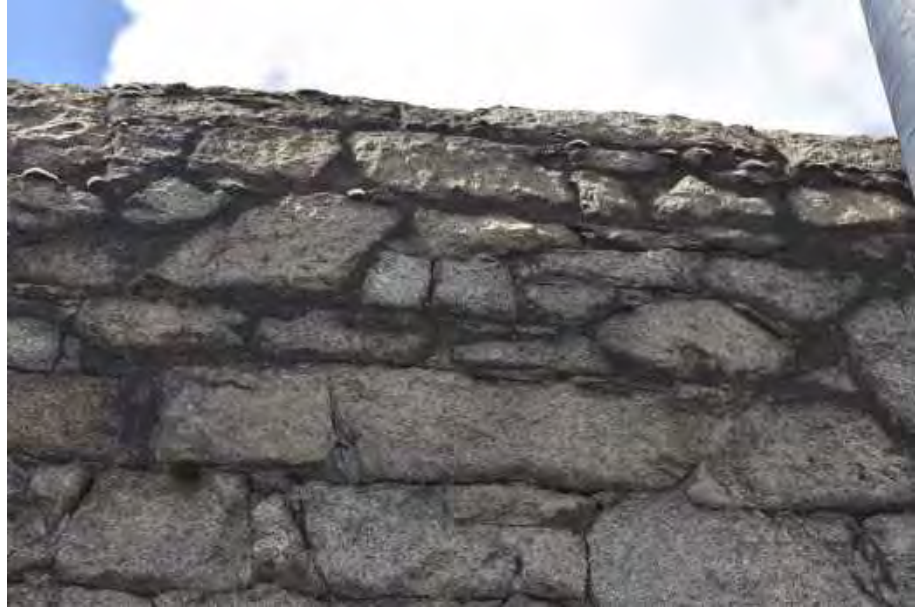
Coping stones have been re-pointed.
Mortar loss and cracking to upper wall.

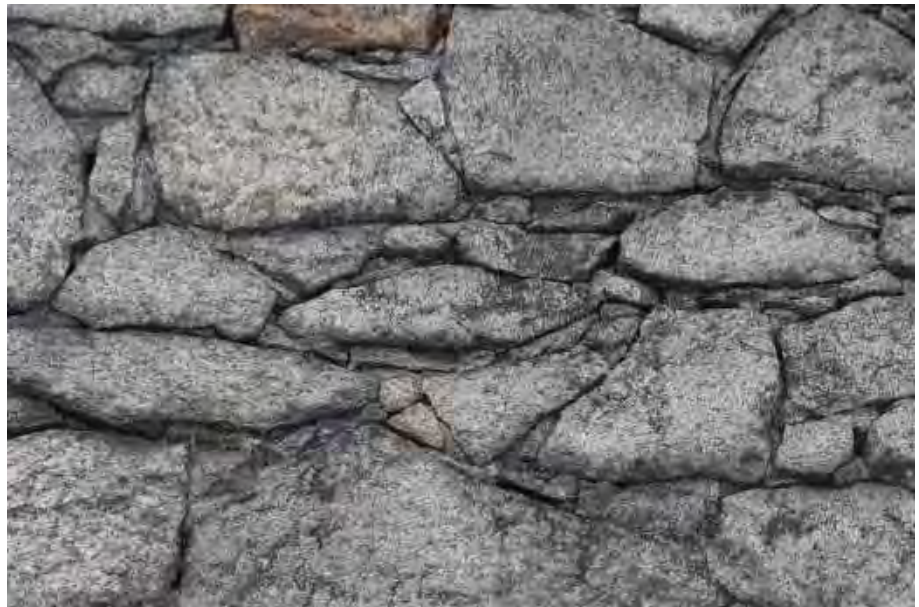
| Location Ref: | RR South Elevation – Section 09 |

Cracking and minor mortar loss to mid / lower areas.

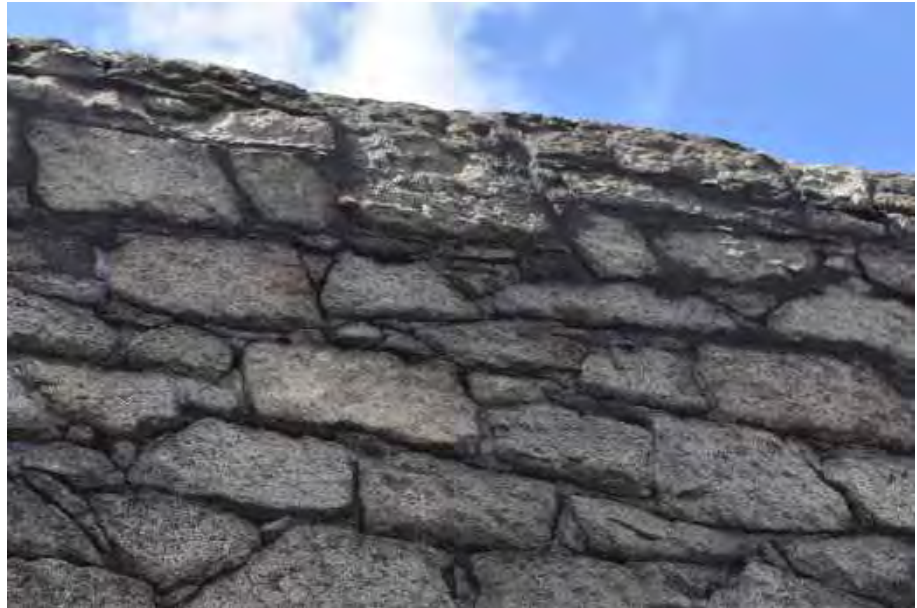
| Location Ref: | RR South Elevation – Section 09 |
|---|--|
| <p>Condition:</p> | <p>Coping stones to top of wall have been repointed (RR side only). Wall is generally stable but with some cracking and mortar loss around stones especially at higher levels which requires repair.</p> <p>Proposed treatment:</p> <p>Re-point areas of cracked and missing mortar - additional grouting of the upper core areas may be required.</p> |

Coping stones have been re-pointed. Mortar loss and cracking to upper wall.

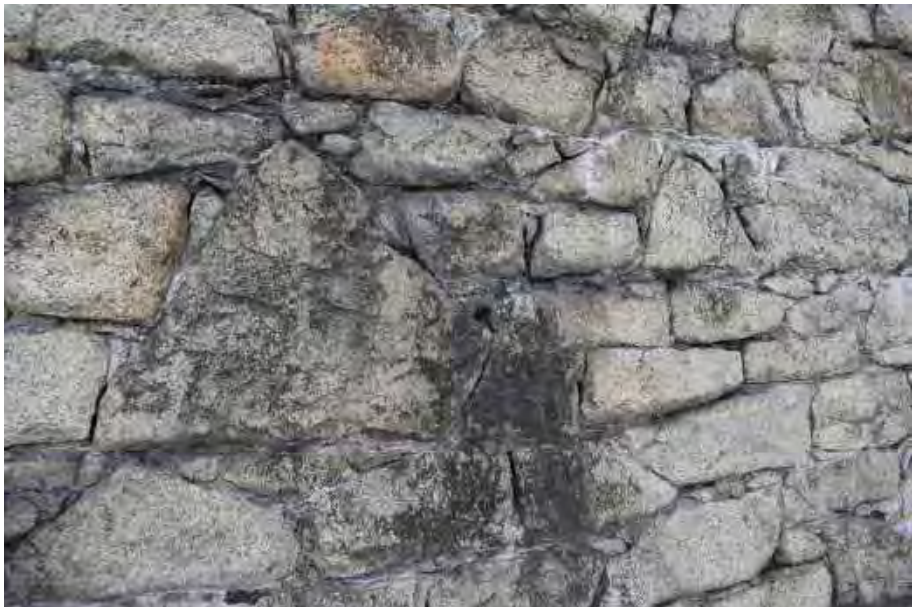
Staining to lower wall areas.

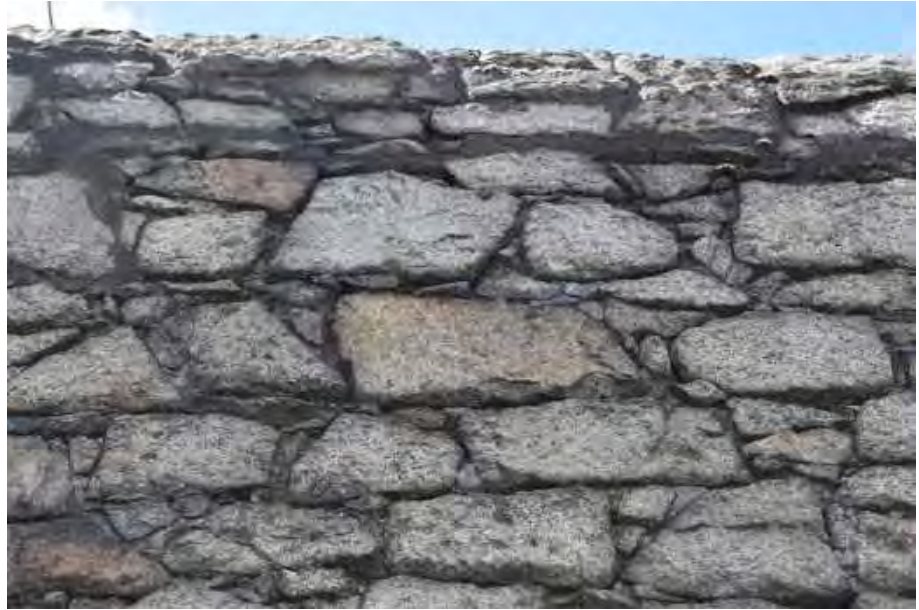
Coping stones have been re-pointed.
Mortar loss and cracking to upper wall.

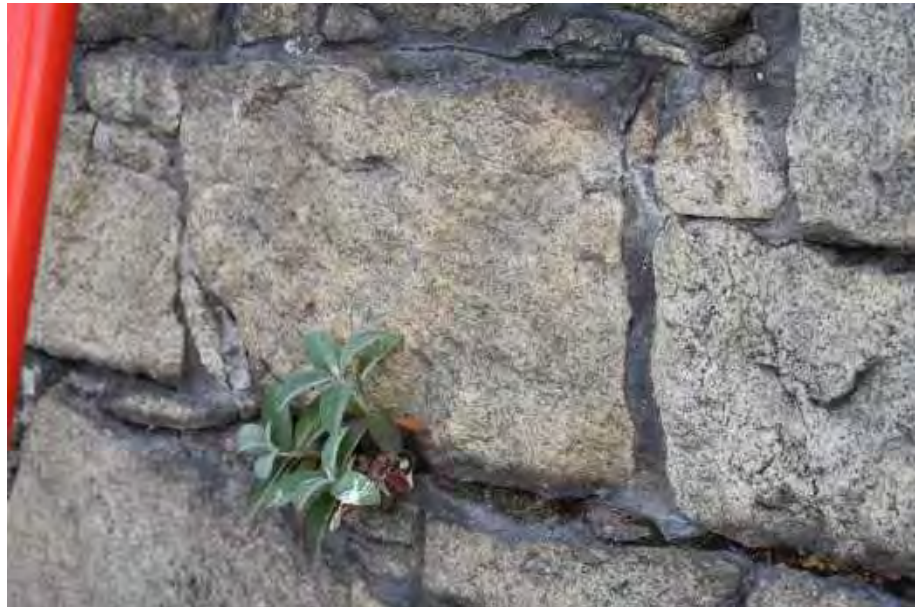
Plant growth to open mortar beds.

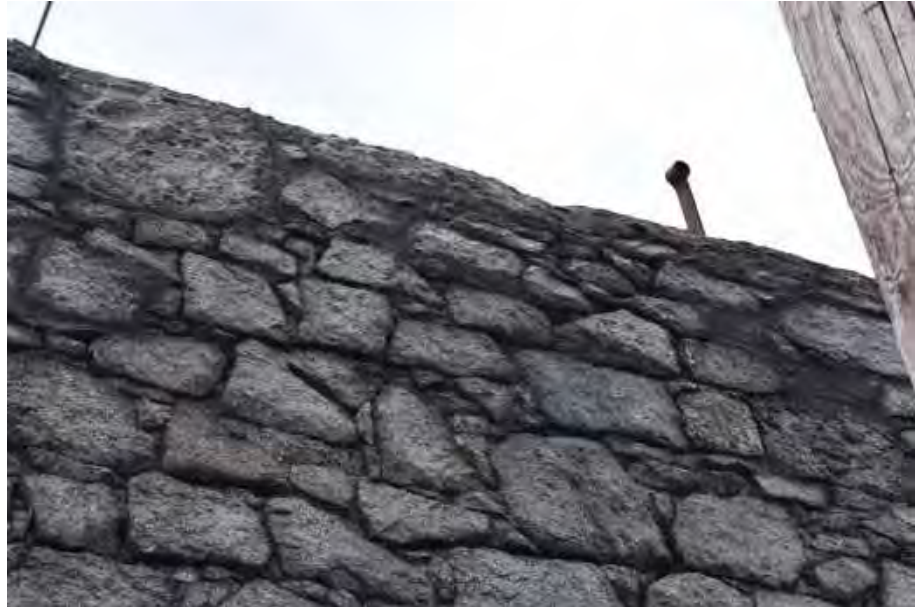
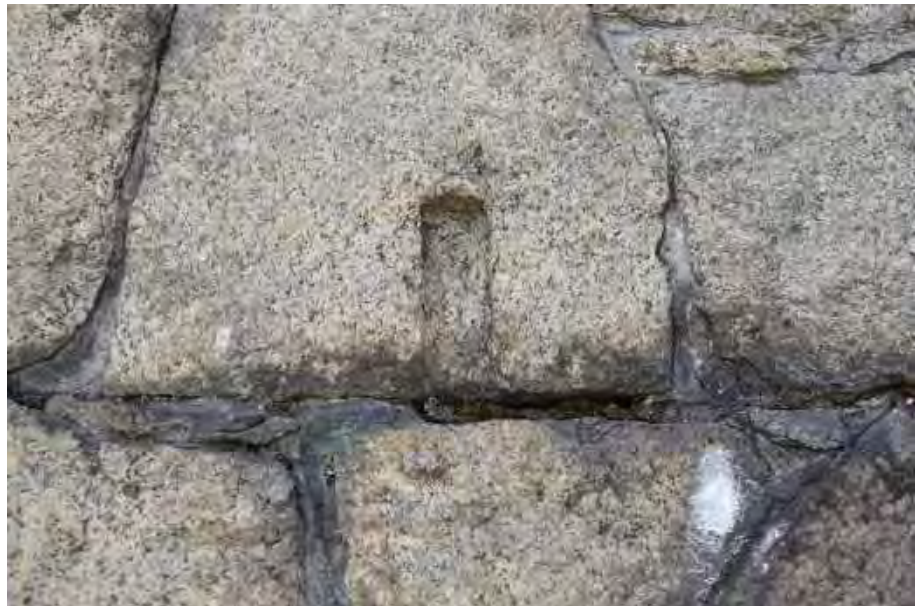
Coping stones have been re-pointed.
Mortar loss and cracking to upper wall.

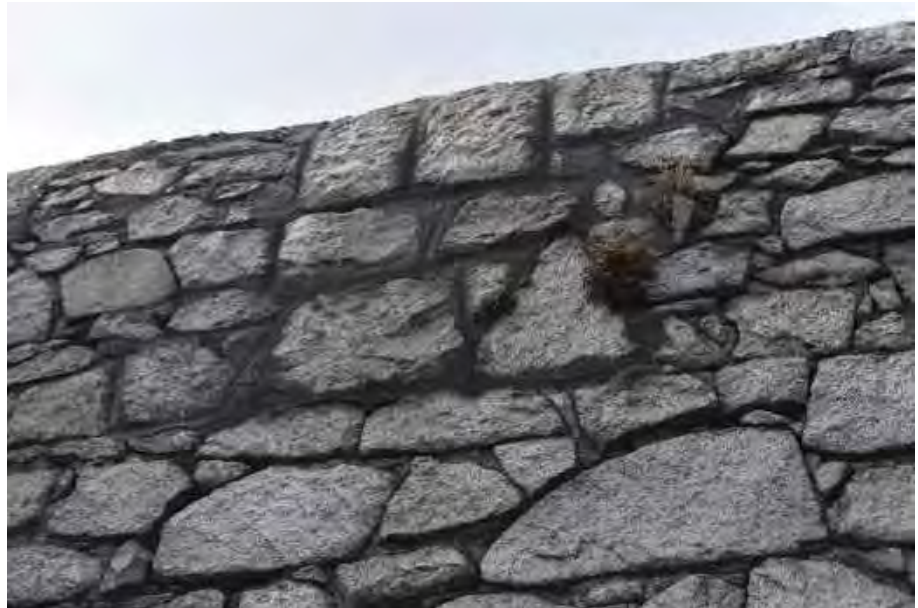
Coping stones have been re-pointed.
Mortar loss and cracking to upper wall.

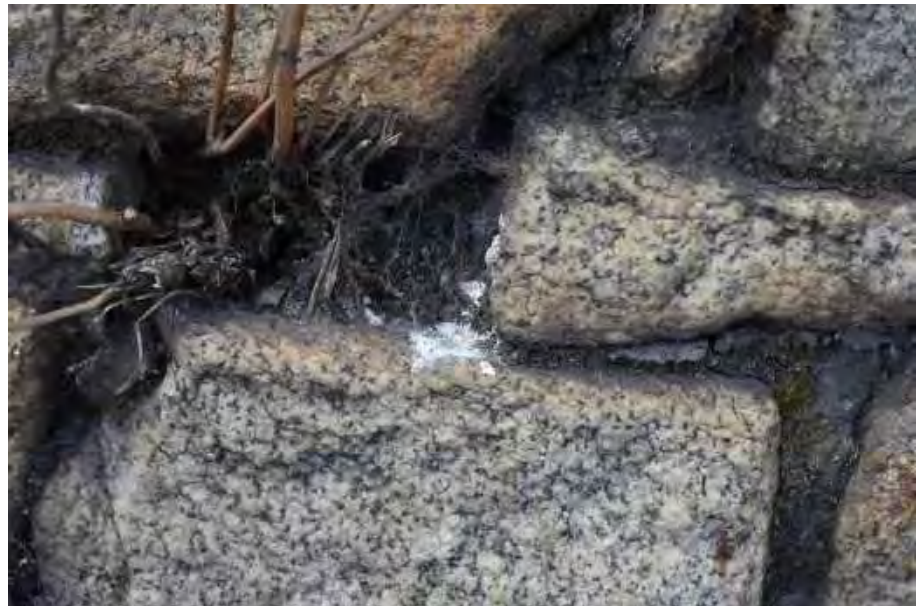
Plant growth in mortar beds.

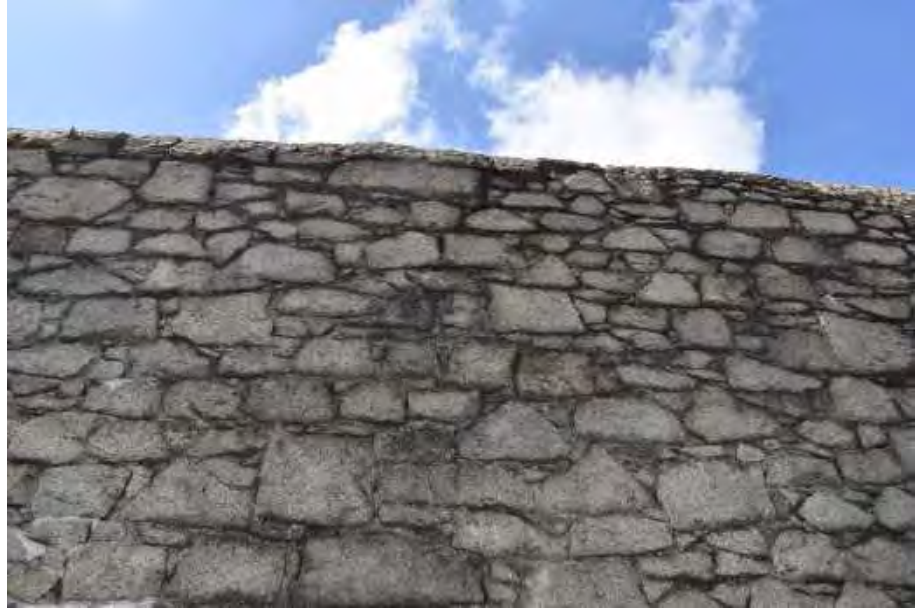
Coping stones have
been re-pointed.
Mortar loss and
cracking to upper wall.

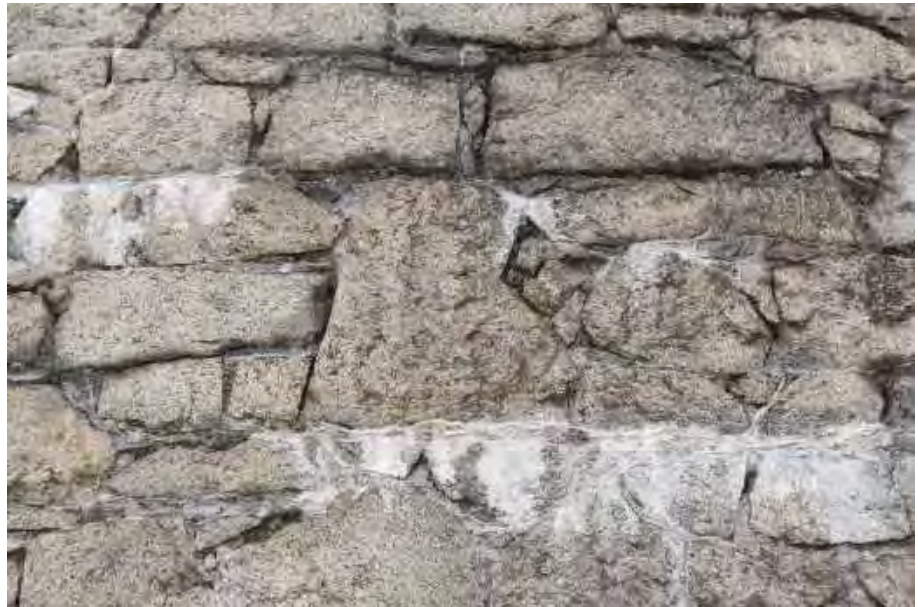
Calcium deposits at
base of wall.

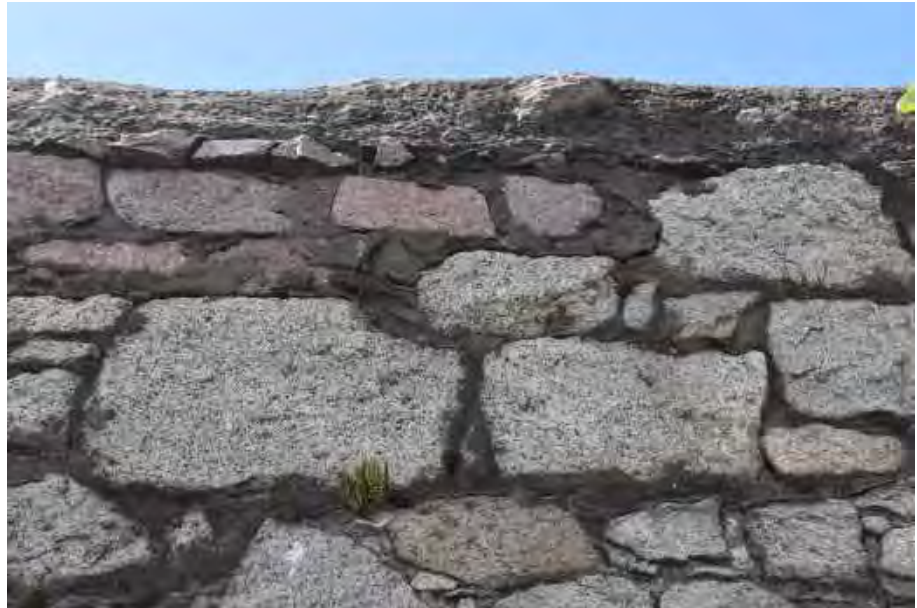
Coping stones have been re-pointed.
Mortar loss and cracking to upper wall.

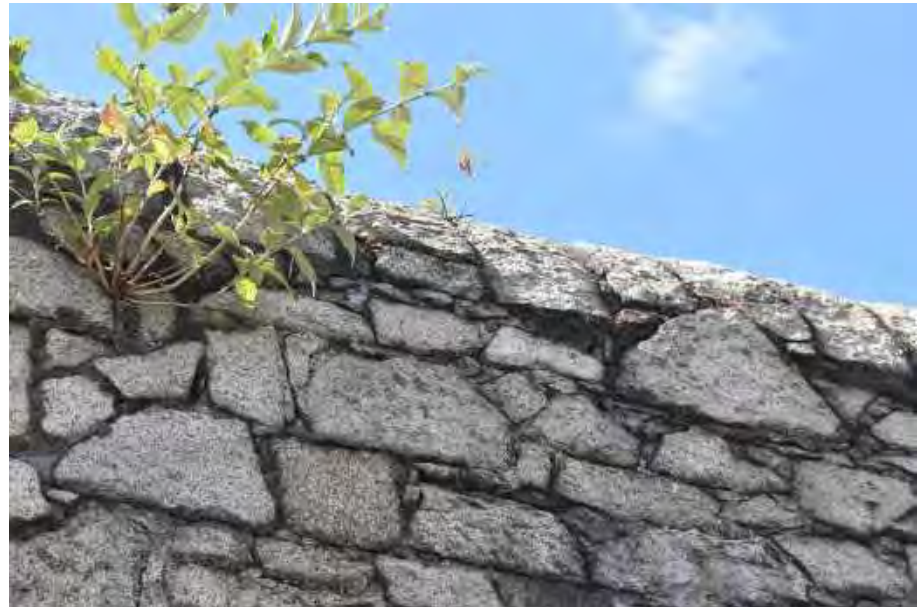
Plant growth in loose mortar beds.

| Location Ref: | RR South Elevation – Section 14 |
|---|---|
| <p>Condition:</p> | <p>Coping stones to top of wall have been repointed (RR side only). Wall is generally stable but with some cracking and mortar loss around stones especially at higher levels which requires repair.</p> <p>Proposed treatment:</p> <p>Re-point areas of cracked and missing mortar - additional grouting of the upper core areas may be required.</p> <p>Remove plant growth and treat roots.</p> |

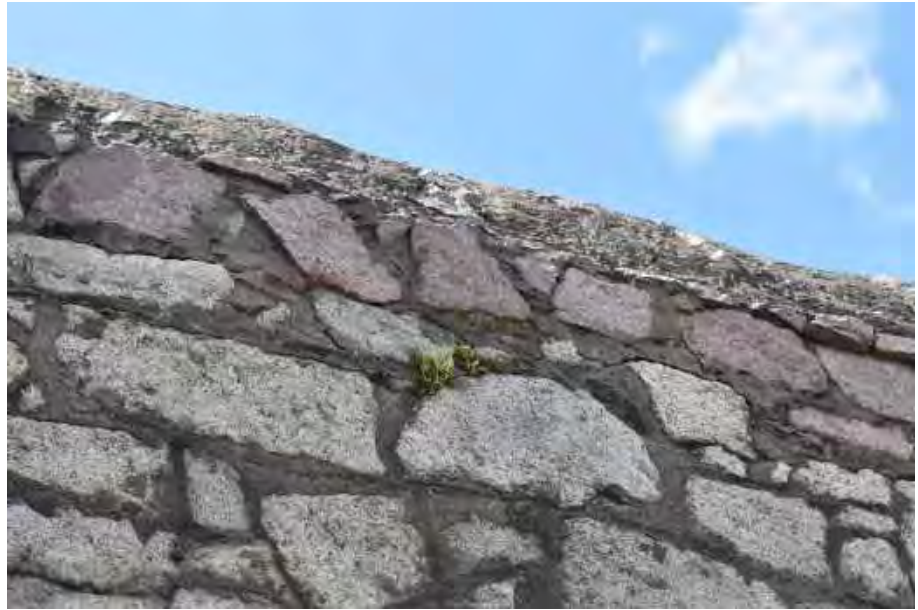
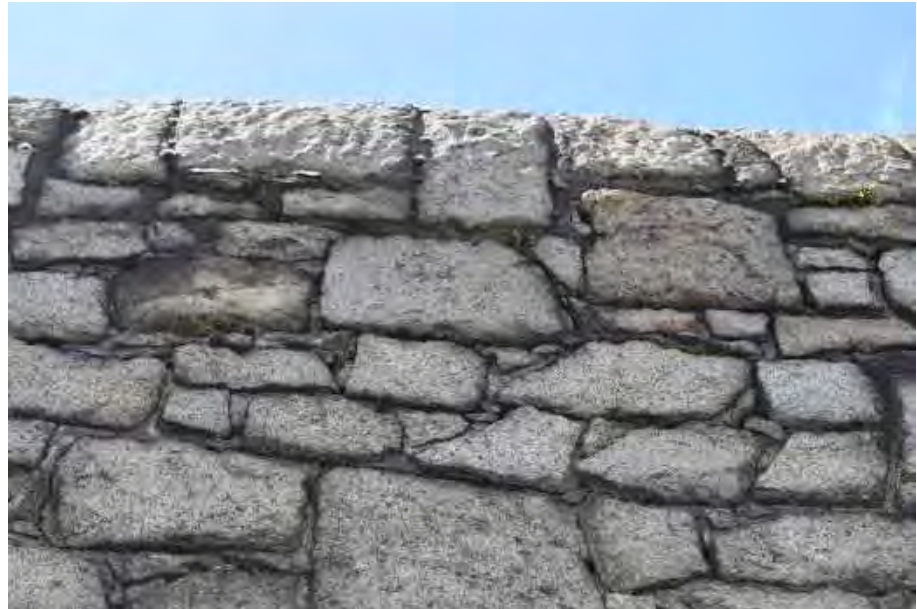
Coping stones have
been re-pointed.
Mortar loss and
cracking to upper wall.

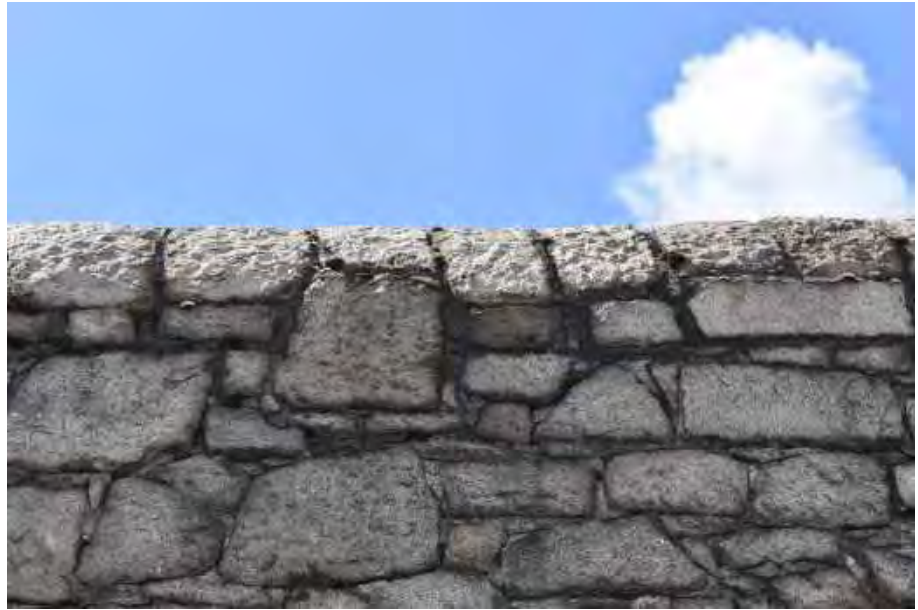
Coping stones have
been re-pointed.
Mortar loss and
cracking to upper wall.

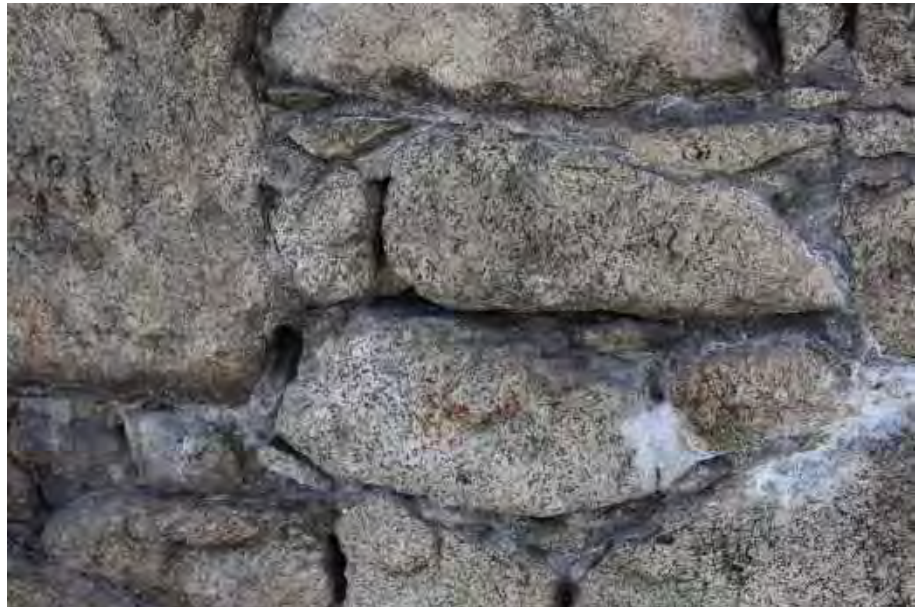
Mortar loss around
stones at mid height.

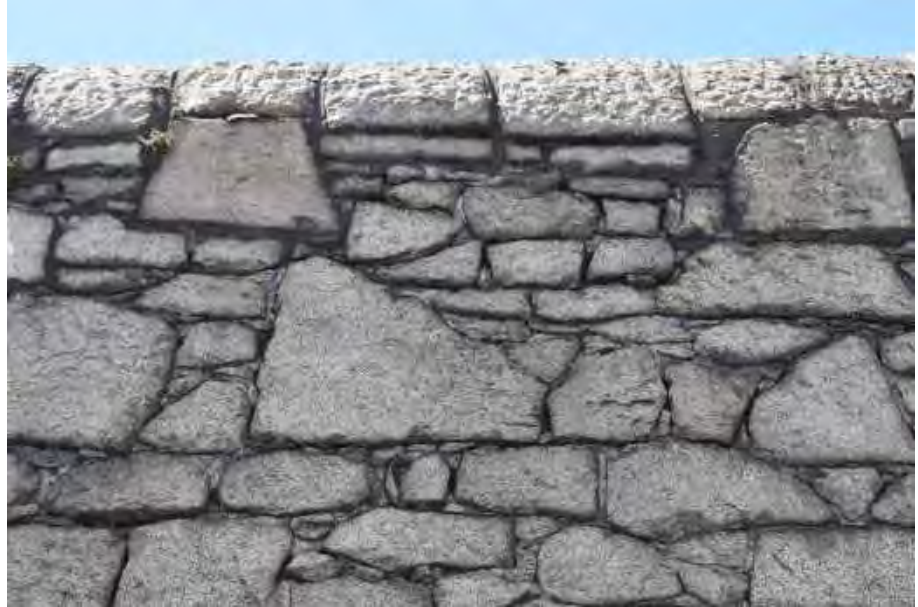
Coping stones have been re-pointed.
Mortar loss and cracking to upper wall.

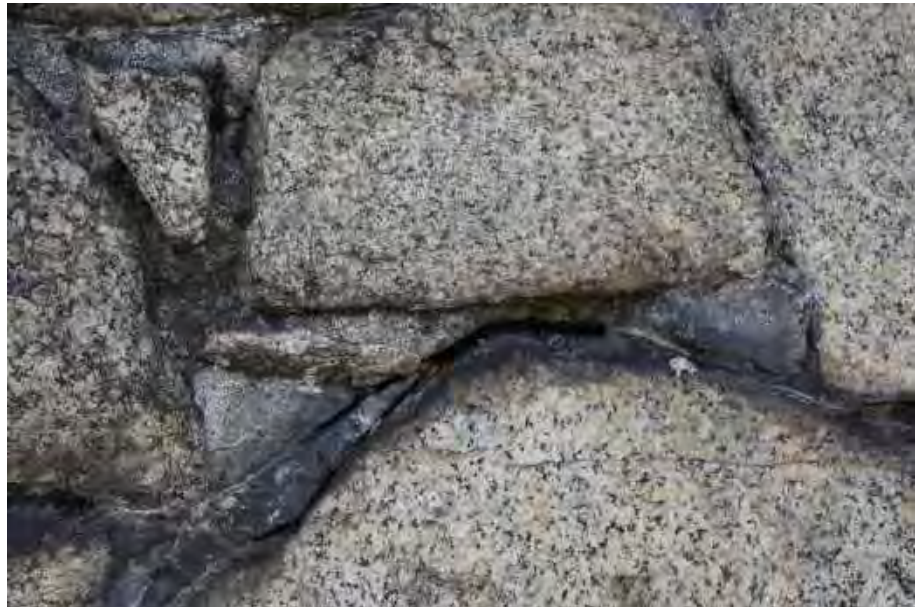
Cracking of mortar at mid height.

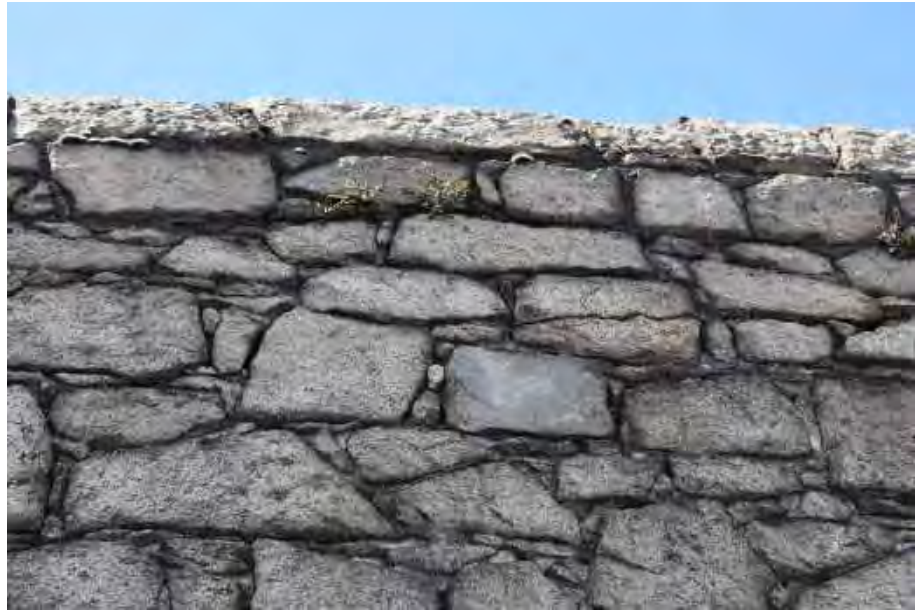
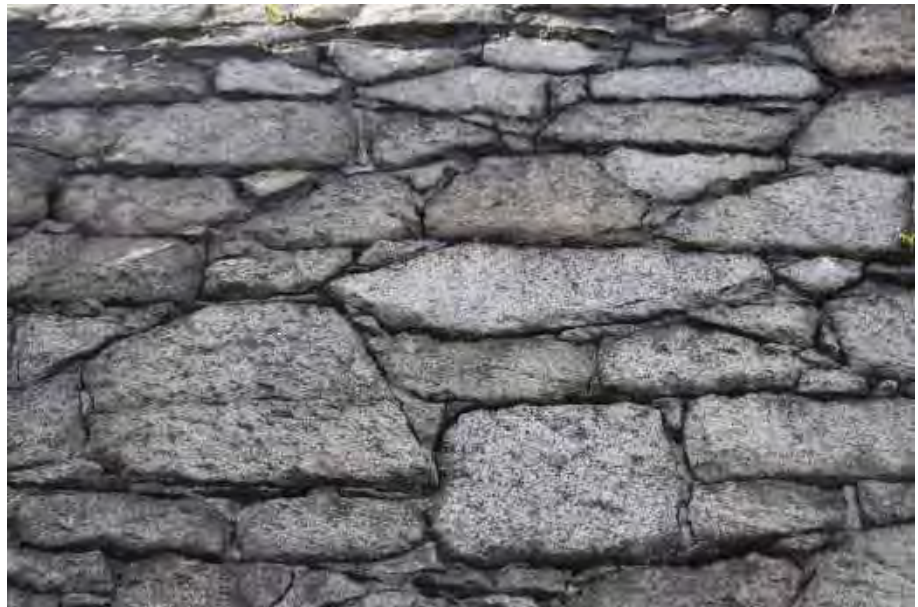
Coping stones have
been re-pointed.
Mortar loss and
cracking to upper wall.

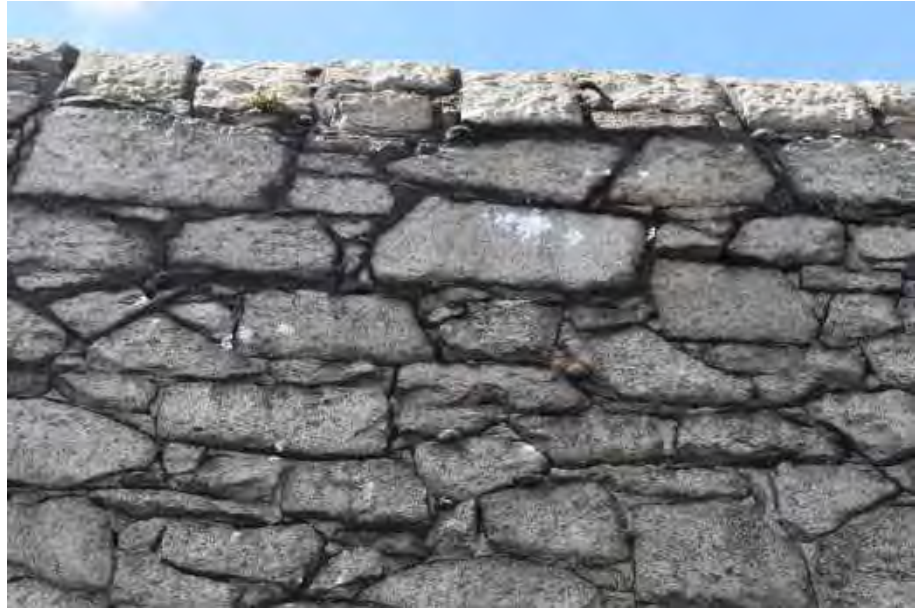
Coping stones have
been re-pointed.
Mortar loss and
cracking to upper wall.

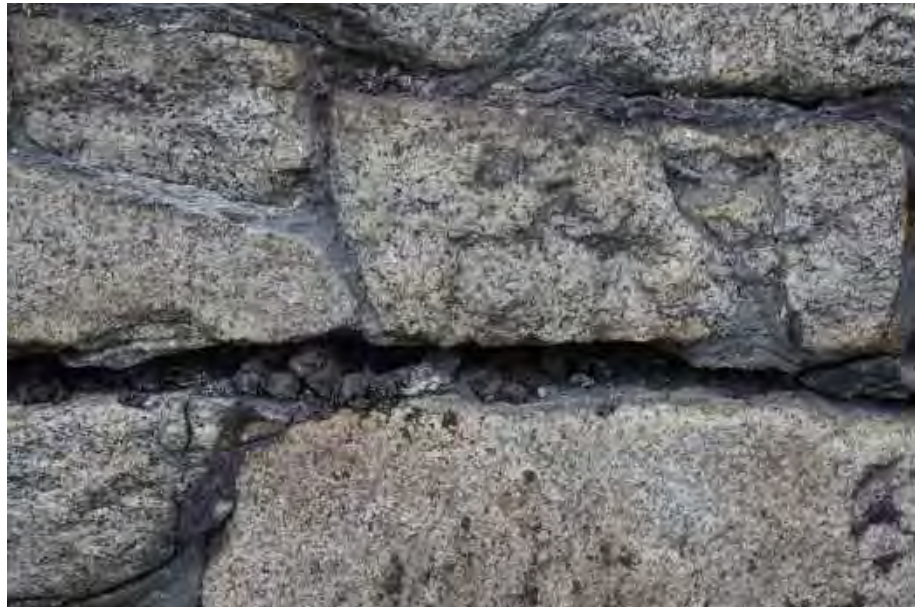
Cracked mortar beds.

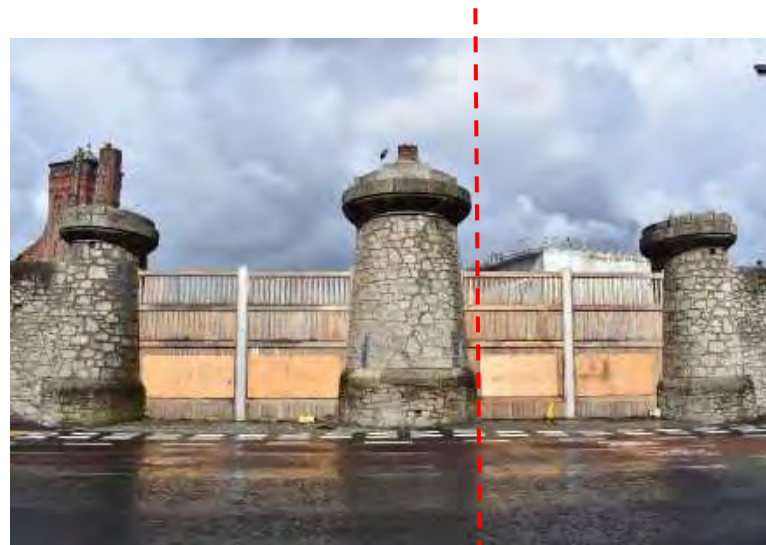
View of the entranceway from Regents Road. Timber gates are present however these are a modern replica of the original gates and are not operable. A post has been formed centrally to provide additional support to the infill panels.

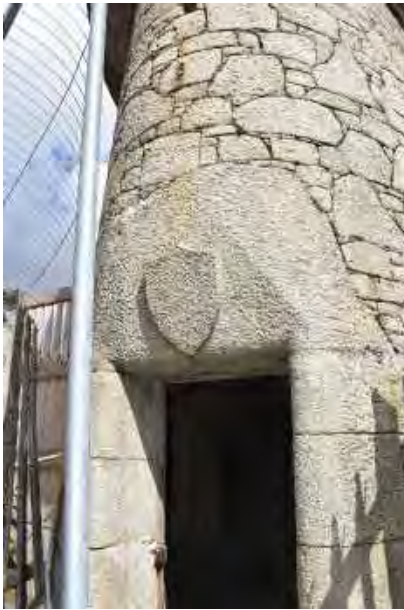
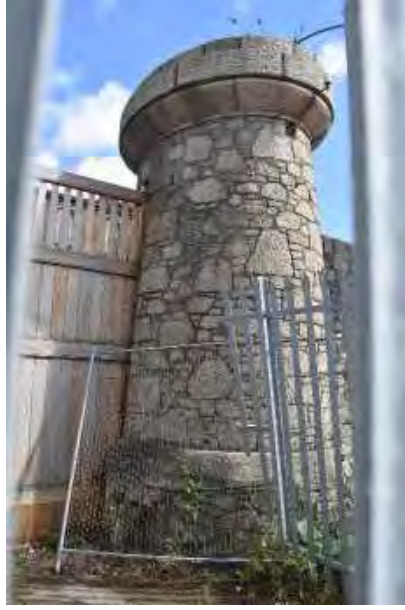
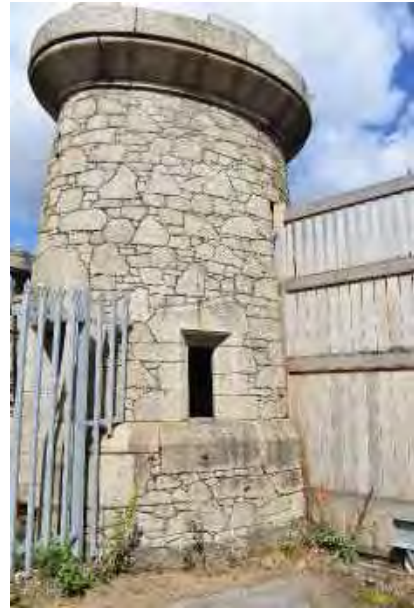
Central Lodge – Formed of random coursed granite stonework of similar construction to the main wall. Dressed plinth and projecting cornice, 2No windows facing the road have been blocked in and evidence of chimney at roof level. The base of the lodge is 4575 x 3080 in plan.

Generally, the lodge appeared in a sound condition with no evidence of water ingress into the interior space. The stonework showed signs of cracking as was evident in the main walls however this was not as severe as the upper wall areas. It was not possible to inspect the stonework to the roof structure although internally there were no signs of displacement or severe degradation.

Interior fittings such as the seating, entrance door and fireplace were present and in a sound condition. It is recommended that the considerable debris build-up on the floor is removed and more detailed inspection of the roof structure are carried out to determine a suitable work-scope to conserve and retain the features of the lodge.

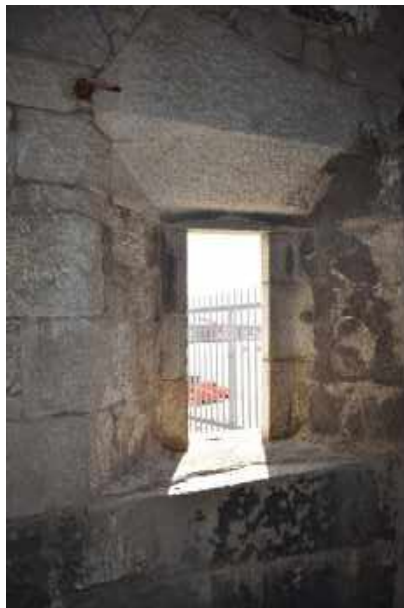
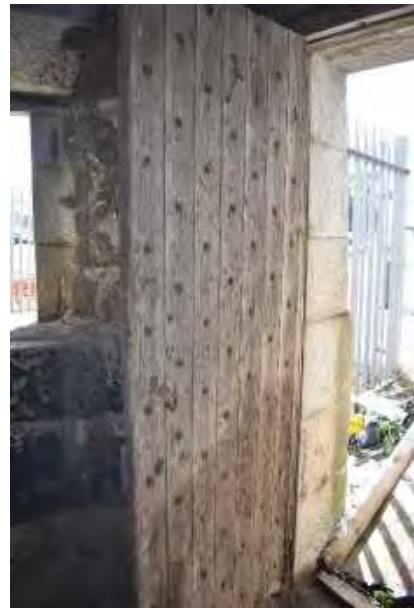
View of lodge from within
Bramley Moore Dock.
Timber doorway to lodge is
present and in fair
condition. 2No windows
formed to face the dock.

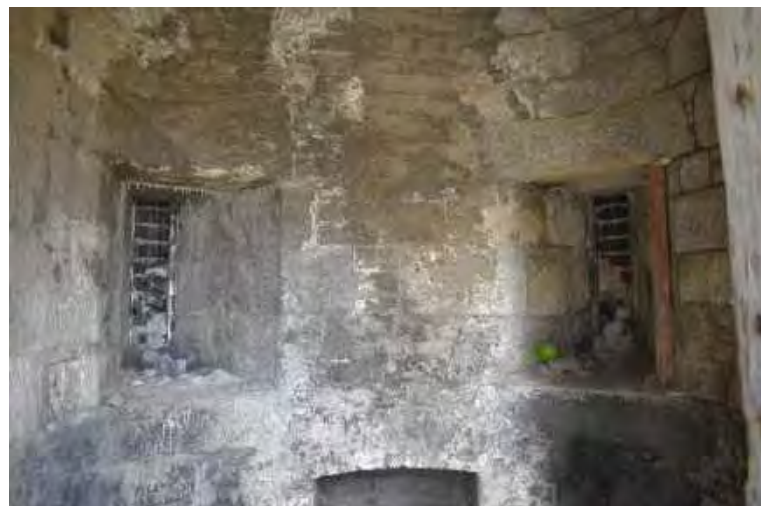
Internal view of the 2No windows
facing the road. Blocked in
however stonework to opening
appears in sound condition.

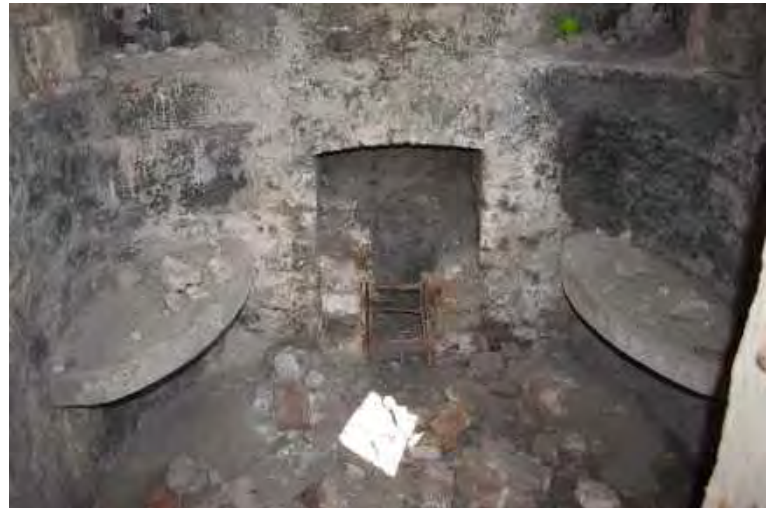
Remains of hearth / grating in fire surround together with 2 No stone benches formed within the wall recess.

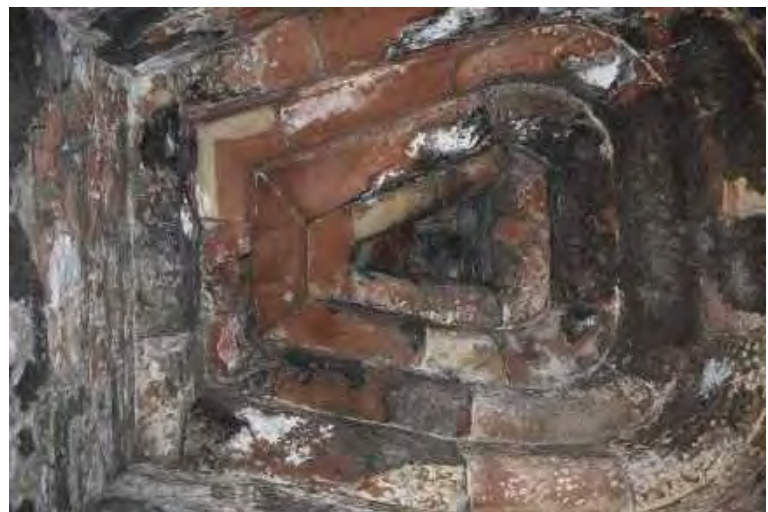
View of corbelled ceiling formed in stonework. Red gritstone rather than granite has been used.

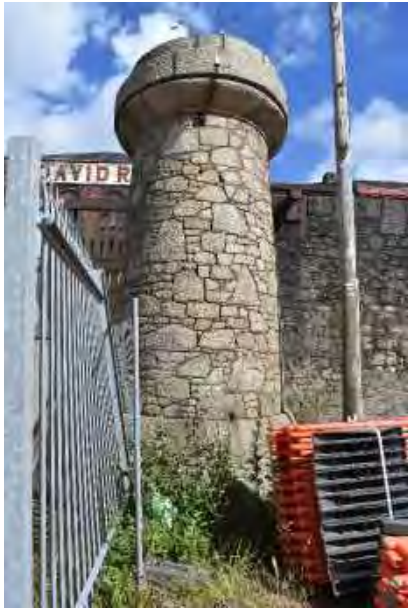
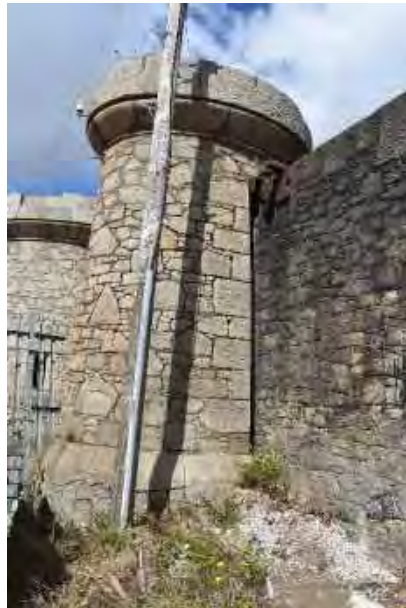
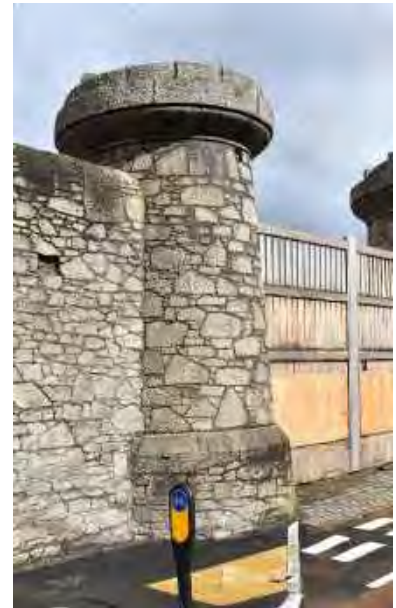
Left Pier

Generally, the pier appeared in a sound condition although some cracking of the mortar was evident at higher level. The top of the pier could not be inspected and it is further recommended that this is undertaken to determine the water tightness and water management from the roof of the pier.

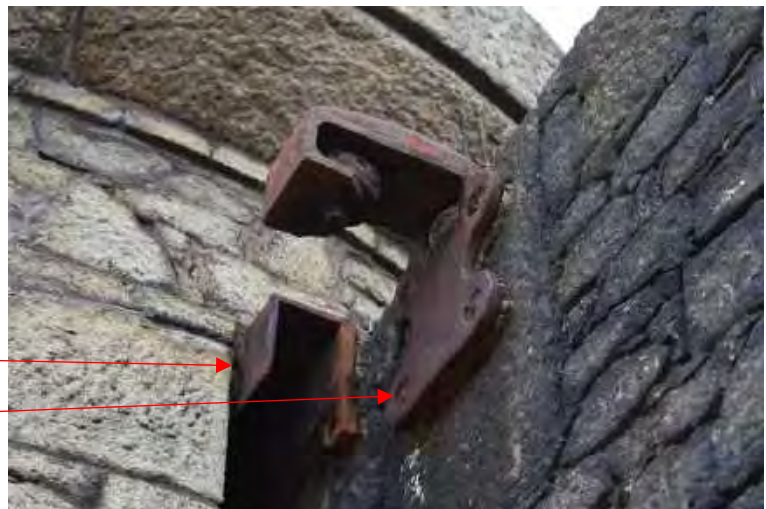
Cast iron guide internally within pier for the timber gate. Externally on the main wall there are 2No additional guides - the more southerly guide is broken .

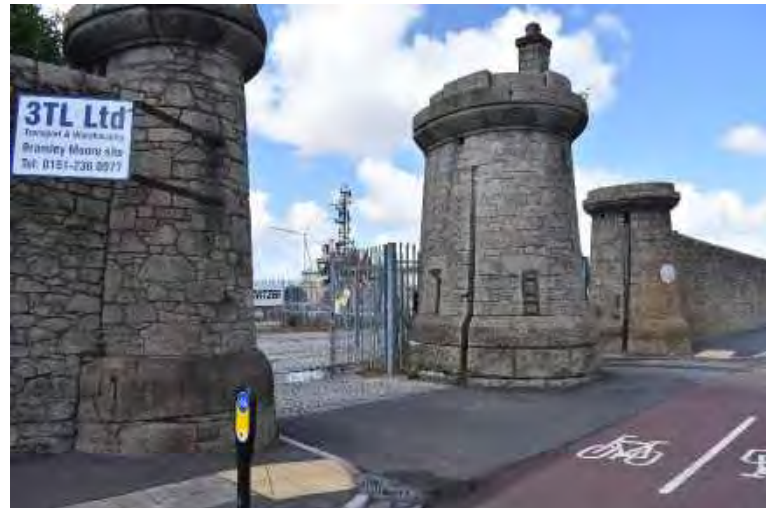
Southern entrance

The southern entrance is in use to access a number of businesses adjacent to Bramley Moore Dock although additional steel gates have been installed behind the line of the piers. Within the recesses of the piers the original timber gates are present although these are in a degraded condition and not operational.

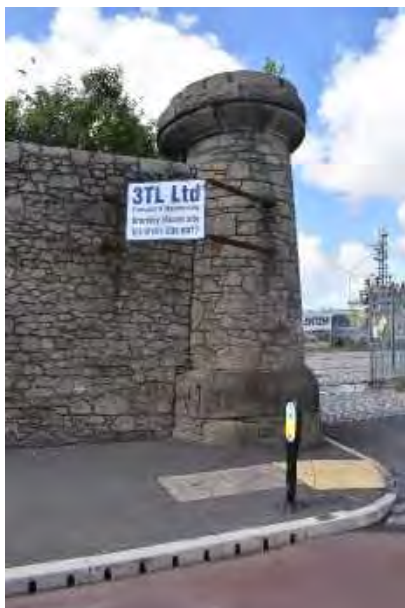
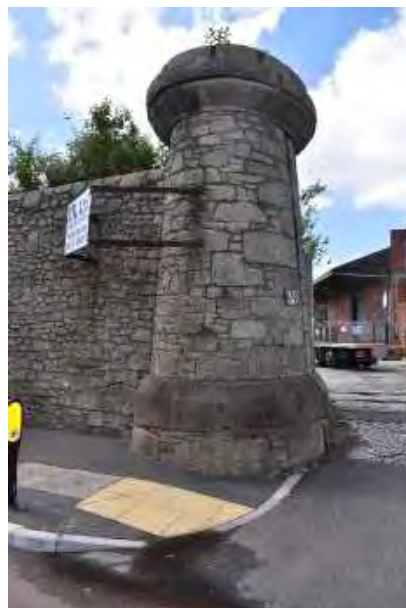
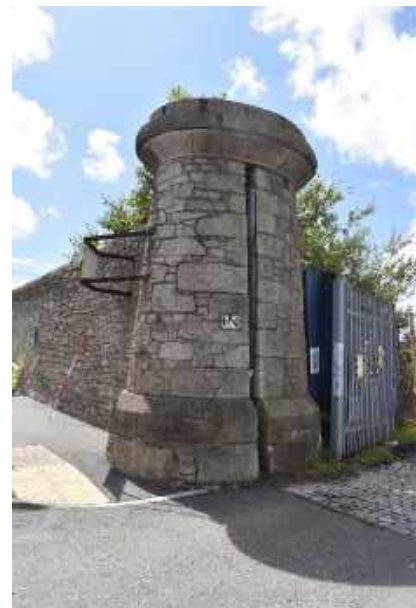
Left Pier

Signage fixed to pier with ferrous staining of the stonework. Plant growth to upper stonework elements. Gate present in recess.

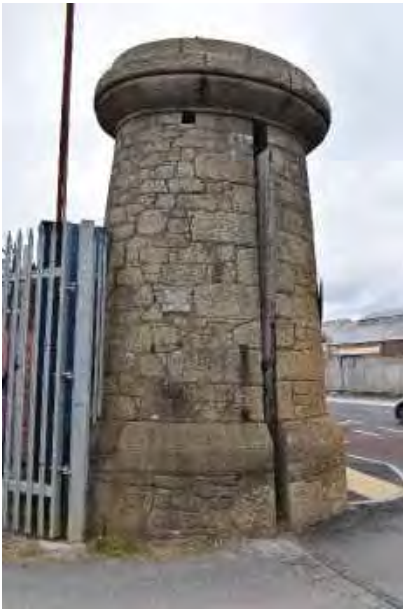
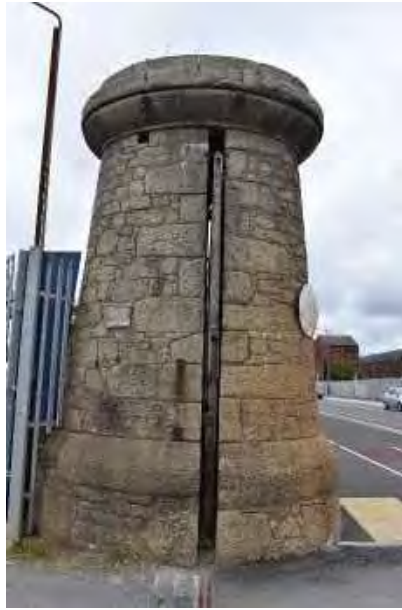
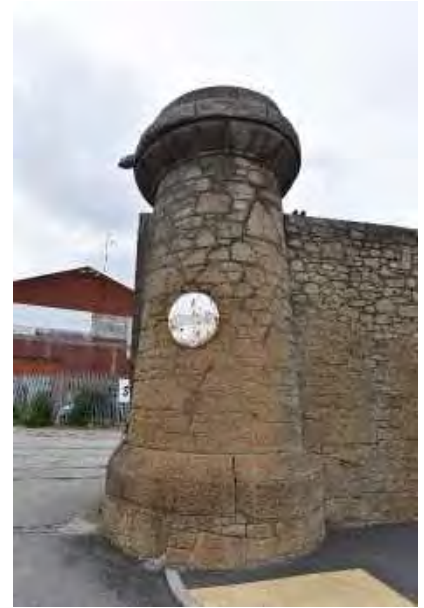
Right Pier

Timber gate (RH Pier) – gate is in a degraded condition however substantially intact.

Gate passes through a slot in the stone pier.

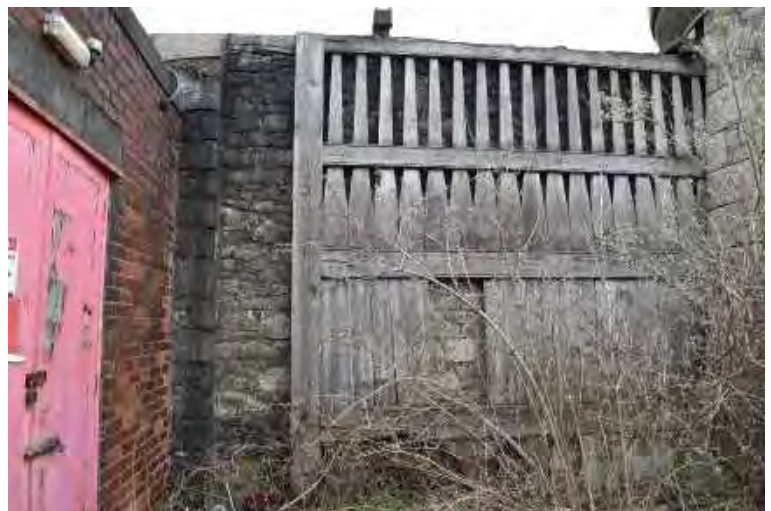
Iron wheel supports the gate on a cast iron track. At high level a cast iron guide is present within the pier stonework.
