| Location Ref: | BMD Elevation – Section 44 |

| Location Ref: | RR Elevation – Section 01 |

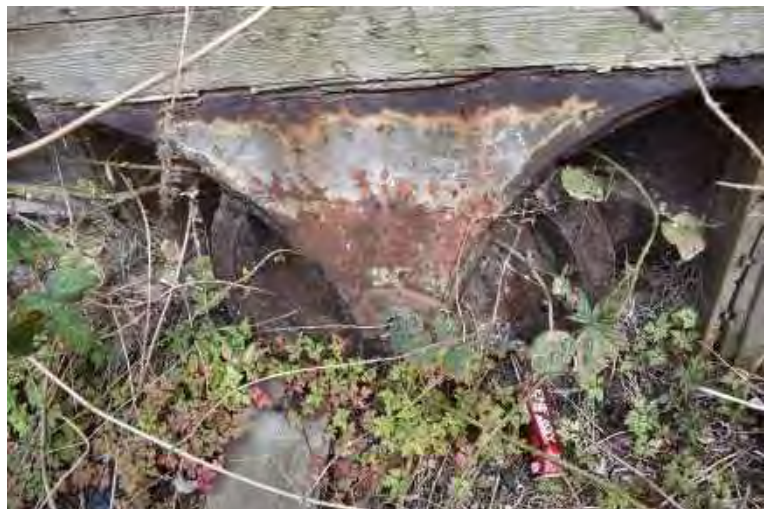
Timberwork is degraded especially at low level however a conservation repair could be undertaken to retain historic elements of the gate in sound condition.

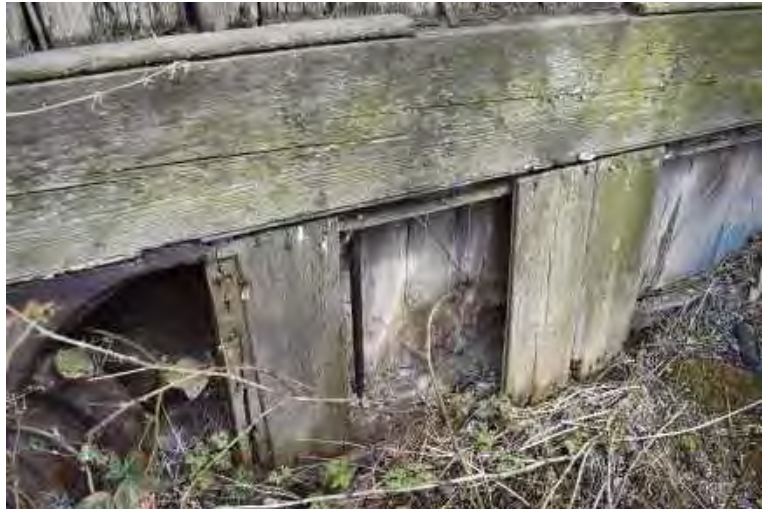
Timber meeting rail is damaged although intact. Uneven coursing of the stonework.

Cast iron gate pull is still present.

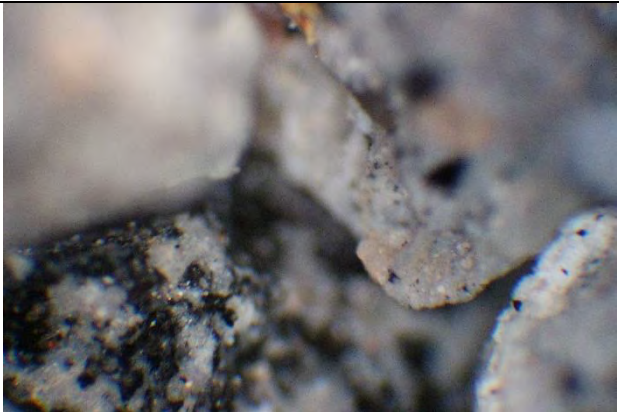
| Material Retained on BS Sieves | Photograph (50x) |
|---|--|
| <p>Retained on 1.00mm sieve</p> <p>Particles of coal with some undissolved binder on surface of particles. Some light brown and clear rounded quartz particles.</p> | |

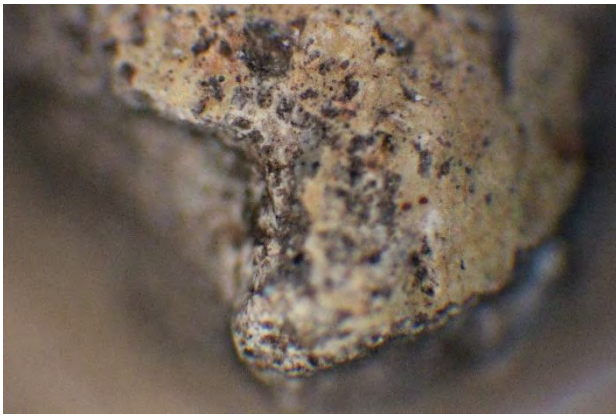
| Material Retained on BS Sieves | Photograph (50x) |
|--|--|
| Retained on 2.00mm sieve Larger particles of limestone. | |

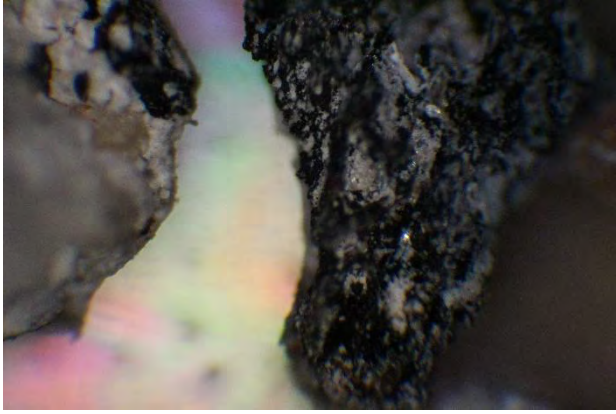
| Material Retained on BS Sieves | Photograph (50x) |
|--|--|
| Retained on 1.00mm sieve Particles of coal with some undissolved binder on surface of particles. Some light brown and clear rounded quartz particles. | |

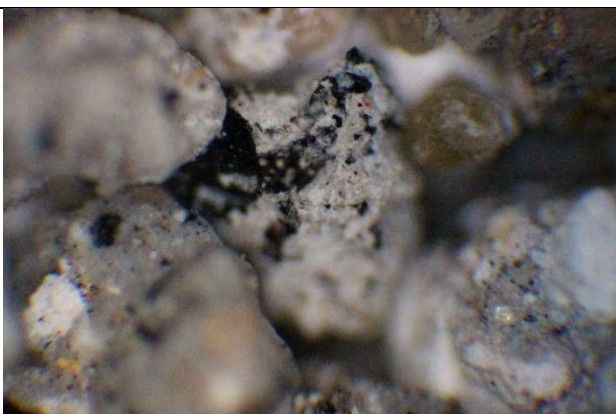
| Material Retained on BS Sieves | Photograph (50x) |
|--|--|
| Retained on 0.5mm sieve Particles of coal with some undissolved binder on surface of particles. Some light brown and clear rounded quartz particles. | |

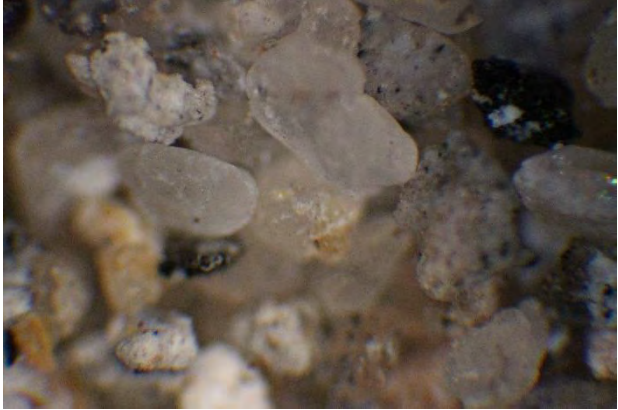
| <p>Retained on 250 micron sieve</p> <p>Some larger rounded particles of light brown, white and clear quartz with some coal particles.</p> | |

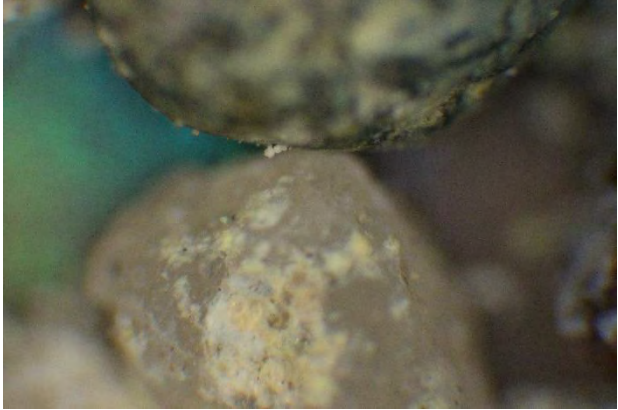
| Material Retained on BS Sieves | Photograph (50x) |
|---|--|
| <p>Retained on 1.00mm sieve</p> <p>Larger particles of rounded light brown and clear quartz with some undissolved binder on surface of particles.</p> | |
