# **STRUCTURAL SURVEY REPORT**

**BEECHLEY HOUSE, LIVERPOOL**

**REDROW HOMES LIMITED**

**CF 7834  
MARCH 2016**

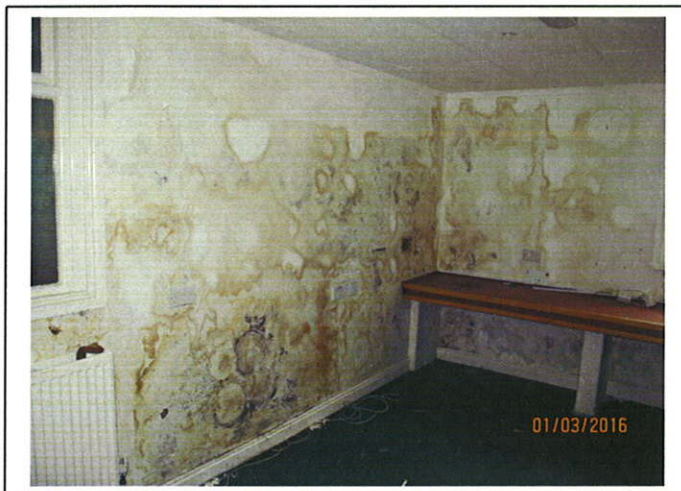
Room 2 has also been refurbished using plasterboard walls, carpeted floor and a suspended ceiling. Again, there is no evidence of cracking in the structural walls, but damp ingress is apparent though the retaining walls on the rear and side elevations.

Basement  
Room 2 - Damp penetration through retaining walls

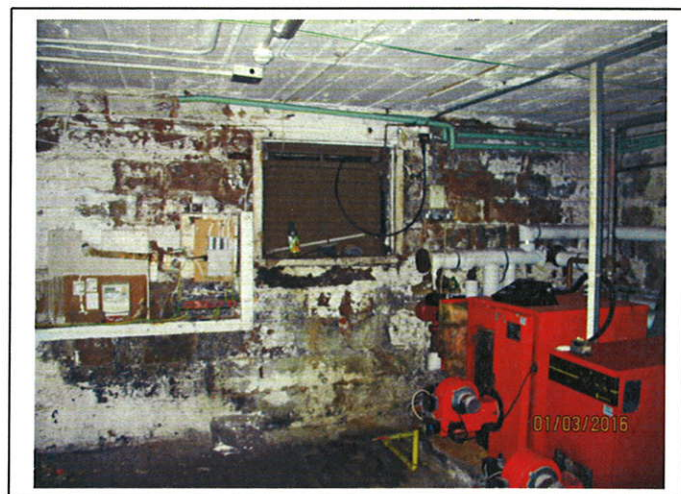
Basement  
Room 10 - Damp penetration through retaining wall

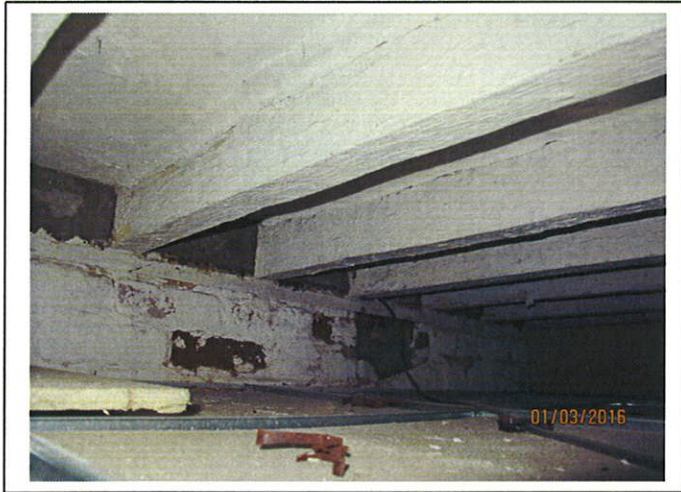
Basement  
Typical joist support detail.

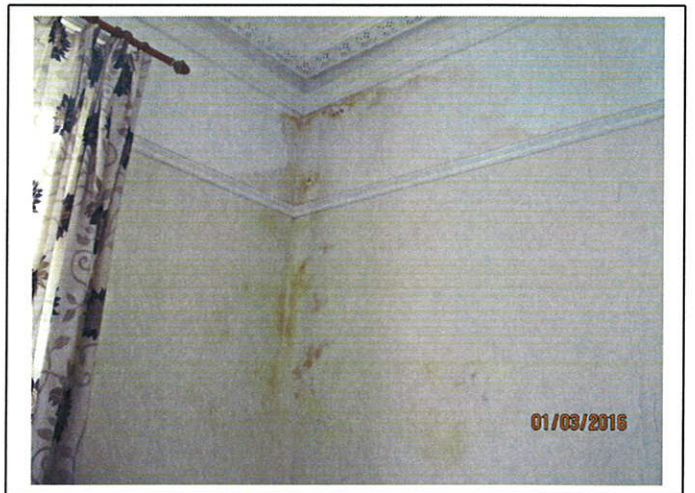
Ground Floor  
Room 10 - Damp penetration through front wall and side wall

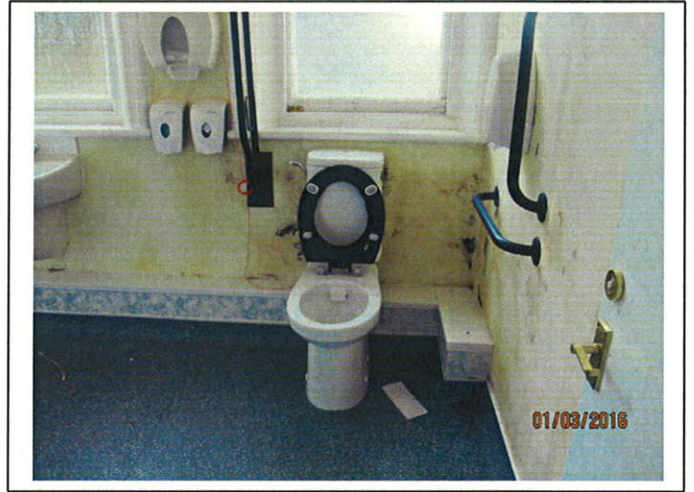
Ground Floor  
Room 15 - Damp penetration through side wall

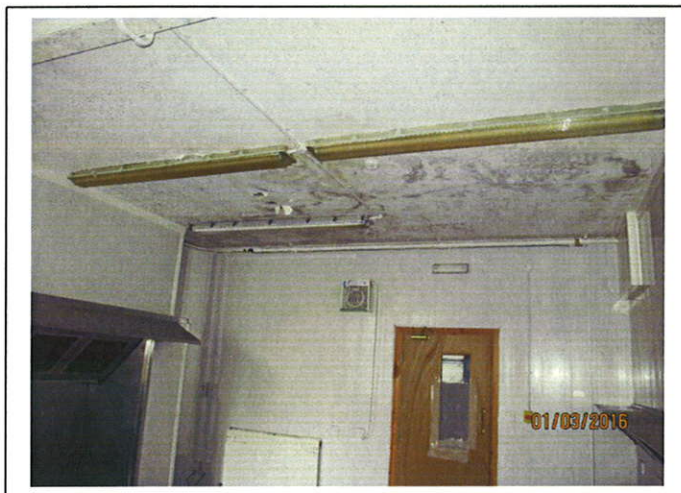
Ground Floor  
Room 19 - Damp in ceiling and fungal growth.

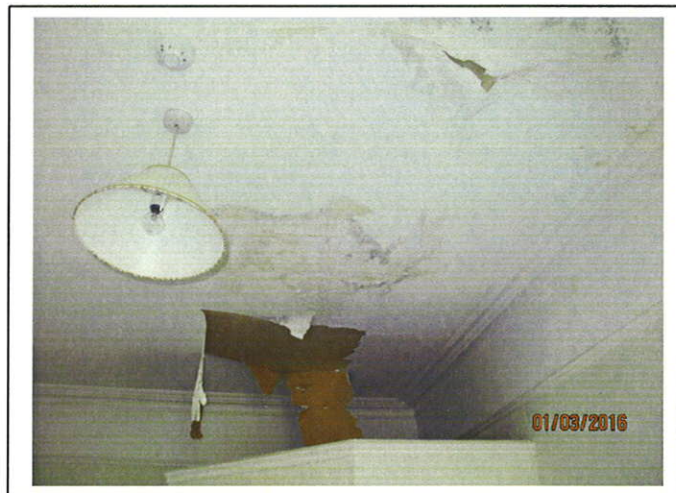
First Floor  
Room 1 - Damp penetration through the ceiling.

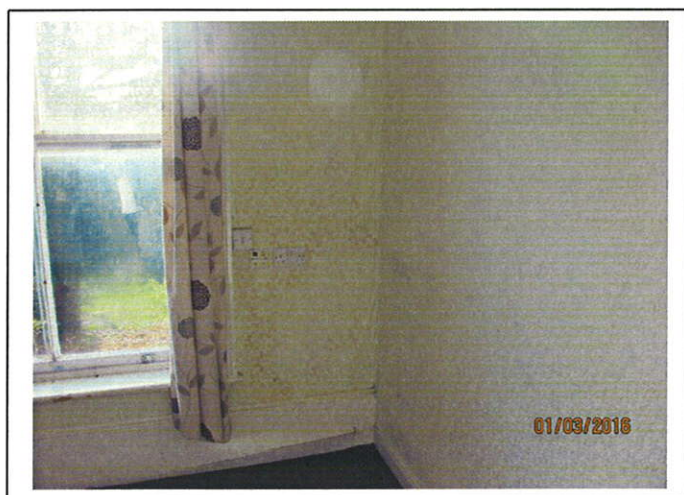
First Floor  
Room 6 - Damp penetration through the front wall.

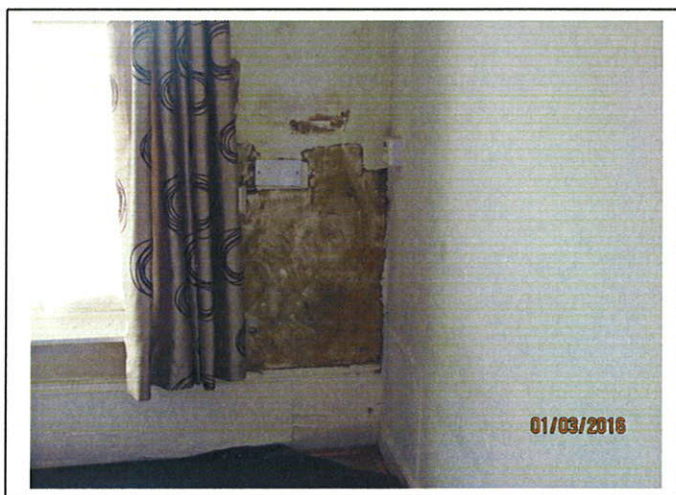
First Floor  
Room 7 - Damp penetration through the front wall.

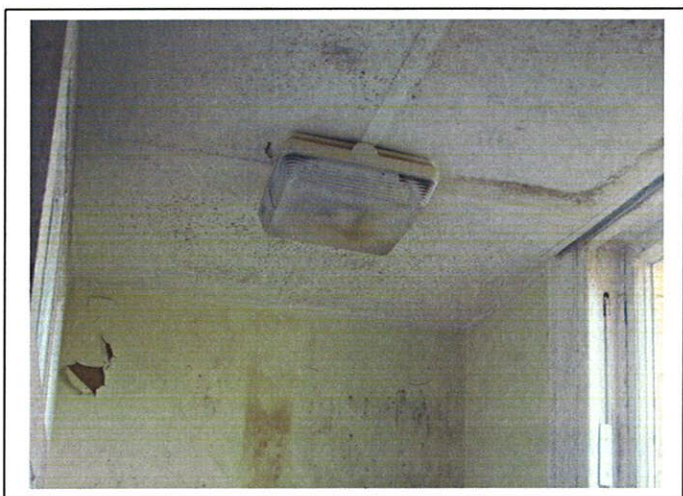
First Floor  
Room 10 - Damp penetration and mould growth.

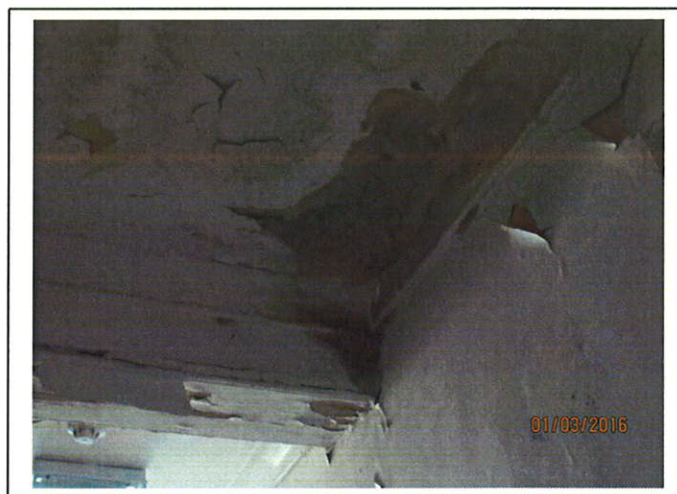
First Floor  
Corridor in front of Room 9 - Damp penetration through ceiling.

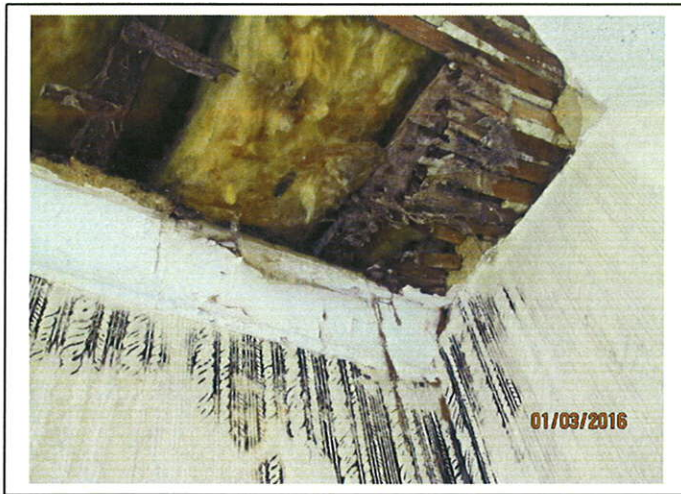
First Floor  
Room 14 - Damp penetration causing collapse to ceiling.

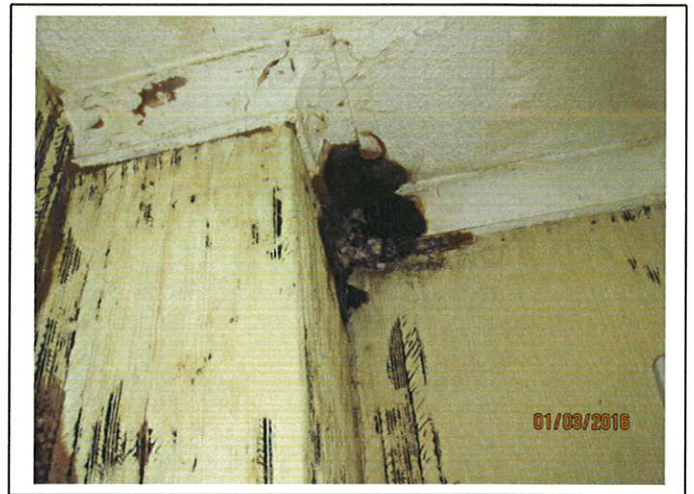
First Floor  
Room 14 - Damp penetration causing collapse to ceiling, mould growth in the en-suite.

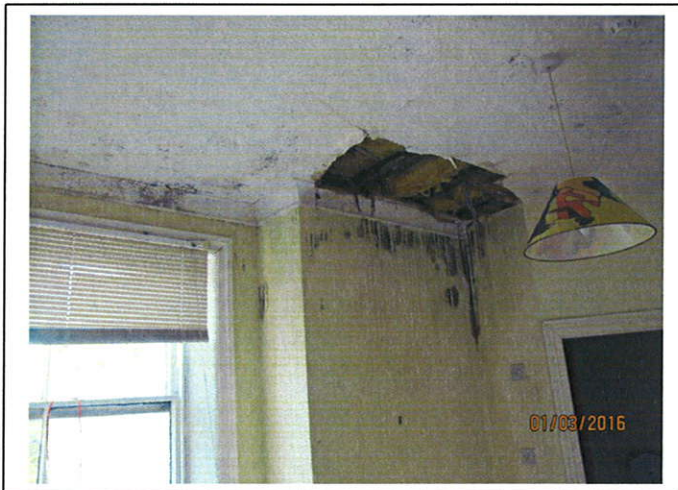
First Floor  
Room 14 - Damp penetration causing collapse to ceiling.

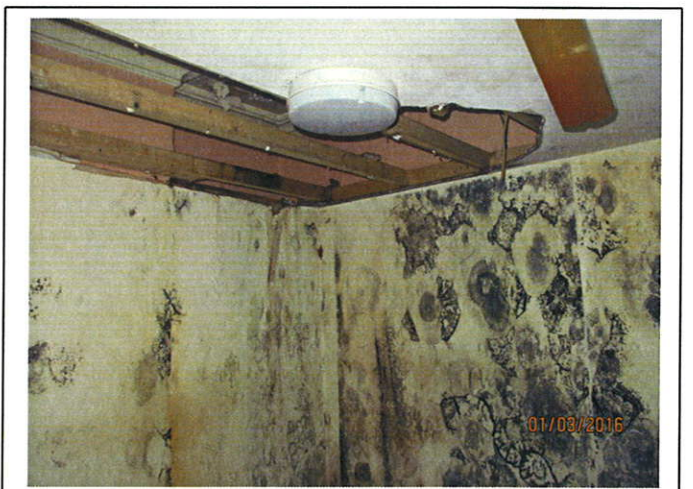
First Floor  
Room 20 - Collapsed ceiling and mould growth

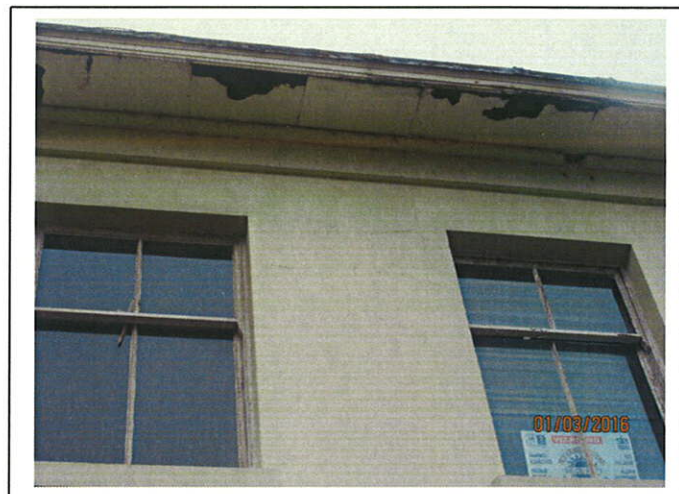
Rotten soffit boards.

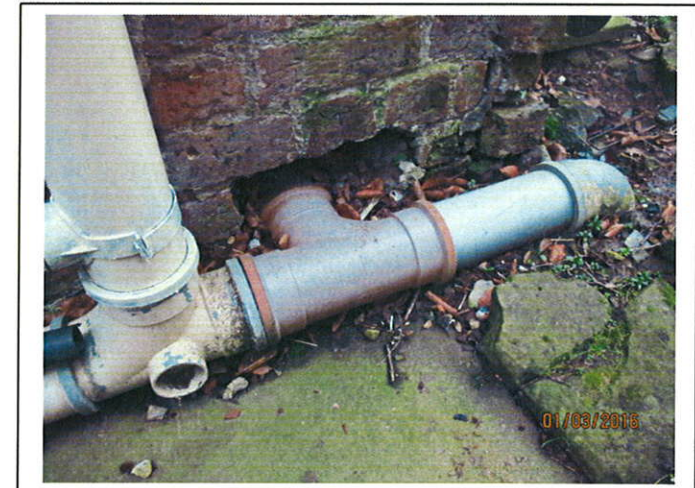
Drainage on the rear elevationl.

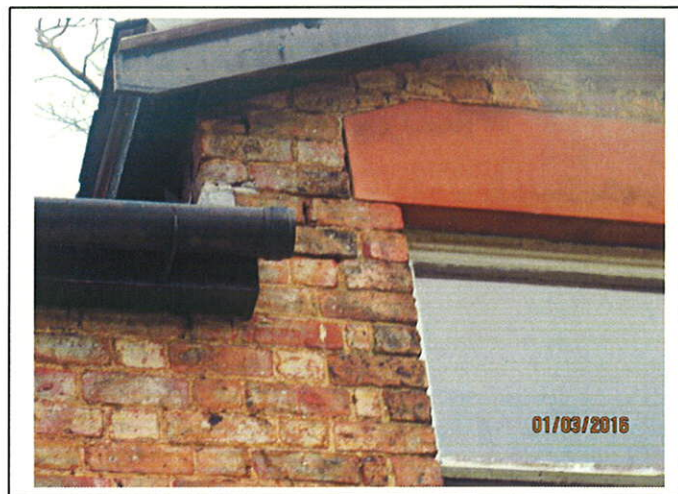
Slight movement at lintel end.

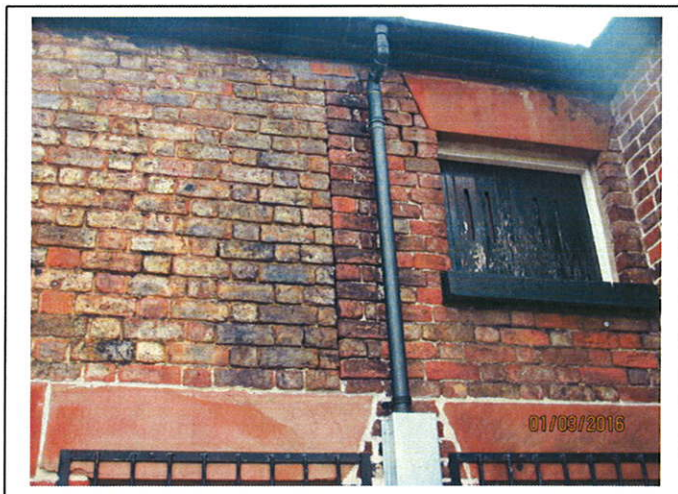
Joint in masonry.

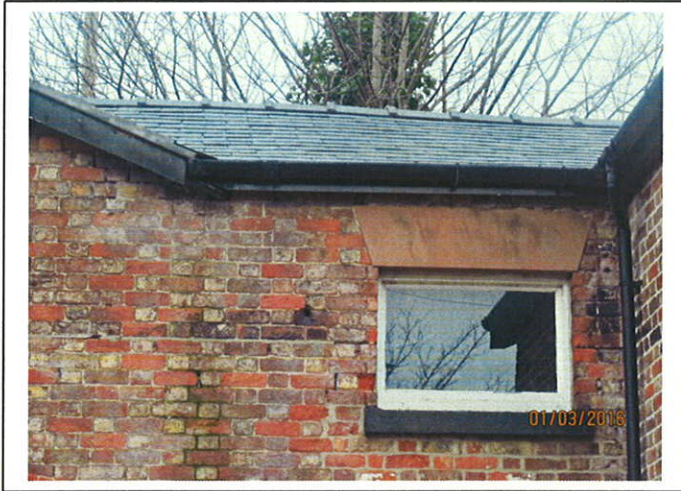
Roof deformation.
